MIFACE INVESTIGATION: #04MI160

SUBJECT: Carpenter Dies When Eight-foot Trench Wall Collapses During Sewer Pipe Replacement

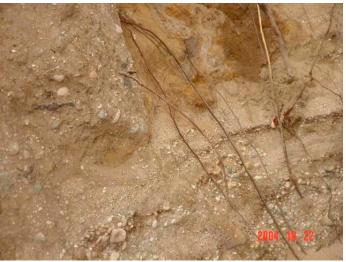
Figure 3. Soil composition and tree roots

alley. The soil conditions in this excavation were sand/gravel (See Figure 3). The owner states that at the time of the wall collapse, the backhoe was located approximately six feet from the edge of the trench and was not idling. The company blocked off the alley throughway so there was no vibration from the alley traffic.
