MIFACE INVESTIGATION: #04MI180

SUBJECT: Mill Hand Dies When Drill Was Thrown From Shattered Hardened Steel Tool Extension and Strikes Him In Chest

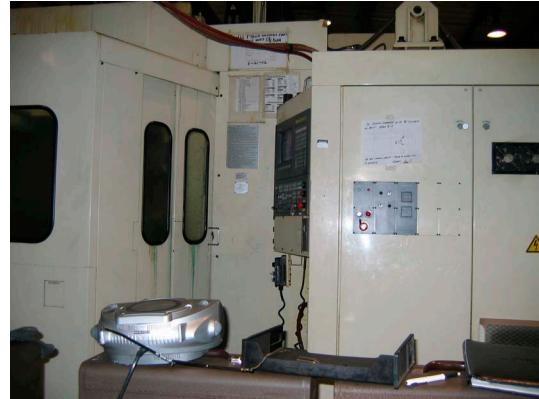
Figure 1. CNC machine involved in incident

The victim was operating a MC-600-H CNC machine with a spindle capability of 5000 rpm. The machine was purchased new in 1997. See Figure 1. The CNC machine was equipped with automatic tool loading. The machine's tool magazine contained many drilling tools, and due to the various milling operations required, it was often necessary to change from one drilling tool to another in the same milling program. The tool used was mounted in a spindle and could move as needed to perform whatever cutting operation was required. The material machined was held steady in a fixture or precision vice on a table. The table was moveable, and the computer controlled the movement. The emergency stop button was clearly identified and accessible on the machine the victim was operating.

MIOSHA examined the CNC machine after the incident. An interlock switch on the doors at the CRT position was out of adjustment. This interlock would prevent the machine from operating if the doors were opened. This non-interlock was not a factor in the incident. It was possible to see damage on the automatic tool change arm. The tool changer swing arm assembly above the machine spindle was dented. Also the dent’s distance from the machine’s “face” appeared to “line up” with the bent tool extension.

Although not a factor in this incident, an interlock switch on the doors at the CRT position was out of adjustment. An out-of-adjustment interlock switch could be a contributing factor in a future injury/fatality. Newer machines have a program override to ensure that doors may not be open when machining is being performed.

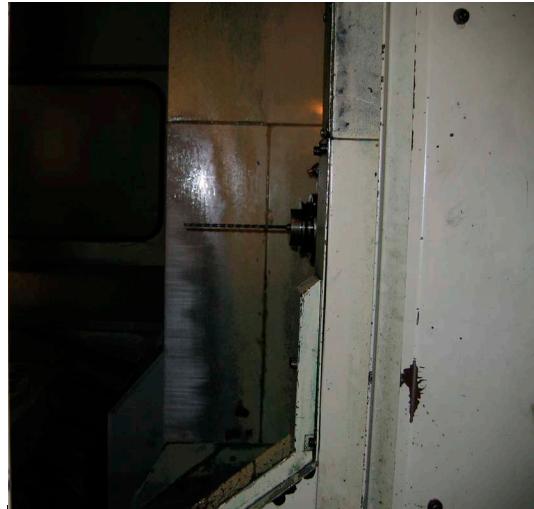
a purchased six-inch long, one-inch O.D. hardened steel tool extension. The hardened steel tool extension had a 1/2-inch internal diameter thread that was connected to an in-house manufactured soft steel tool extension that was 10-inches long and had a one-inch O.D. Two inches of the soft steel tool extension was inside of the tool holder. The victim attached this tooling to the tool holder and pressed the “clamp” button on the computer console. The overall extended tool length was estimated at 24 inches. Figure 2 shows a sample tool (not the tool involved in the incident) placed in a tool holder within the CNC machine with the machine’s doors in the open position.

The spindle speed force exertion caused the soft steel tool extension to bend to an approximate 90-degree angle. The bending caused the hardened steel tool extension to strike part of the automatic tool changer. The hardened steel tool extension shattered and released the drill. The drill shank bent approximately 10 degrees. Both the shattered extension pieces and the thrown drill struck the victim. The extension pieces struck the upper side of his cheekbone, his jaw and neck. The drill entered the victim’s body below the left collarbone point first. The programmer hit the emergency stop button. The supervisor who heard the bang went to the location, attempted first aid measures and tried to stop the bleeding. Emergency response was called and the victim was taken to the hospital where he died.

Figure 2. Example of tool in holder within the CNC machine with doors open

MIOSHA did not issue any citations to the employer. MIOSHA recommended that the firm prohibit the use of mild (soft) steel tool extensions and use only properly hardened tooling.

After the incident and in compliance with the MIOSHA recommendation, the company incorporated the use of hardened steel extensions. They also developed a color-coding system when unusual tools are required.
