MIFACE INVESTIGATION: #05MI024

SUBJECT: Owner Of Excavating Company Dies When Excavator Overturns Into Water/Mud of Gravel Pit.

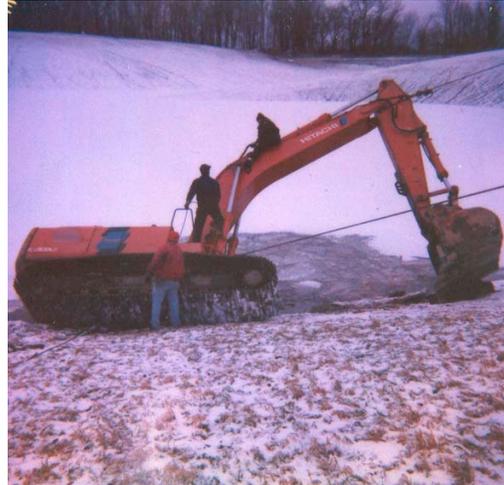
Figure 4. Divers hooking cables to excavator

excavator was needed excavate around the cab in the mud and water because the cab was so deep in the mud. It took approximately one hour to upright the excavator. The upright operation was stopped when the cab of the excavator was out of the mud and water. The victim was removed from the cab and resuscitative efforts were initiated at the scene. The victim was taken to a local hospital via ambulance where he was declared dead.
