## MIFACE INVESTIGATION: #05MI064

### SUBJECT: Farmer Pinned Under Left Rear Tire of Industrial Tractor-Loader With Backhoe

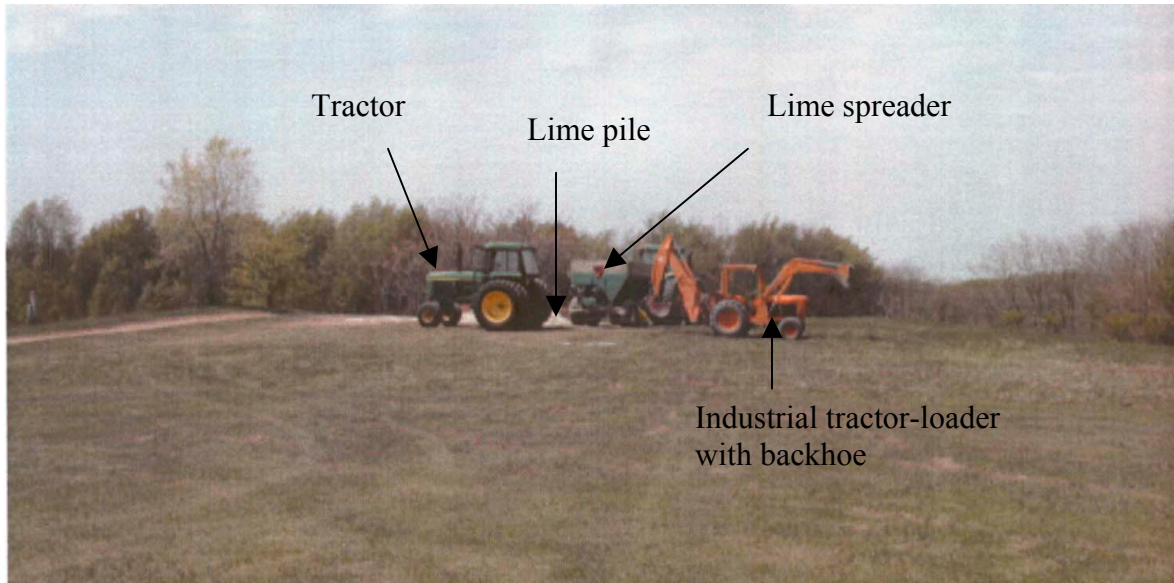
Figure 1. Overview of incident scene showing industrial loader on slight decline, location of lime pile, tractor and spreader

On May 6, 2005, an 82-year-old male farmer was pinned under the left rear wheel of the John Deere 300-B industrial tractor-loader with backhoe. He was in the process of loading lime into a spreader so it could be distributed on his fields. He left the loader bucket in the air, and had not placed the tractor-loader in park. The engine was idling. It is presumed that as he was trying to exit or enter the tractor-loader, it began to roll down a slight incline and he was pinned under the left rear wheel. Neighbors who heard the tractor-loader idling looked out their window with binoculars and saw the victim under the left rear tractor wheel. They called 911. When emergency response arrived, he was declared dead at the scene.

- When parking a machine on a slope, position the machine at a right angle to the slope.

It is always best to park a machine on level ground. But in many instances, this is not possible due to terrain. If you must park on a slope or incline, position the machine at a right angle to the incline to prevent machine movement down the incline.

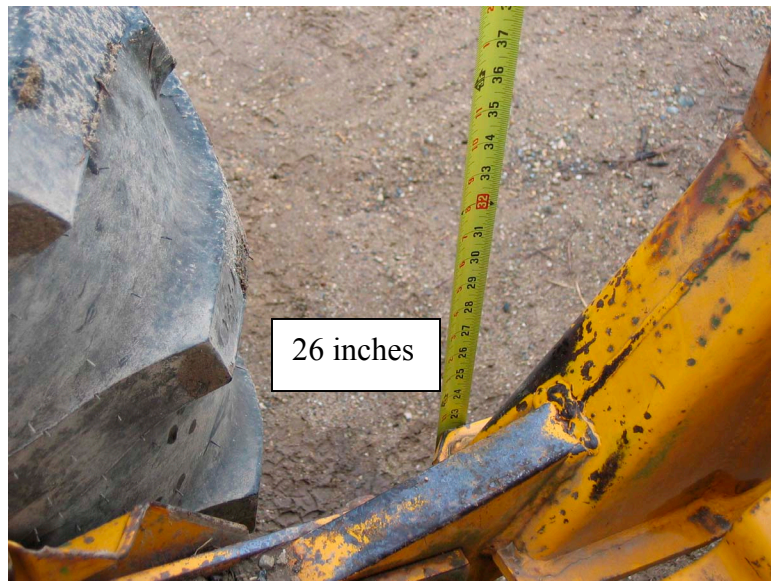
The victim was operating a John Deere 300-B industrial tractor-loader with backhoe. He purchased the equipment new in 1976. The rear tires were 49 inches tall with a tire tread width of 17 inches. The rear tire size was 17.5 L24. The distance between the ground and subframe (top of where you step into the tractor-loader) that carried the loader weight was 26 inches. See Figure 2. The distance between the rear tire and loader frame was 12 inches. See Figure 3. The loader weight was approximately 8,000 pounds.

Figure 2. Height of subframe from ground

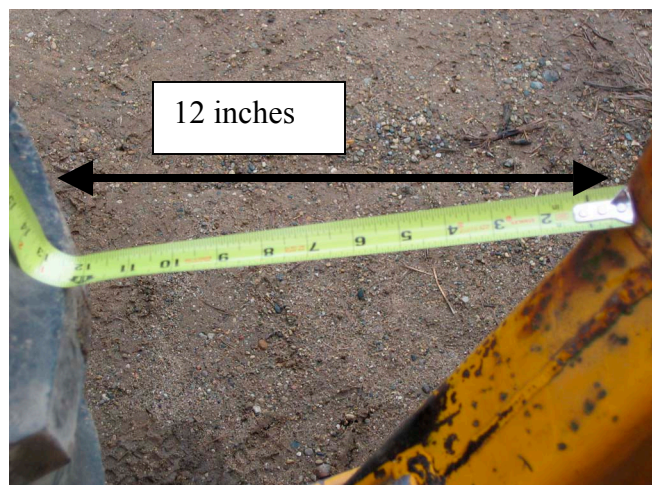
Figure 3. Width between subframe and rear tire

The victim probably placed the right lever of the tractor-loader into a “neutral” shift position (in the middle of the “H”) and left the engine running. The left tractor-loader lever was engaged in the low speed position. See Figure 4. His family members developed the following scenario: The victim noticed that he did not have his work gloves on when he was beginning to load the lime with the 300-B. The tractor-loader was located on a slight incline, estimated at approximately two degrees by his son. Without lowering the bucket or placing the speed gearshift in park, he dismounted the tractor-loader while it was idling to walk to the 8110 to retrieve his gloves. It is unknown when he may have been struck by the left tractor-loader tire; he could have been dismounting or trying to stop the tractor-loader movement while standing on the ground. If the victim had already dismounted, he was probably trying to stop the moving tractor-loader by either reaching between the frame and the fender or by trying to step back into the loader to place the gearshift into park. He had approximately 12 inches between the frame and the bumper to enter the cab (See Figure 3). He either slipped or was caught by the left rear wheel and he was pinned under the wheel.

The fatal injury may have occurred when the victim was attempting to stop the moving tractor-loader, either when reaching between the subframe and the fender or while trying to step into the cab. Operators should not attempt to remount moving vehicles. In this case the tractor-loader would not have caused any significant human or environmental damage. It should have been let go and retrieved once it came to rest.

- Do not try to re-enter moving machinery.

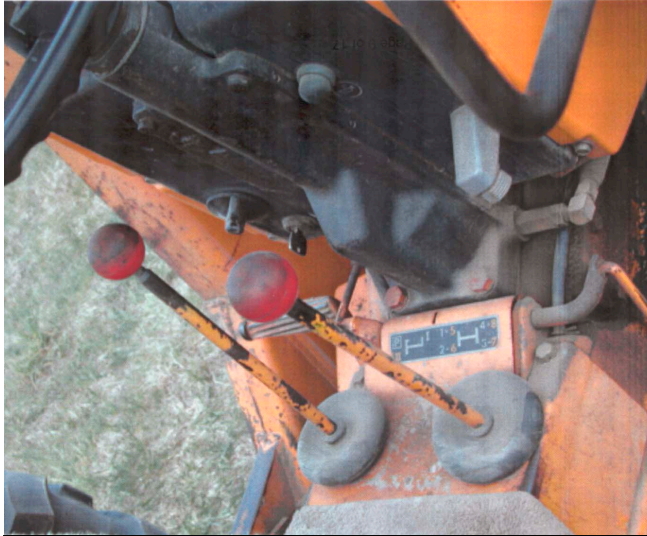
Figure 4. Position of gear levers taken after incident.

- Practice safe dismount procedures including lowering the bucket and locking the brakes or using the park-lock.

Generally, an operator, while sitting in the operator's seat, should stop the machine, lower any attachments to the ground, shift controls to neutral/park and lock (if so equipped), engage the parking brake, stop the engine, cycle all hydraulic controls to relieve system pressures and remove the key. Performing these steps will reduce the likelihood of a tractor or machine unexpectedly moving forward or backward.
