MIFACE INVESTIGATION: 05MI065

SUBJECT: Hispanic Brick Mason Electrocuted When Rerod Contacts Powerline

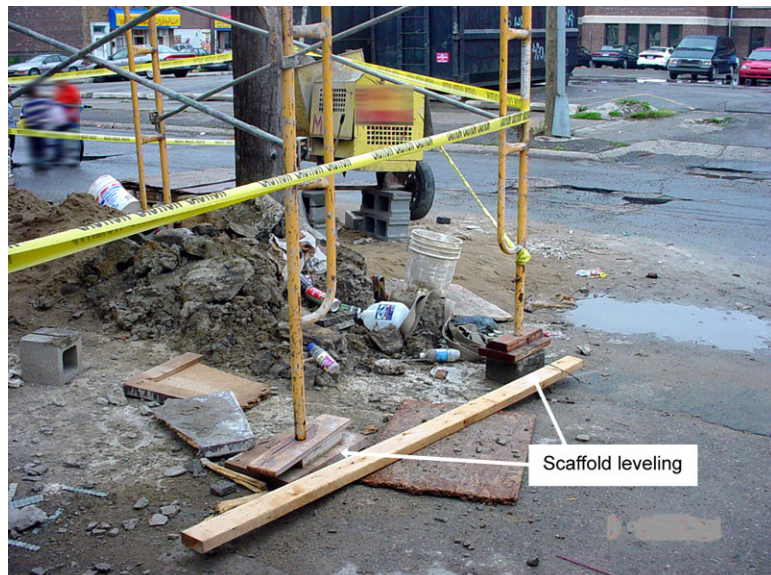
All four workers at the job site had set up the scaffolding for this job. The scaffold was erected improperly and was leaning. They had learned how to set up a scaffold on-the-job by helping others. They had erected it on concrete, so they felt it was secure, and they felt they did not have to level it more than they had (Figure 2). They thought they had done a good job. Apparently the superintendent and the general contractor were satisfied that it was sufficiently stable, because they had both looked at the scaffold and had not commented otherwise.

Figure 2. Example of scaffold leveling

- Employees required to work from a scaffold should be trained by a person qualified in scaffold safety.

The workers believed they had erected the scaffold safely, because it was erected on concrete, and they thought it did not tilt. They had erected it the way they had been taught to do so by others with whom they had worked. Although the faulty scaffold erection did not directly contribute to the electrocution, other than that it was erected too close to the powerlines, it was indicative of the inadequate training and understanding of safe work practices of the employees at the jobsite.

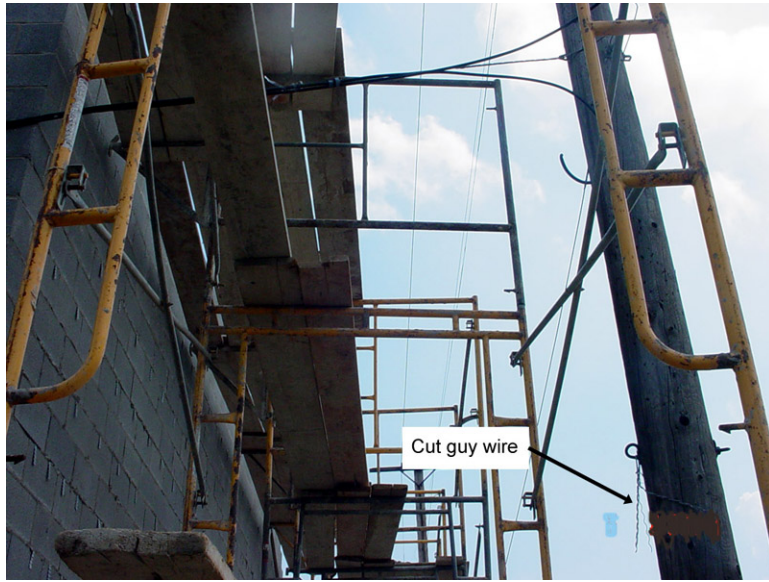
construct the wall, a guy wire had been attached between two electrical poles on the street near the job site to stabilize them. It had been cut (Figure 3), because the wall could not have been constructed if it were left where it had been originally. The angle of the wire as it connected the poles would have carried it through the area where the wall was to be constructed. Both workers said they had not cut the guy wire, and indicated that it had been cut prior to the time they first arrived at the job site.

Figure 3. Photo showing cut guy wire

It is not known who cut the wire, but whoever it was had little regard for safety, either of the workers or of the community. The stability of the electrical poles was compromised by this action.
