MIFACE INVESTIGATION: 05MI084

SUBJECT: Worker Dies in Trench Collapse

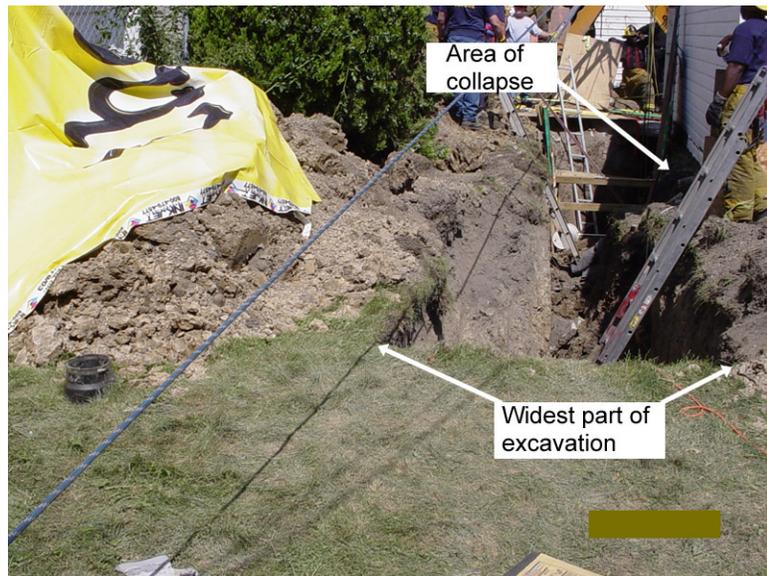
On Friday, August 19, 2005, at approximately 12:00 p.m., a 24-year-old worker died when he was buried under a wall of the trench he was working in (Figure 1). The excavation wall and part of the sidewalk next to the concrete garage floor collapsed onto him while he was attempting to attach the new PVC pipe he and his coworkers had installed that morning to the main sewer in the alley. One of the decedent's coworkers was also caught in the collapse. Two other

Figure 1. View of excavation from west to east showing widest part, area of collapse, vertical sides and spoils.

Excavation, Trenching and Shoring, Part 9, Rule 941(1) The sides of an excavation greater than 5 feet deep shall be sloped unless otherwise supported. The sides of the excavation were not sloped; there was no shoring; and no trench box was used.

- Employers and self-employed contractors should slope or shore or use trench boxes in all excavations greater than 5 feet deep.

MIOSHA Part 9, Rule 941(1) Excavation, Trenching and Shoring requires that any trench greater than 5 feet deep which may be entered by a worker be sloped or shored in order to prevent cave-in. Shoring may be accomplished by the use of trench boxes or by construction of an adequate structure. Because of the limited space available for sloping the sides of the trench in this backyard, the use of a trench box might have prevented this fatality.

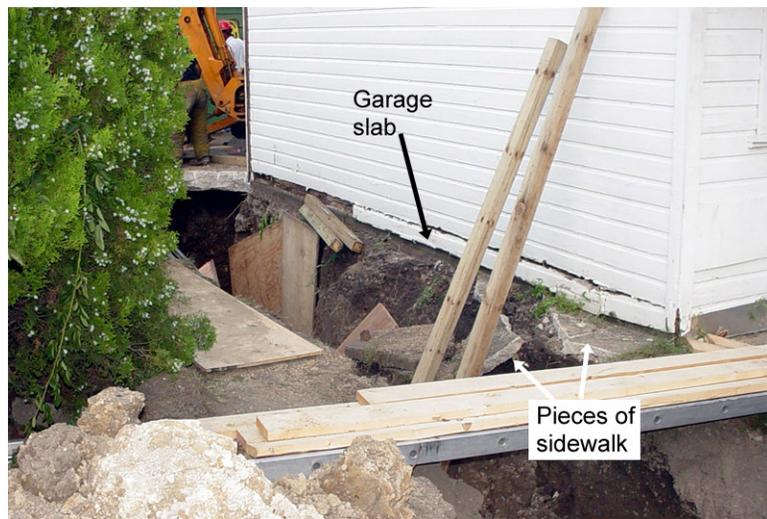
Figure 2. Pieces of sidewalk in collapsed area and garage slab separated from foundation.

The broken sewer line under the garage had been leaking water and saturating the soil under the garage floor for several months before the day of the incident. The trench wall area that collapsed was where the water had been leaking from the old, broken sewer line under the garage. Approximately 20 feet of water-saturated dirt 24 to 30 inches wide and a 4-inch thick concrete sidewalk running directly next to and the full length of the garage collapsed into the trench (Figure 2). The garage slab tilted toward the cave-in.

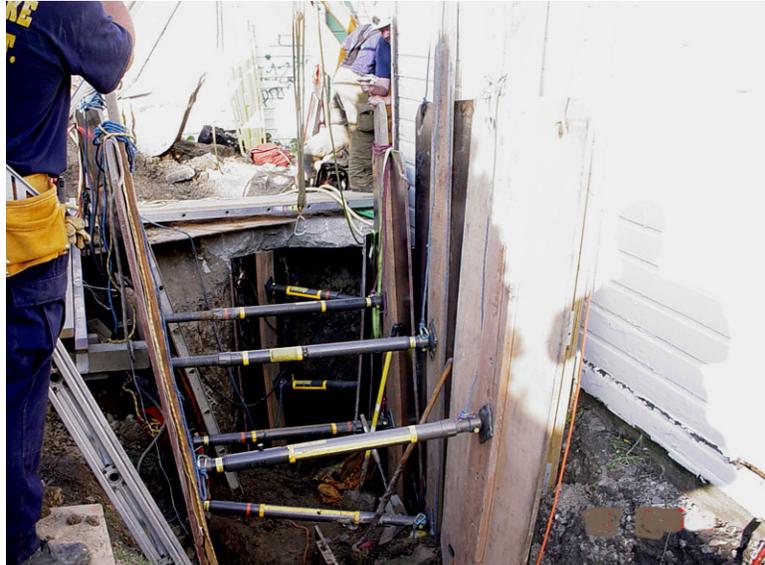
First responders used sections of neighbors' picket fences and 4-foot by 4-foot posts to create temporary shoring to rescue the company owner. Because the trench sides were still unstable, they waited for responders with the appropriate excavation shoring equipment (Figure 3). The body of the decedent was recovered approximately 8 hours later.

Figure 3. Shoring installation

- Emergency medical services and fire-rescue personnel should be knowledgeable about proper rescue techniques involving excavation sites and ensure that adequate shoring equipment is on hand at all times.

Untrained coworkers (neighbors) and first responders using inadequate materials (picket fence sections) uncovered and removed one victim from the trench before trained rescue personnel with the proper equipment arrived at the scene. Workers should never, under any circumstances, enter a hazardous environment to attempt a rescue operation unless properly equipped and trained in the use of the equipment and methods required for rescue. In this instance, untrained workers entered the trench, uncovered one of the victims and removed him from the trench, placing themselves at risk of becoming victims.

Also, it was pointed out to them that the spoils were still too close to the excavation when they were installing shoring. Only those persons trained in the requirements of NFPA 1670 should attempt rescue operations after a trench cave-in occurs. All persons at the incident site should follow the directions given by the Incident Commander or his/her designee in order to provide the most optimal circumstances for the safety of all persons on the site during rescue operations. Rescue attempts should be discontinued when rescue personnel are placed in imminent and immediately dangerous situations until proper shoring of excavations can be accomplished.

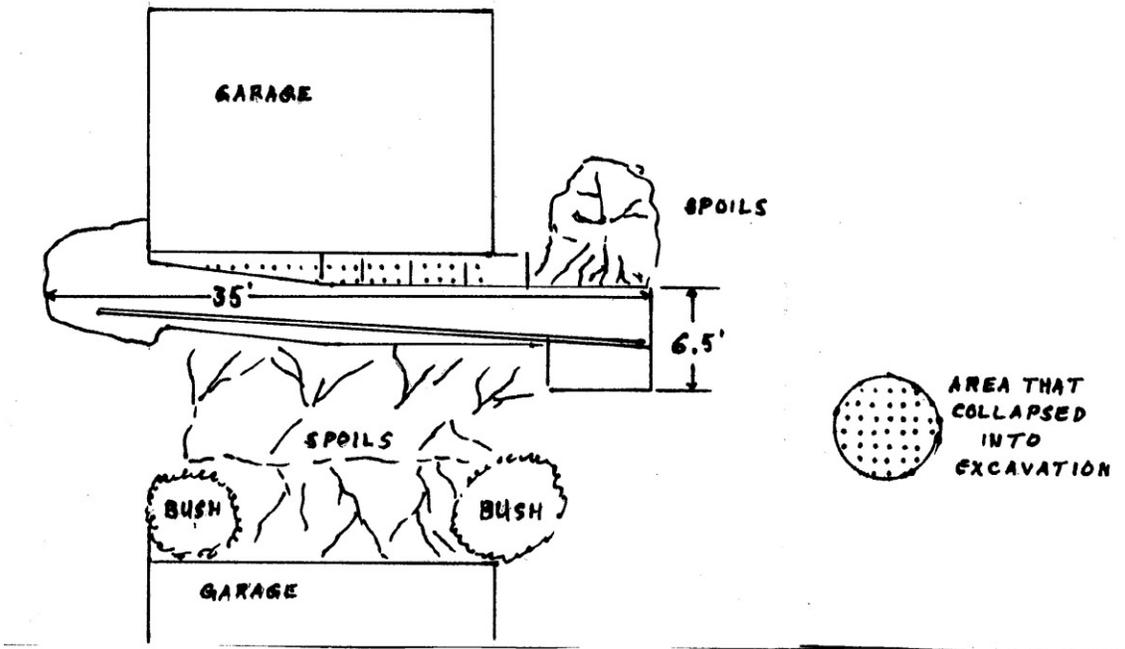
Diagram 1

The trench that had been dug from near the back of the house to the sewer main was approximately 30 feet long. It was approximately 5-feet wide at the beginning near the house. When the excavation reached the garage, it narrowed from 5 feet to 3-1/2 feet and continued at this width to the alley. The initial depth near the house was approximately 6 feet and the trench slanted down toward the sewer main to approximately 9-1/2 feet deep (Diagram 1). The sides of the trench were close to vertical.

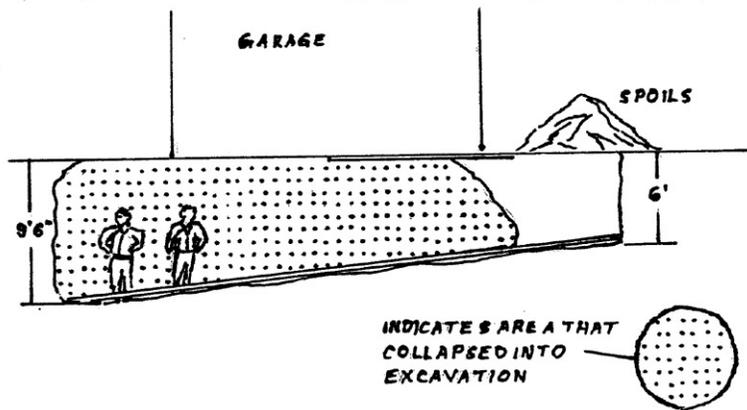
Diagram 2

The employee outside the trench saw the dirt start to collapse and yelled something like, "Dirt." The company owner, who was standing several feet away from the decedent toward the house where the trench was approximately 7-feet deep, stood up (Diagram 2). He was buried to his chest, but he was able to be extricated by neighbors and first responders. The

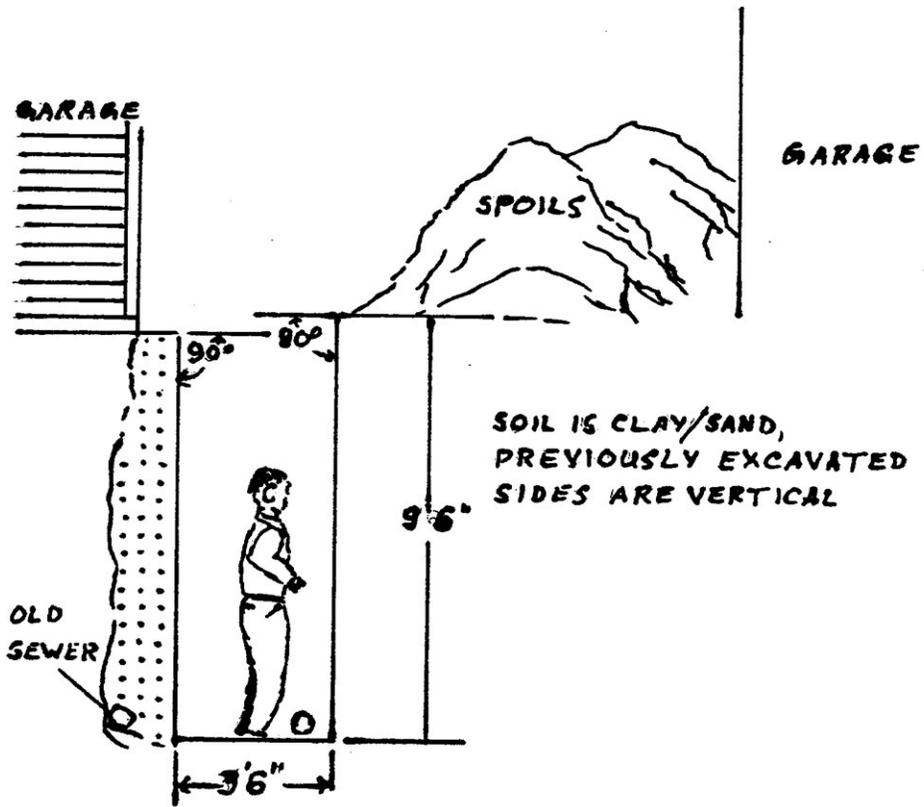
Diagram 3

decedent, bent over tying the pipe to the main in tight quarters where the trench was 9-1/2 feet deep, was completely buried (Diagram 3).
