## **MIFACE Investigation #06MI006**

### **Subject: Truck Driver Killed After Falling Through Unprotected Skylight**

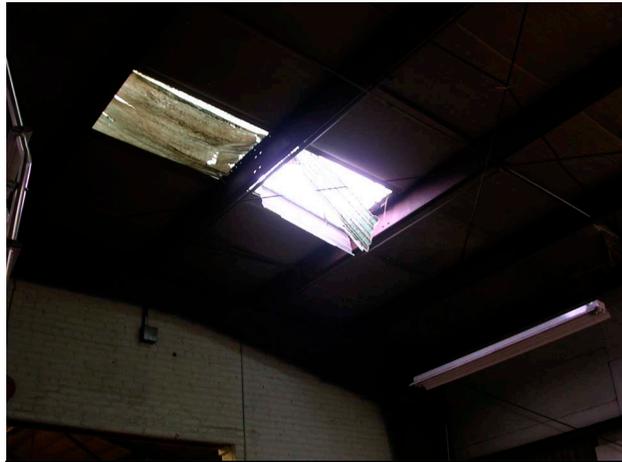
On February 3, 2006, a 44-year-old male truck driver/crane operator was killed when he fell through a 3 x 8-foot unprotected corrugated fiberglass skylight that was approximately 1/8 to 3/16 inch thick (Photo 1). The decedent was delivering roofing materials to a firm contracted to re-roof the southwest section of a warehouse. He climbed a ladder to the roof and spoke with three roofing contractors about placement of the roofing materials. For reasons unknown, the decedent stepped over a roof parapet wall onto the low-sloped

Photo 1. Picture of broken skylight

Three days after the incident, the MIOSHA compliance officer climbed a ladder on the north side of warehouse #2 and observed the metal roof and existing skylights. His report stated that the metal roof and skylights “blended together” making it difficult to distinguish between the two, especially if you were not looking for skylights.

Building owners should install protective guards over individual skylights meeting Part 2 requirements, or consider installing guardrail systems around the perimeter of the skylight area that comply with the requirements contained within Part 45 to eliminate the hazard of an employee falling through the skylight.

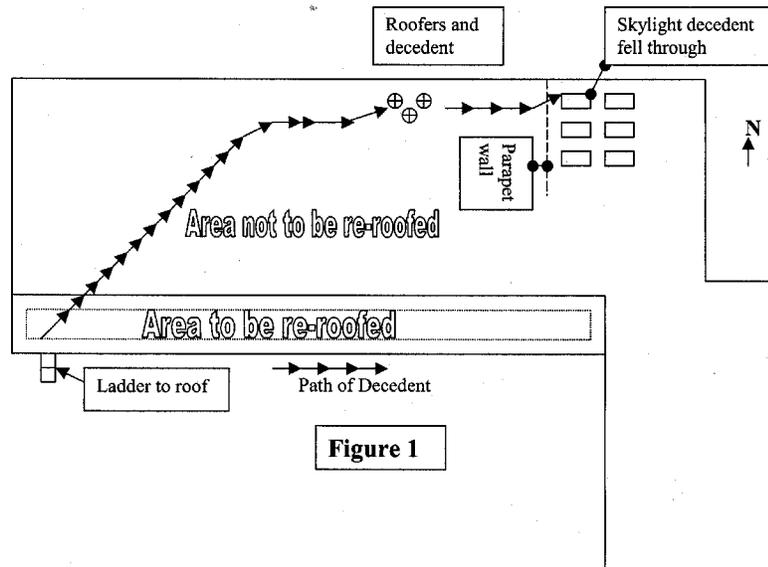
The decedent exited the crane truck. The outriggers had not yet been placed. He climbed a ladder to get onto the roof (Figure 1). It was common practice for the decedent to go onto roofs when delivering material, as stated by an employee of both the roofing contractor and the employer's operations manager. The operation manager stated that the work practice at the time required the crane truck driver to go up on the roof to look for obstructions, wires, and to make sure the roof could handle the load. The operation manager stated that the contract language at the time of the incident stated that that if the roofing material was attached to the crane, the responsibility for the load was the decedent's employer, not the roofing contractor. Therefore, the company's individuals who delivered the roofing materials would check the roof prior to unloading the truck.

On the roof were employees of the roofing company that subcontracted the decedent's employer. While walking on the roof with the roofing company employees, the decedent discussed the location of roofing material placement. When the discussion was completed, the decedent continued walking northbound on the roof stepping over a parapet wall onto the roof of warehouse #2.

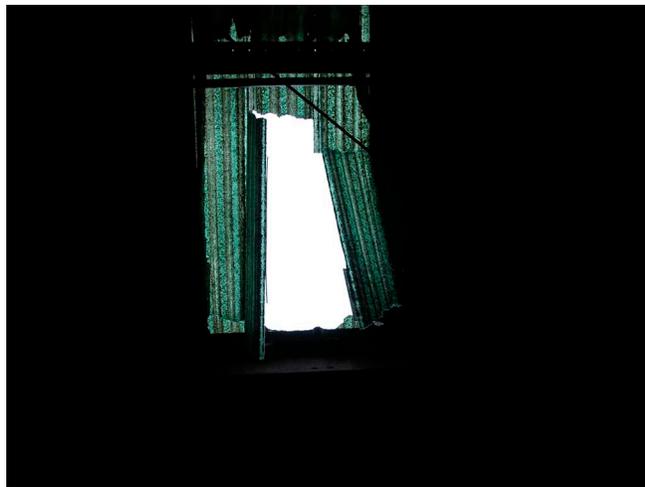
Warehouse #2 had six skylights that were installed to provide additional lighting for the building. The roof was dry and not snow-covered. Both the roof and fiberglass panel were weathered and dark in color. Although no work was to be performed in the area, neither the roofing company nor the owner of the building had installed visual markers or barriers to identify the skylight area nor covered the skylights in accordance with MIOSHA requirements.

As the decedent was walking northbound toward the Warehouse #2 roof, one of the roofing company employees warned him about the presence of the skylights. After stepping over the parapet, the decedent took several steps and fell through one of the 3x8-foot corrugated fiberglass panels that were flush with low-sloped metal roof (Photo 2). He landed on the concrete floor 20 feet below. The fiberglass panels were not designed as a weight-bearing skylight. It is unknown why the decedent continued northbound and walked on Warehouse #2 roof, which was so far away from the construction area. The roofing company employees stated to the police that they were not hired to repair that section of the roof. They were contracted to repair the front section or the section to the south/southwest of the building.

Photo 2. Broken skylight
