# MIFACE Investigation #06MI007

## Subject: Forklift Driver Pinned Under an Overturned Forklift Dies

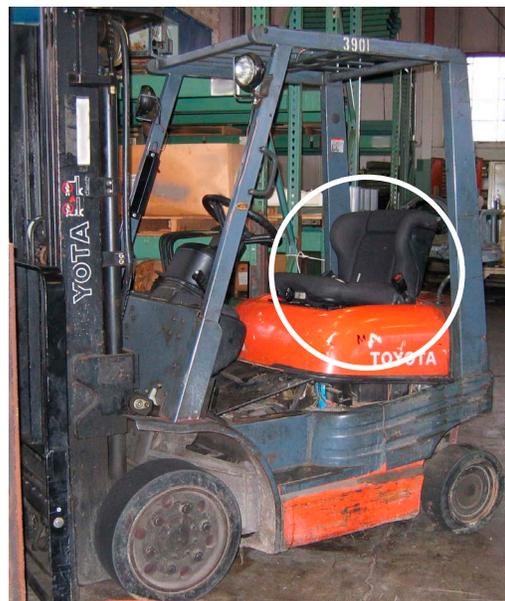
Figure 2. Forklift involved in incident

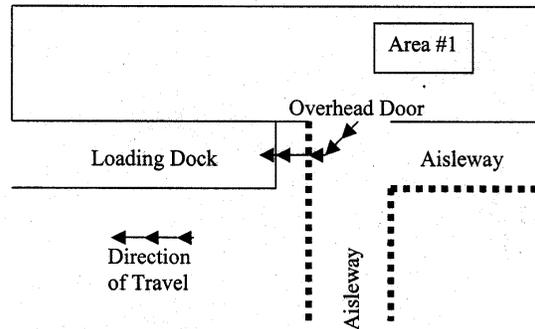
On the day before the incident, Area #1 had a roof leak and water was entering the plant area via the leak. To catch the dripping water, the decedent was directed to take a palletized empty 27-inch wide x 17-inch tall x 28-inch long heavy cardboard box, line it with a plastic bag, and take it to Area #1, mop up the leak, and place the box under the leak. Area #1 also stored other empty similarly sized palletized cardboard boxes. The next evening, the decedent told the supervisor that he had found two additional areas with roof leaks and would place a box with liner in those areas as he had done the night before.

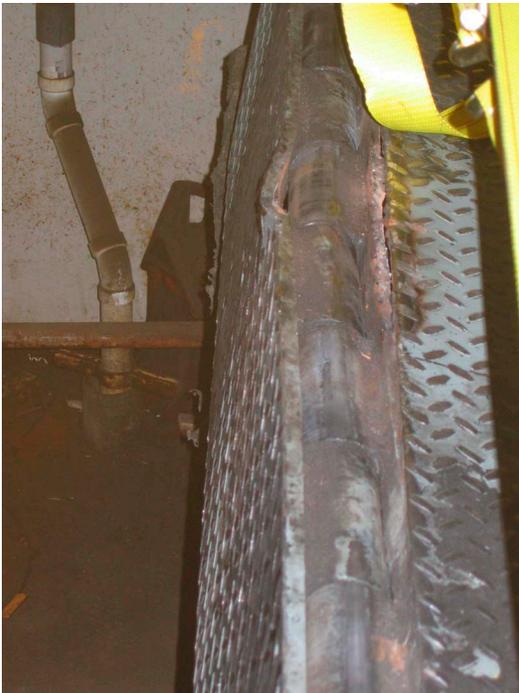
Figure 5. Bent dock boarding plate

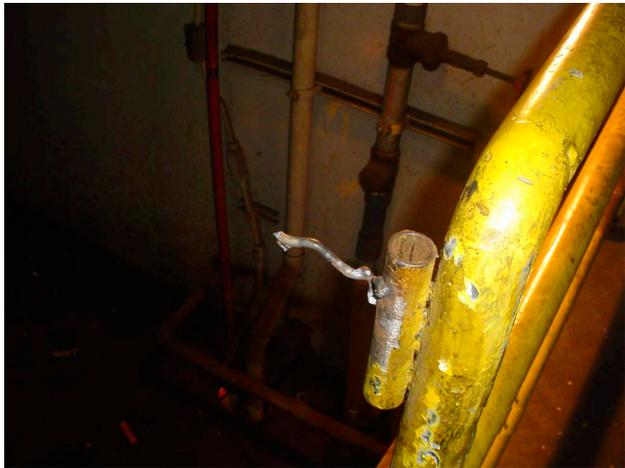
Figure 6. Straightened chain fastening loop

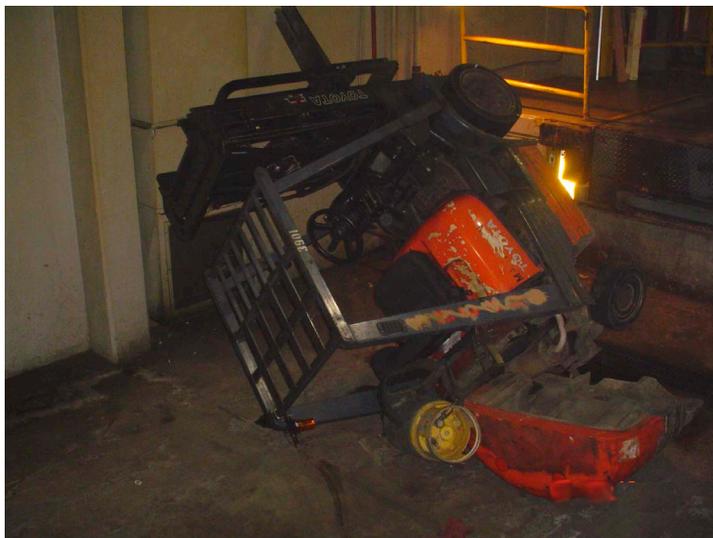
Figure 7. Position of forklift in relation to loading dock platform
