MIFACE INVESTIGATION #06MI096

Subject: Ground Man For Milling Operation Dies When Struck by a Dump Truck Backing Into Work Zone

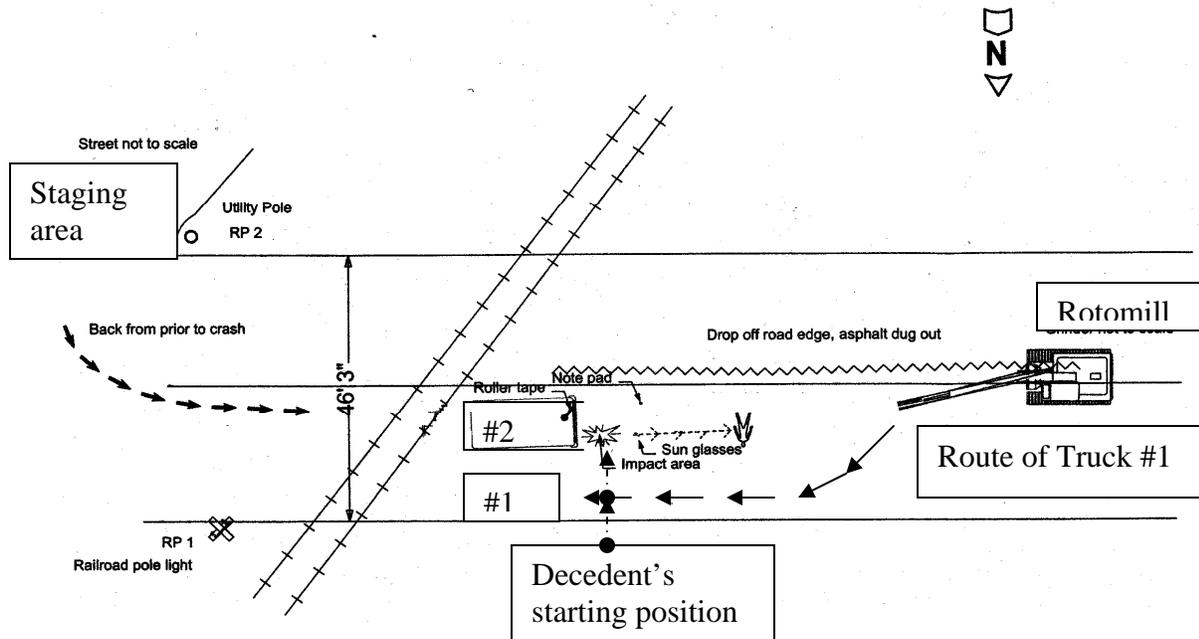
Figure 1. Police Diagram of Incident Scene with MIFACE additions

Truck #1 pulled away from the rotomill. As Truck #1 drove away, Truck #2 began to back into the worksite. At approximately 80 feet from the rotomill they were nearly parallel to each other. The decedent stepped out from the curb behind Truck #1 after it passed him with his notepad and digiroller (Figures 1 and 5). He apparently did not hear or disregarded the audible backup alarm of Truck #2 backing into position. He was struck by the Truck #2 driver's side rear wheels and dragged approximately 19 feet. Emergency response was called and the decedent was transported to a local hospital and pronounced dead.

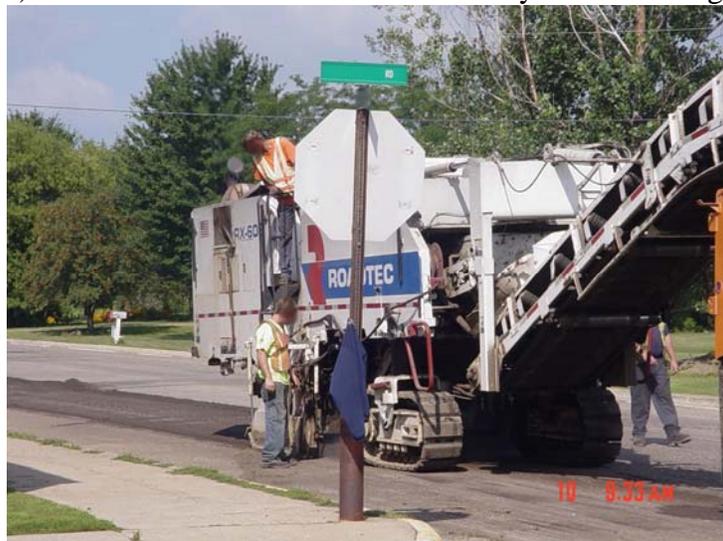
Figure 2. Typical rotomilling operation with rotomill operator and two ground men

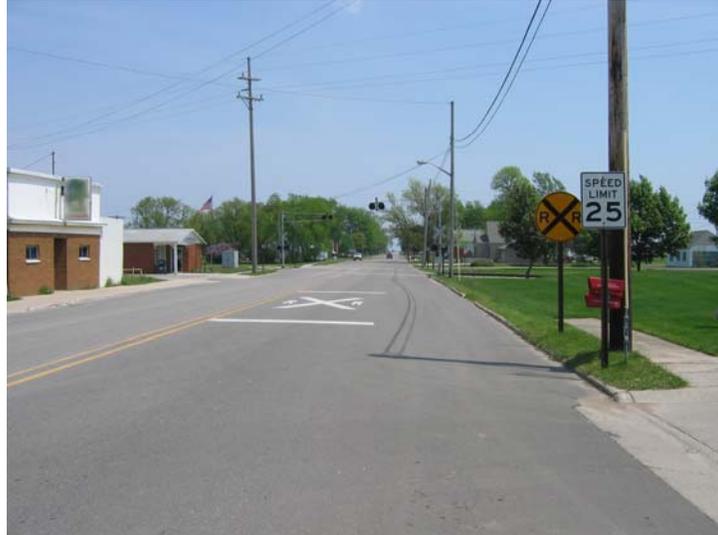
Figure 3. MIFACE photograph of incident scene, facing east, standing at intersection

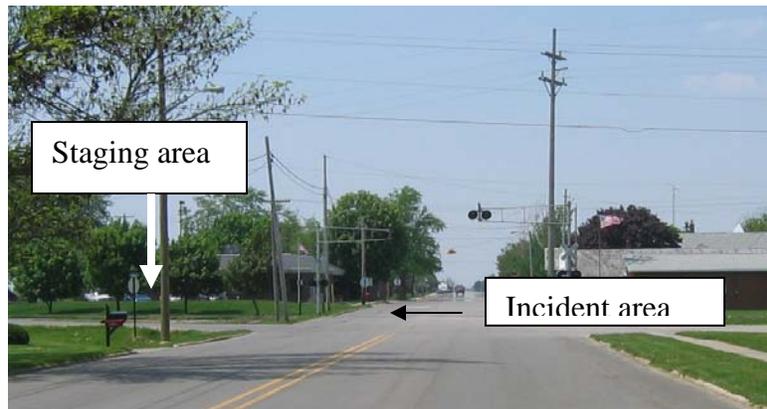
Figure 4. MIFACE photograph of incident scene, facing west

The incident occurred during the dump truck change out. It is unknown why the decedent chose to cross the road with his yellow note pad and digiroller, and begin the measuring process from the north side of the westbound lane ahead of the rotomill instead of taking the measurements behind the rotomill out of the path of construction vehicular traffic. Prior to the time of the incident, he had drawn a rough sketch of the worksite on his note pad. He had not written any work zone measurements on the note pad.

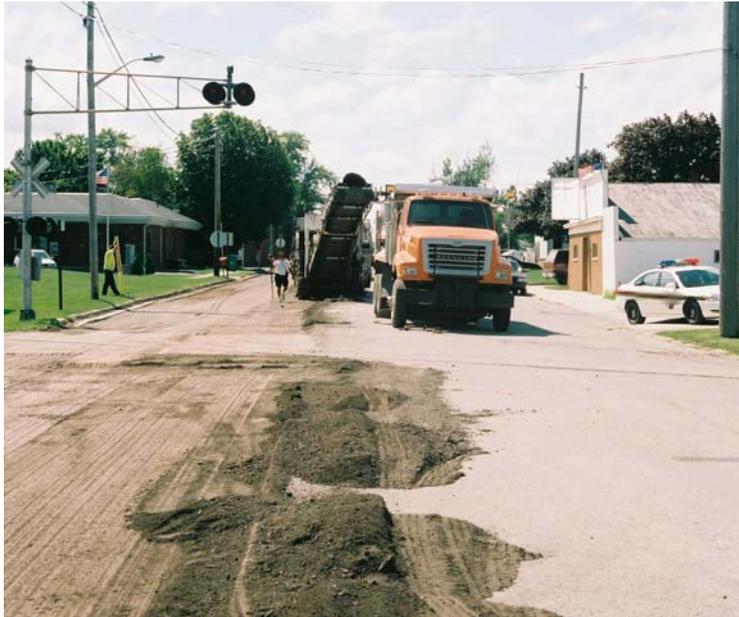
Another road commission truck driver in the staging area witnessed the incident. He stated that he noticed a worker starting to walk behind Truck #2. The police report stated that the driver of Truck #2 stated that he didn't see anyone behind him. Most likely, while backing to the chute the milling machine, the driver would have been focusing his attention to his right side view mirror in order to line up with the rotomill discharge chute, which was on his right side.

Figure 5. Position of dump truck and rotomill

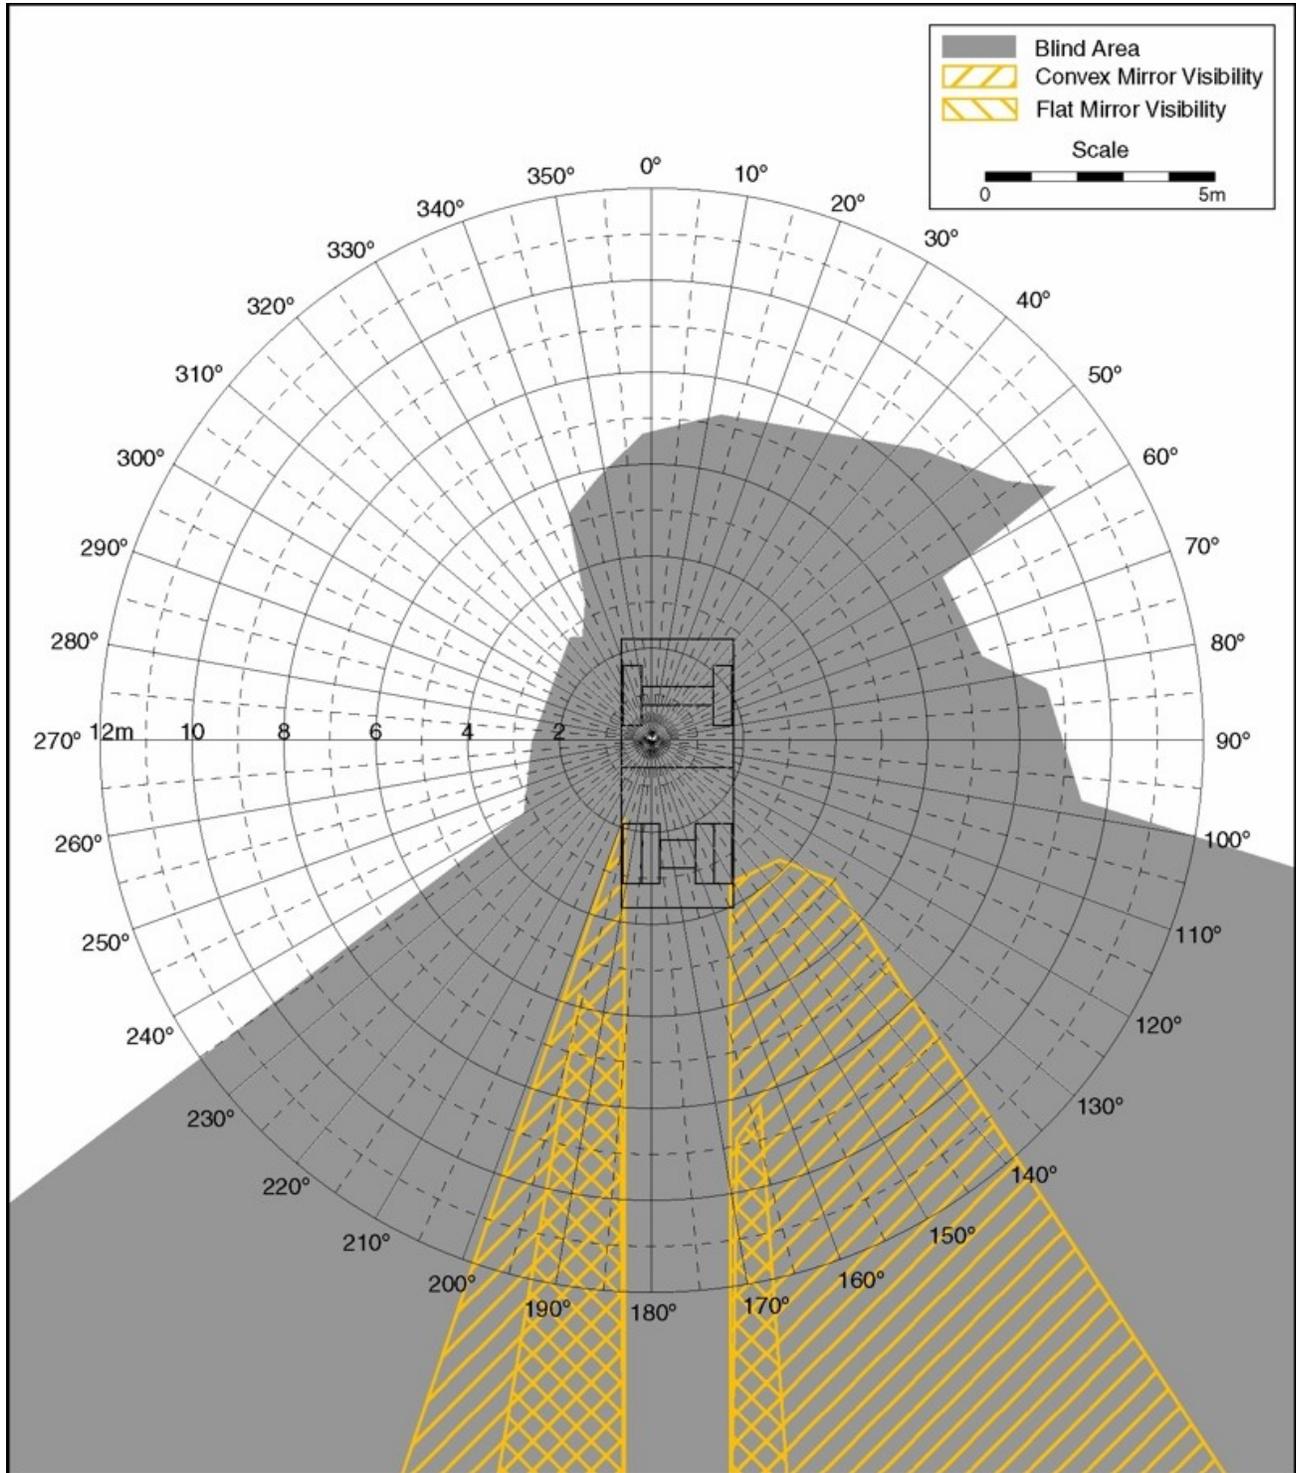
As part of a research project evaluating different strategies to prevent worker injuries in construction work zones, NIOSH contracted with Caterpillar to provide blind area diagrams for 38 different vehicles or machines used in the construction industry. Appendix I contains blind area diagrams for a Sterling Acterra 7500, which is a little smaller in terms of gross vehicle weight of the truck that struck the decedent. These drawings are for operator visibility (driver in the driver's seat) of objects at ground level, 900mm above ground level and 1500 mm above ground level by looking out of the front windshield, rearview mirror and both side view mirrors. MIFACE cautions employers that there may be potential differences between the diagram(s) depicted in Appendix I and the blind areas for the truck involved in the incident. Employers may find the diagrams in Appendix I useful in worker training to demonstrate the sizeable blind areas around a common piece of construction equipment, a dump truck.

Blind Spot for Driver for Objects at Ground Level

- Employers should develop and implement specific training for mobile equipment operators and workers on foot regarding driver blind areas on equipment.

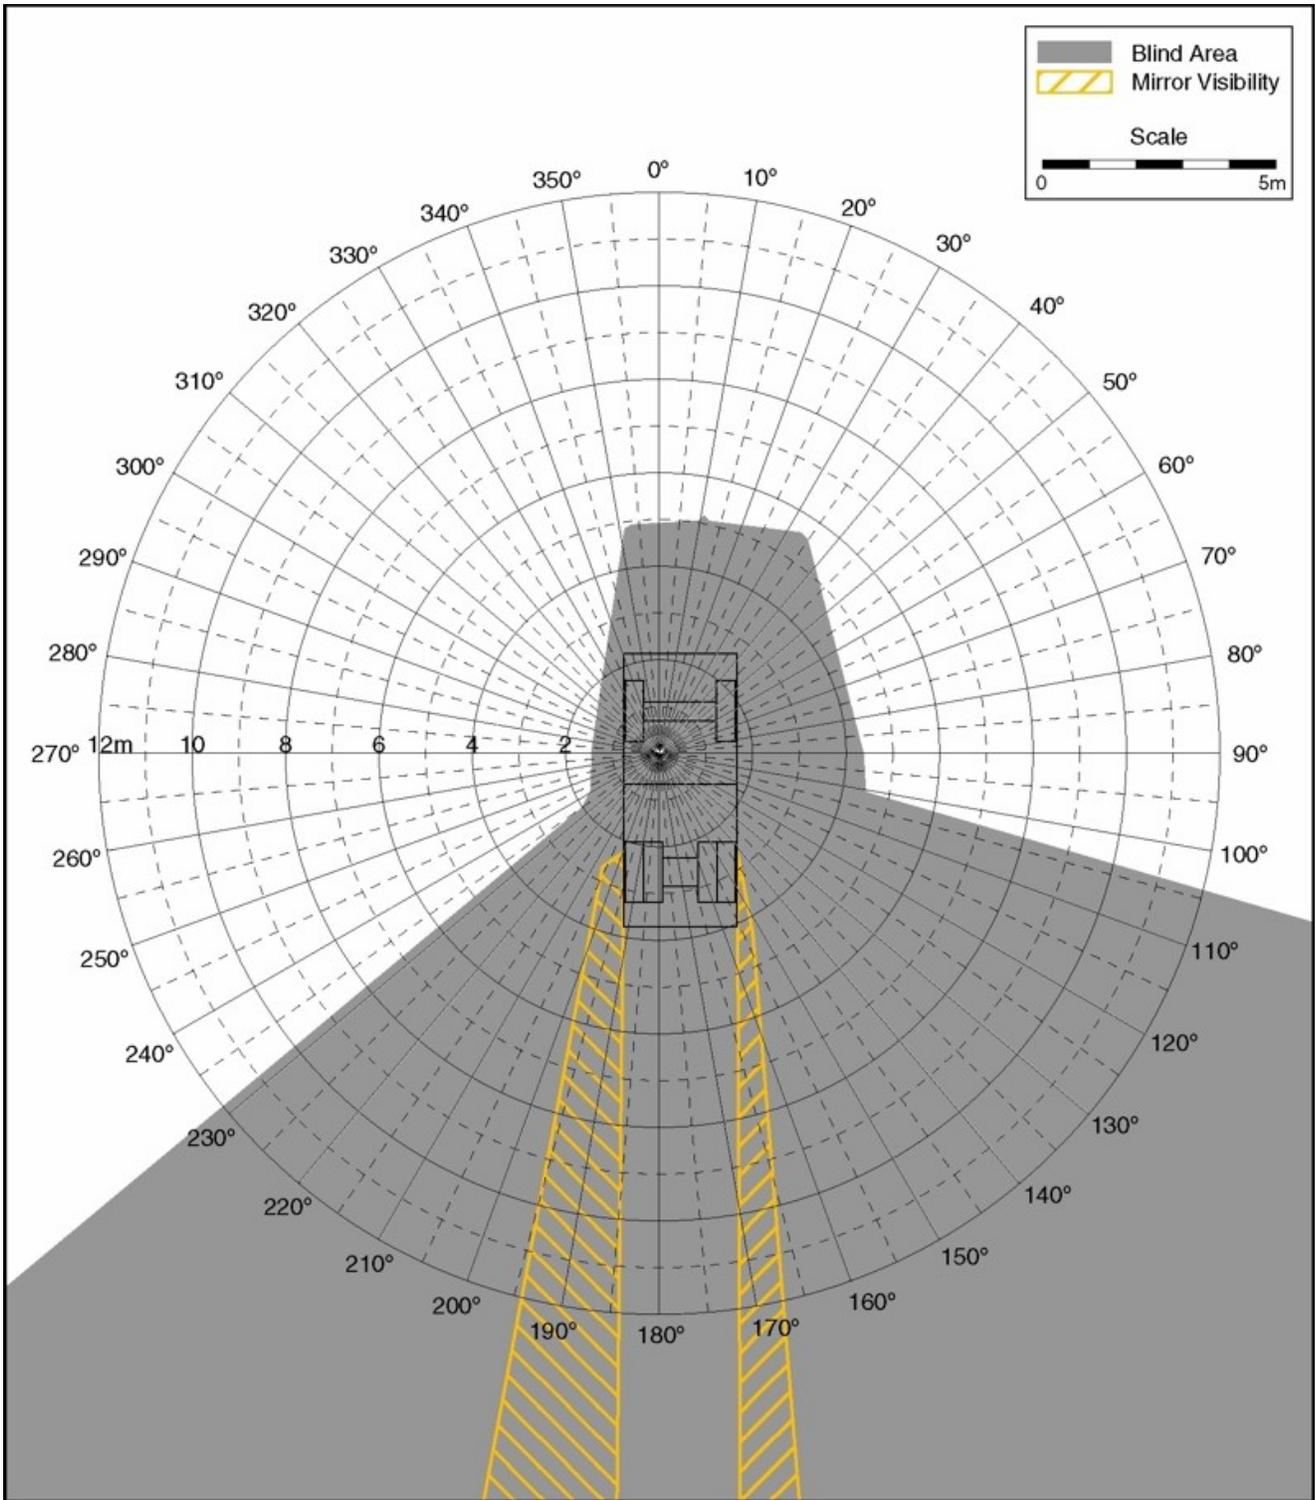
**Blind Spot for Driver for Objects that are 35.4 Inches (900 mm)
Above Ground**

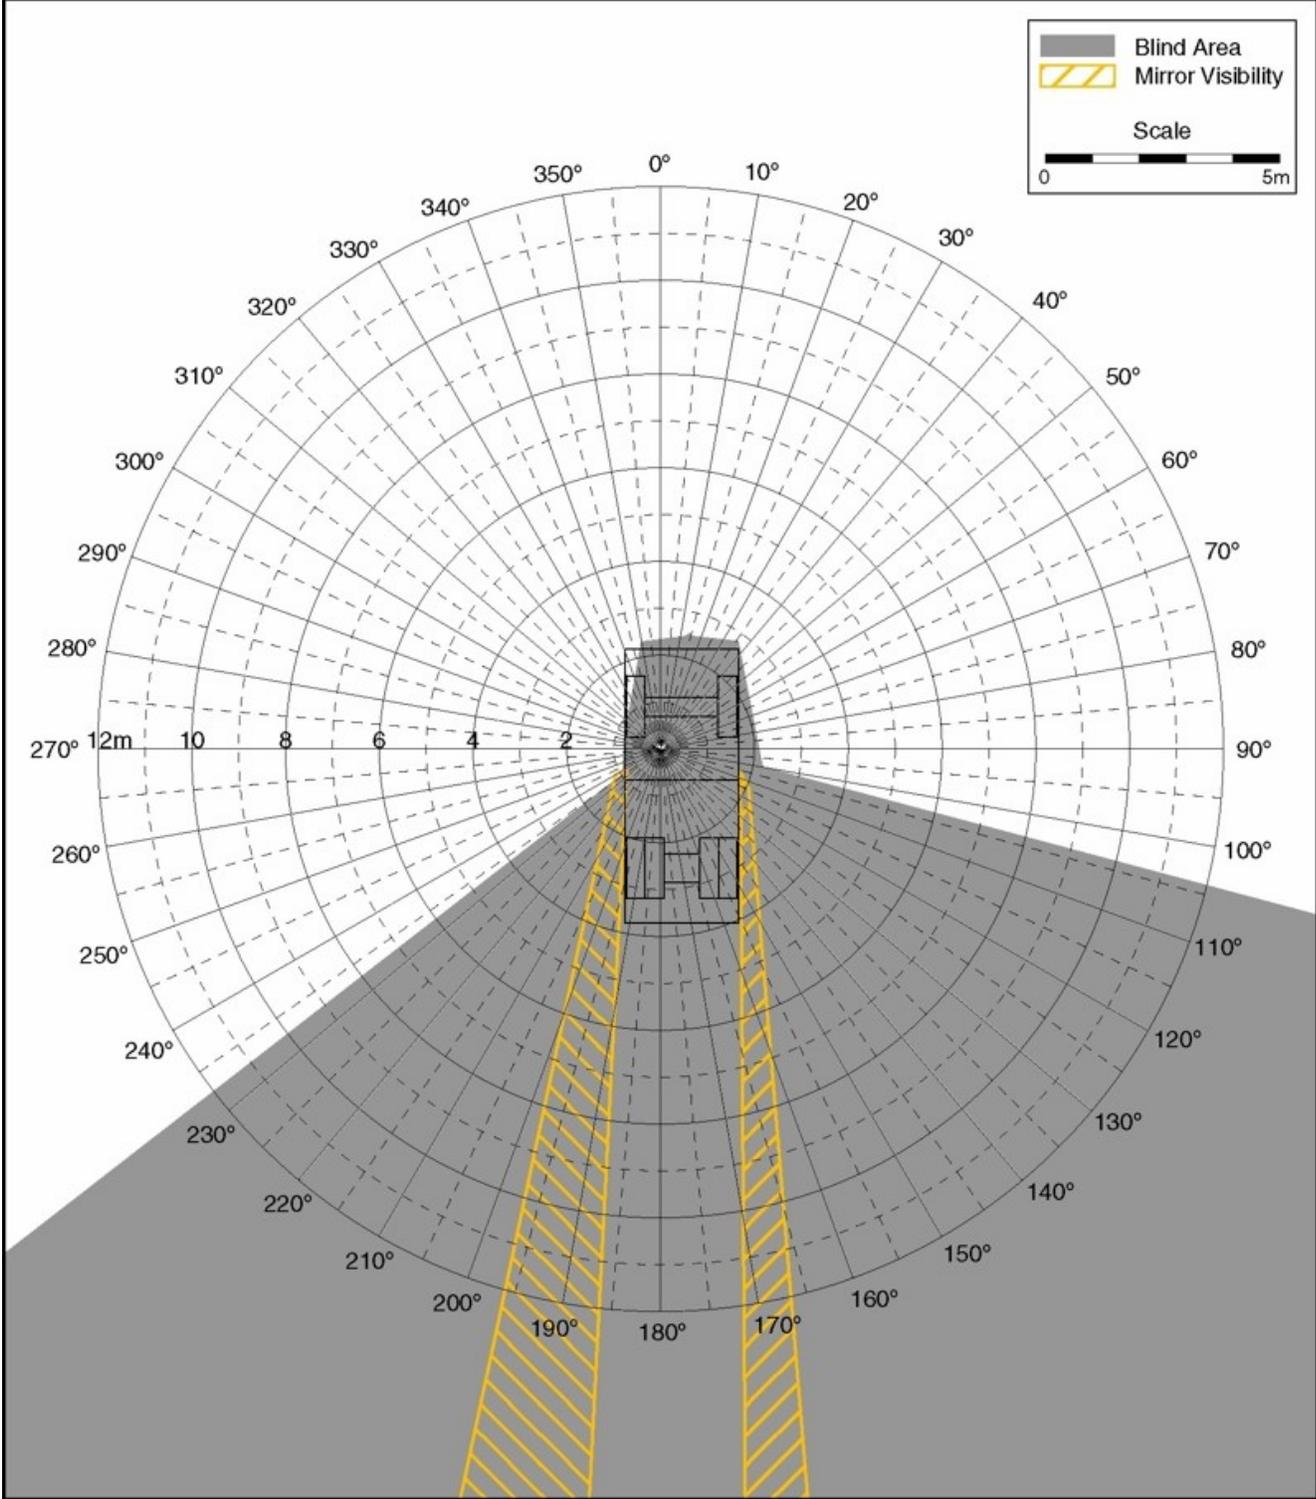
**Blind Spot for Driver for Objects that are 59.1 Inches (1500 mm)
Above Ground**
