MIFACE INVESTIGATION REPORT: #06MI188

SUBJECT: Welder Dies During Welding Repair Inside of Cargo Tank Compartment

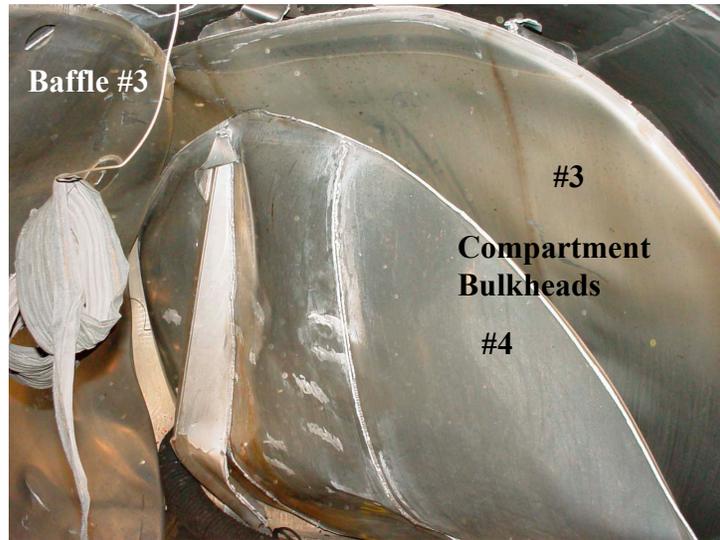
Figure 1. Damage to tanker baffle #3 and bulkheads #3 and #4, viewed through Compartment #3 portal hole facing toward the front of the tanker

from Compartment #4 to Compartment #3. The decedent did not open the portal covers for compartments #1 and #2. With the blower hose operational, the decedent entered Compartment #3 on four different occasions; once to check the Compartment for the leak location, once to perform grinding to prepare the leak location for welding repair, and twice to perform welding. It is unknown if the decedent conducted air monitoring. After entering Compartment #3 for the fourth time, vapors from Compartment #4 ignited during the welding in Compartment #3 and an explosion occurred (Figure 1). The decedent died at the scene.

The explosion occurred approximately 15 to 20 minutes after the decedent had entered Compartment #3 to resume welding. It was determined that the explosion initiated inside Compartment #4. The tanker's interior compartment dividers (baffles and bulkheads) were damaged. The front bulkhead and two baffles inside Compartment #4 were completely dislodged and blown forward toward Compartment #1. All of the tanker's baffles and bulkheads were dislocated.

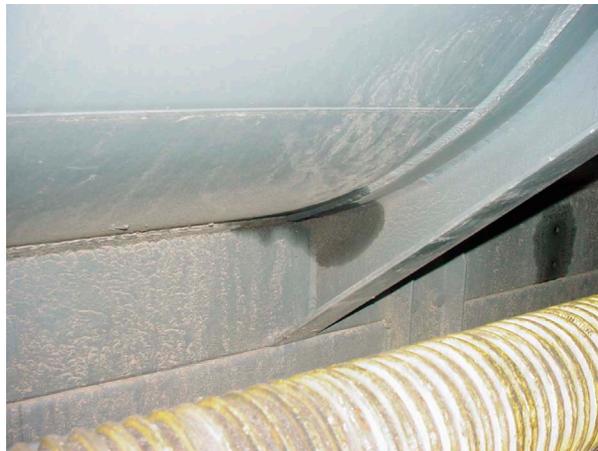
Figure 4. Leak location at base of tanker Compartment #3

After an unknown period of time, the decedent entered Compartment #3 and visually located the leak. He indicated that there were leaks over the frame on both sides (Figure 4). The decedent exited the tank and procured grinding equipment to prepare the weld site.

The diameter of wire that the decedent was using to repair the tank's interior is unknown. The most common diameters of welding wire are .035 inches and .045 inches. For thinner materials, a smaller diameter wire, such as a .025-inch diameter usually will create a good weld. A weld that is too large can lead to burn-through of the base material. Because a smaller diameter wire welds at a lower current, there is less arc force and a reduced tendency to burn-through the base material. For thicker materials (>3/16 inches) a smaller diameter wire would be problematic because there may be a risk of lack of fusion. Burn-through of the baffle in Compartment #3 may have been a factor in this

incident. It is unknown if there was diesel fuel between the baffles of Compartment #3 and Compartment #4 or if a burn-through of both baffles occurred. Welding practices, especially within a confined space should be reviewed prior to conducting the welding operation to ensure all safe welding practices are followed.

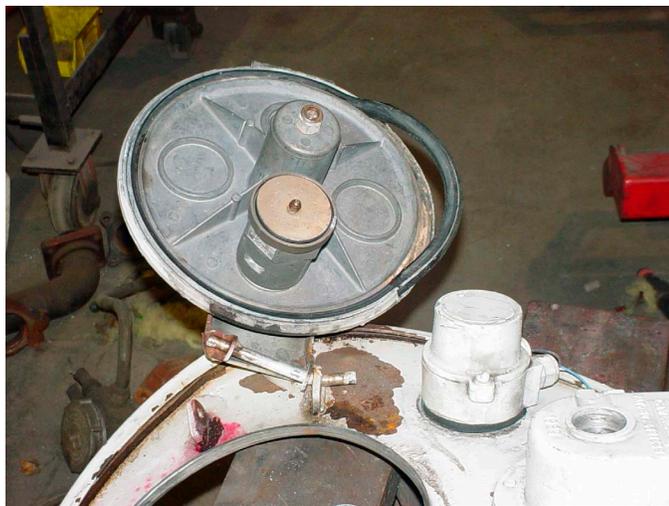
Figure 5. Condition of Compartment #4 10-inch lid after the explosion

The outside skin of the trailer was wrinkled on both the right and left side near Compartment #3 and Compartment #4. The roof of the building above the trailer had a hole in it from the explosion. Compartment #4's tank lid was found on the roof (Figures 5 and 6). A three-inch diameter natural gas pipe was severely bent upward and broken into two pieces. Natural gas was spilling out of the pipe and was eventually turned off by the responding fire department. A ceiling fan above the tanker was severely damaged and was lying on the floor. A large amount of ceiling insulation was hanging from the ceiling and also on the floor due to the explosion.

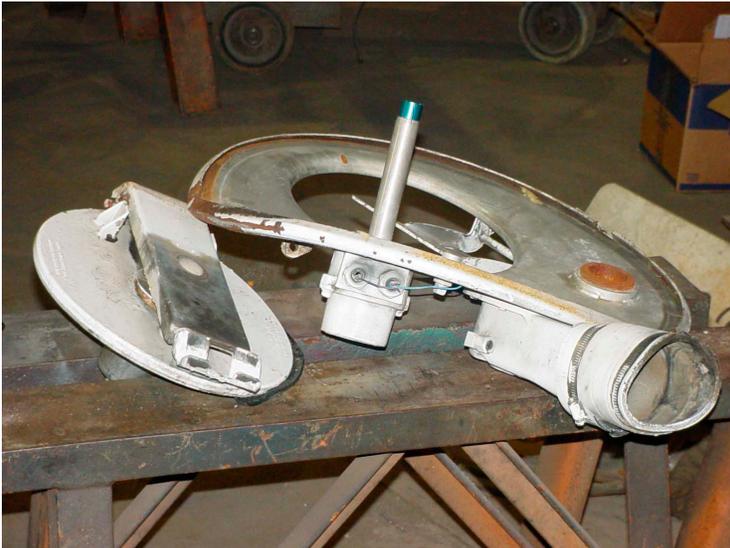
Figure 6. Condition of Compartment #4 portal covering after the explosion
