MIFACE INVESTIGATION #06MI193

SUBJECT: Field Technician Dies When Struck By Geofoam Block

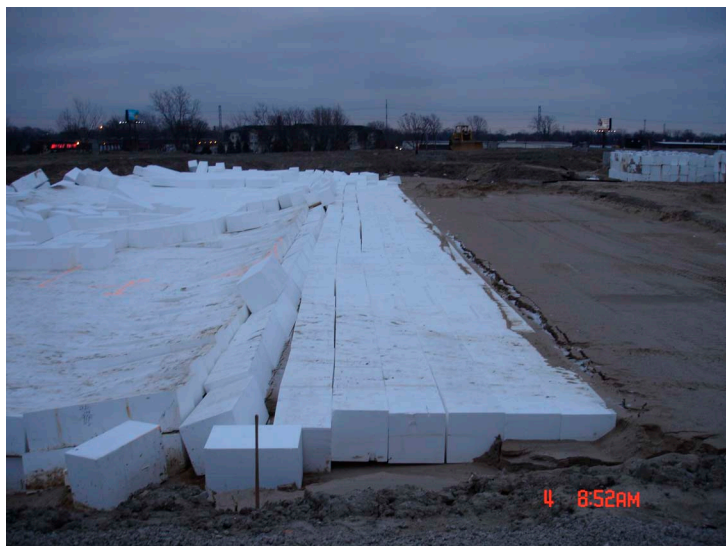
Figure 2. Ballasted edge of geofoam foundation

drains. Over this grid was a 4-inch layer of compacted sand. On top of this sand, geofoam blocks were placed in a series of tiers. Each tier of the blocks was laid 90-degrees to the one below it, creating an interlocking pattern. Once the tiers reached a height of 16 feet, then more sand was placed and compacted. Actual building construction would then be done on this large mat of geofoam. One section of the geofoam foundation had been completed and six inches of soil had been placed on the top of the blocks (Figure 2).

- Contractors should secure/ballast geofoam block edges in accordance with manufacturer specifications for installation and storage.

The MIFACE researcher looked on the Internet for geofoam block manufacturers in an effort to identify common installation and storage instructions. When geofoam installation instructions were present on the manufacturer's webpage, every geofoam block manufacturer instructed the end user to ballast and/or secure the blocks during placement and storage. The geofoam block sections that had been completed had been ballasted with soil. The section of geofoam that had not been completed was not ballasted. Stacks of geofoam blocks in the storage area were also not ballasted/secured prior to the MIOSHA inspection.

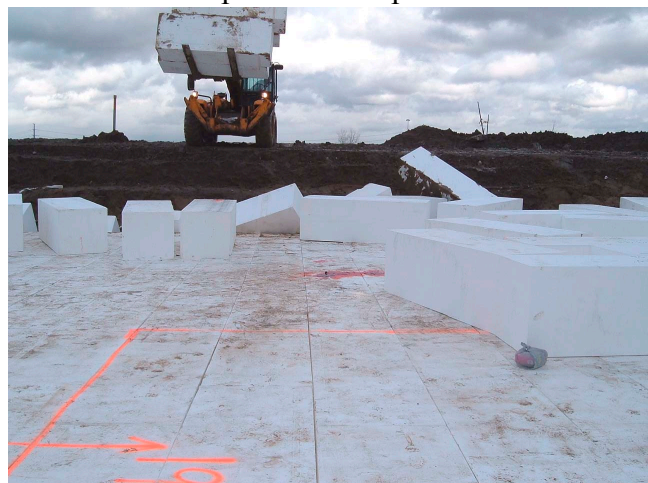
Figure 3. Incident site looking North

from the west/northwest towards the northeast. A pair of rough terrain forklift trucks was used to transport stacks of blocks from the northeast side of the excavation to a parking lot storage area (Figure 3).

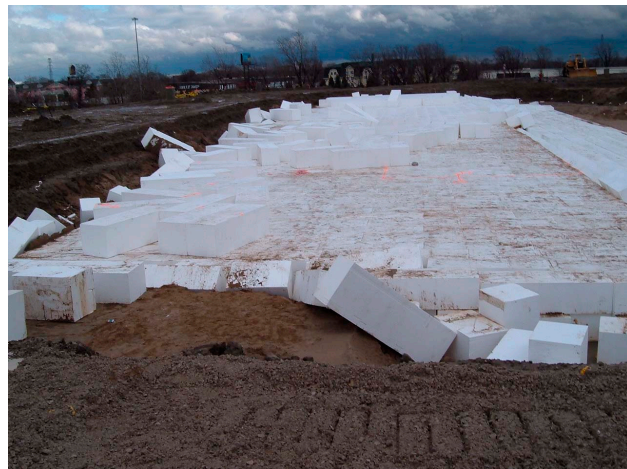
Standing on blocks at the northwest edge, the decedent spoke with the Company A employee as the other Company A employees moved the 24-inch high by 32-inch wide by 8-foot long (weight 53-80 pounds each) blocks from the foam pad. At approximately 1:00 p.m., the wind changed direction (from northeast to southwest) and increased in velocity to nearly 35 mph. A 53 mph wind gust picked up the unsecured/unballasted blocks and blew them into the workers. Just prior to the gust of wind Company A employees noticed foam blocks being blown off of an unsecured/unballasted pile located directly southwest of their work area. Company A employees saw the wind lift the edge of the layer #3 blocks that were to be moved, and then the blocks rose up like a wave as the wind blew under them. This wave of blocks reached approximately 12 feet in height before it broke apart. The individual blocks broke loose and were then blown into the area where the decedent was standing and Company A personnel were working.

At least six Company A employees reported getting hit by the flying/tumbling blocks of foam (Figure 4). Some lost consciousness for a short while. No one saw the decedent being struck in the face and upper chest by one of the blocks. Company A employees found him lying on the foam pad bleeding from his nose. A Company A employee noticed that the decedent was having trouble breathing and rolled him on to his back and then onto his side to keep the air passage clear. The employees called 911 and began First Aid/CPR. Emergency response arrived and transported him to a local hospital where he was declared dead.

Figure 4. Incident site looking East

MIOSHA calculated that the wind exerted 110 pounds of force on the blocks.
