MIFACE INVESTIGATION #06MI201

SUBJECT: Journeyman Pipefitter Dies When Struck in Chest While Removing Vic Fitting End Cap From a Pressurized Pipe

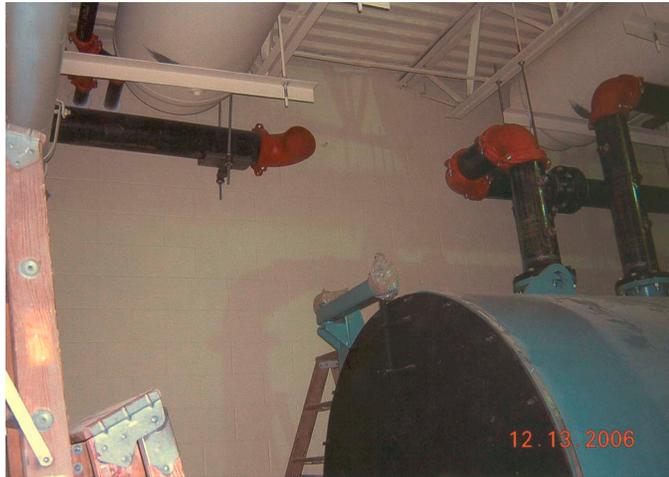
Figure 1. Incident scene

“downstream” of a closed valve, which left a section of line still pressurized to 80 psi. At the end of the 8-inch line, there was a vic fitting end cap (also referred to as a victaulic, groove lock or gasketed end cap). The decedent was removing the 25-pound vic fitting end cap from the 8-inch line in the main boiler room in preparation for continuing the waterline project. The metal cap struck the decedent in the neck and upper chest area when it blew off the end of the pipe. Fellow workers called 911. Emergency response arrived, and the decedent was taken to a local hospital where he was declared dead.

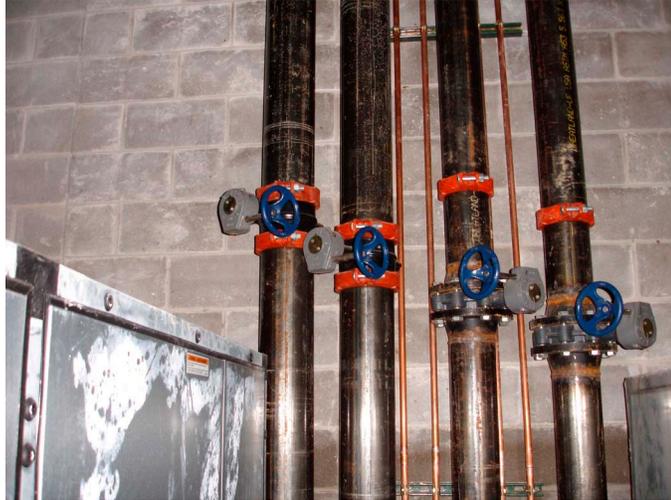
Figure 2. Valves in lines in Second Floor Mechanical Room

After repairs were made, the line was recharged, and the field foreman for the decedent’s employer and the construction manager for the project completed a test report to verify that the lines were free of leaks. After the construction manager signed off on the form that the lines passed inspection, the field foreman told the decedent to release the pressure off all the piping. Air was released from the pipes, except for a portion of line “downstream” of the closed valve. This section of line was left pressurized to 80 psi. The reason for this is unclear. Pressure was released in the Boiler room, and the gauges that had been set up in the Boiler room read zero. It appears that after the successful pressure testing of the piping, the decedent did not go back to the second floor Mechanical room to open the valve that he had closed.

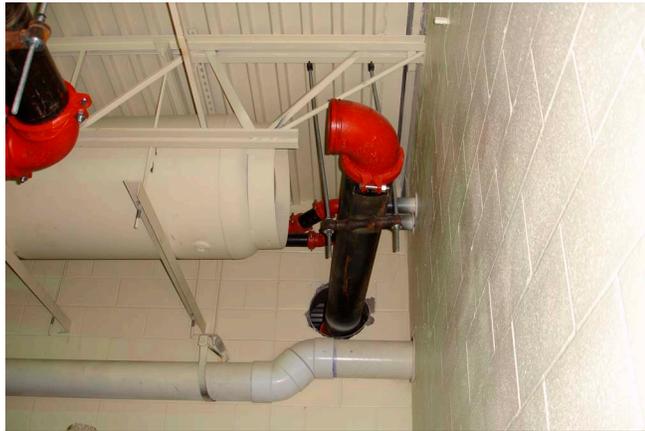
decedent stated to his coworkers that he was going to configure the run for the 8-inch pipe that was located approximately 12 feet from the floor. At the end of the 8-inch line was a vic fitting end cap that had to be removed. The cap that was used is also known as a groove lock cap, or gasketed end cap. These names describe a method of isolating a pipe that consists of bolting a coupling with a gasket in which the cap or plug is seated onto the end of the pipe by a two-piece clamp with a nut and bolt on each side. The incident occurred while the decedent was removing the 25-pound vic fitting end cap from the 8-inch pipe. While loosening the cap clamp, the cap blew off the end of the pipe, striking the decedent in the neck and upper chest area. It is unclear from the photos if the decedent was straddling a 10-foot ladder, standing on the top step of the ladder, or standing on top of the boiler, which was close to the capped pipe. It is also unclear if the decedent was directly in line with the end cap or if the cap blew off at an angle other than parallel with the direction of the pipe run.

Figure 3. Pipe and elbow involved in the incident

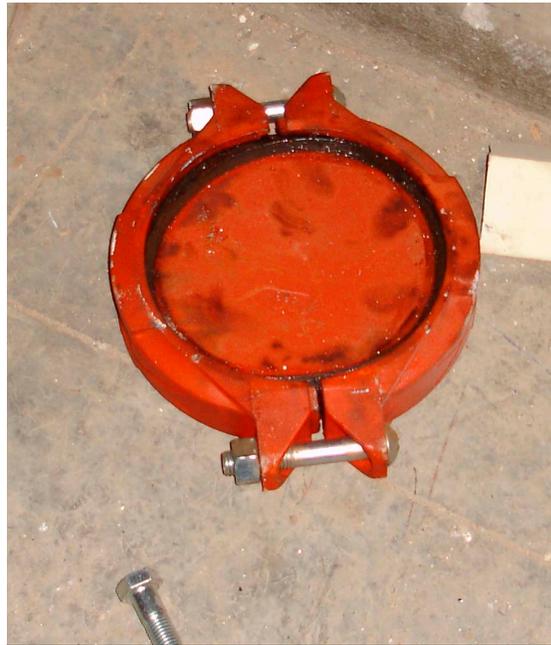
None of the coworkers in the Boiler room actually saw the incident occur. Hearing a noise, they moved from their work area and found the decedent on the floor approximately 15-20 feet away from the end of the pipe. The end cap was found on the floor approximately seven feet from the decedent. The wrench the decedent was using to loosen the clamp was found caught between the boiler and its associated piping. One of the coworkers called 911. Emergency response arrived and transported the decedent to a local hospital where he died.

Figure 4. End cap that struck decedent

A threaded fitting may allow a worker to hear air escaping from the fitting, but with the “vic” end cap, the cap is clamped down on a groove in the pipe. When a vic clamp is loosened from the groove, a worker does not have time to accurately determine how loose the cap is or to hear air escaping before the cap releases from the groove. The company’s procedure now requires “installing a tee in place of a 90-degree elbow, or use of a tapped cap or plug with a valve. A boiler drain, coin vent, or a small ball valve, can then be installed to relieve pressure after a test has been successfully completed.” The employer could also consider using an end cap that remains attached to the pipe during

- Employers should use an end cap that remains attached to the pipe during loosening and prior to removal, or outfit the end cap with a pressure-relieving device.

loosening. Whichever method is used to guard against a cap exploding from the end of a pressurized line, the most important control is to make every effort and plan to ensure the line is depressurized before removing any end piece.
