MIFACE INVESTIGATION #06MI207

SUBJECT: Apprentice Lineman Dies When the Vibratory Plow He was Operating Struck a High Pressure Natural Gas Line.

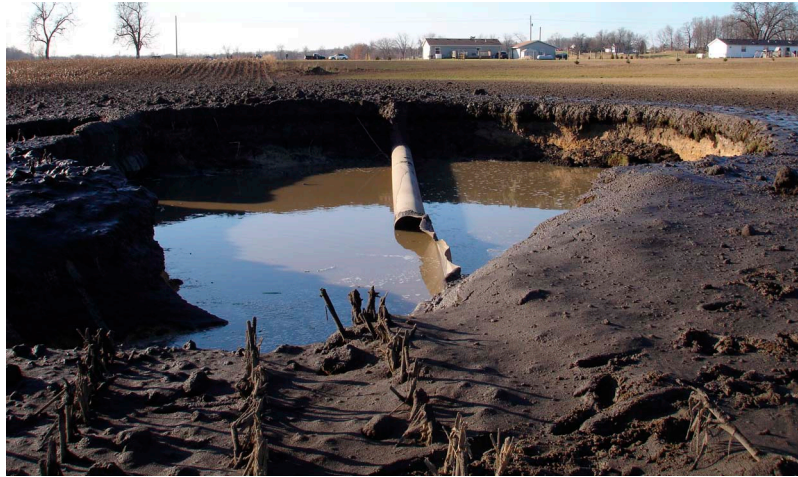
Figure 1. Incident scene showing crater and pipeline

Approximately 58 yards from the corner, the vibratory plow hit a 24-inch high-pressure natural gas pipeline belonging to the company that had not provided a Positive Response on the MISS DIG ticket. The pipeline was buried 36 to 40 inches below the existing grade. The rupturing pipeline created an explosion throwing dirt and debris into the air and created an 80-foot crater. Coworker #1 was knocked to the ground. Coworker #2, who was also thrown to the ground, found his way to a nearby truck and called a May Day on the truck radio. After Coworker #1 picked himself up from the ground, he turned to look at where the roaring sound was coming from and saw about 150-200 feet of dirt flying in the air. He crossed the street to the west side of Road A and dialed 911 on the cell phone provided by the electrical company. He told the dispatcher that he thought that a high-pressure gas line had been hit and gave the dispatcher the incident location. He then called the electrical company and informed his boss that they may have hit a high-pressure gas line and that the decedent was still in that location.

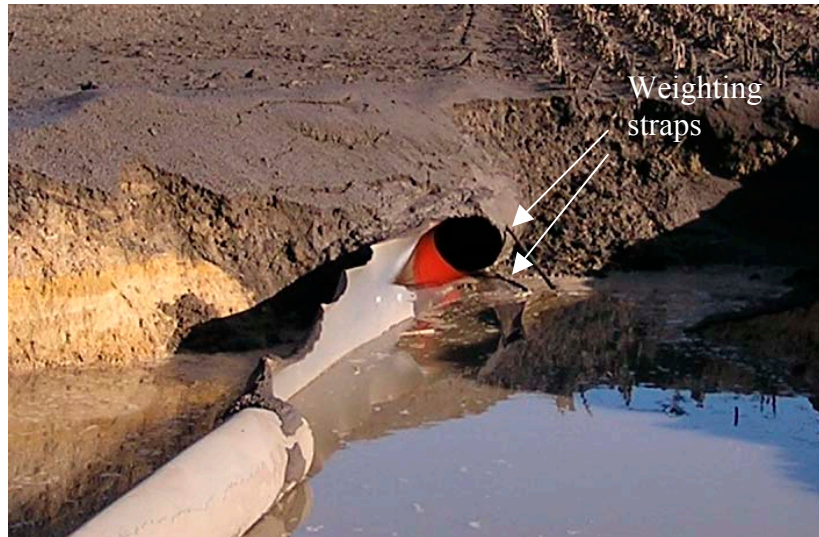
There were two natural gas pipelines in the construction area. One pipeline was 22 inches in diameter. The pipeline that was struck was 24 inches in diameter. The electric company indicated that the pipelines had been laid in the 1950s. The 24-inch pipeline was pressurized to 800 psi. Pipe composition, integrity, and maintenance are unknown. The electric company indicated that the area had a high water table and that the pipes were “held” in place by straps with cement weights. The electric company indicated that as part of their investigation of this incident, local farmers had stated that they had hit the pipes during plowing and had contacted the gas company to inform them that the pipes had been hit during plowing.

Figure 2. Weighting straps on pipeline.

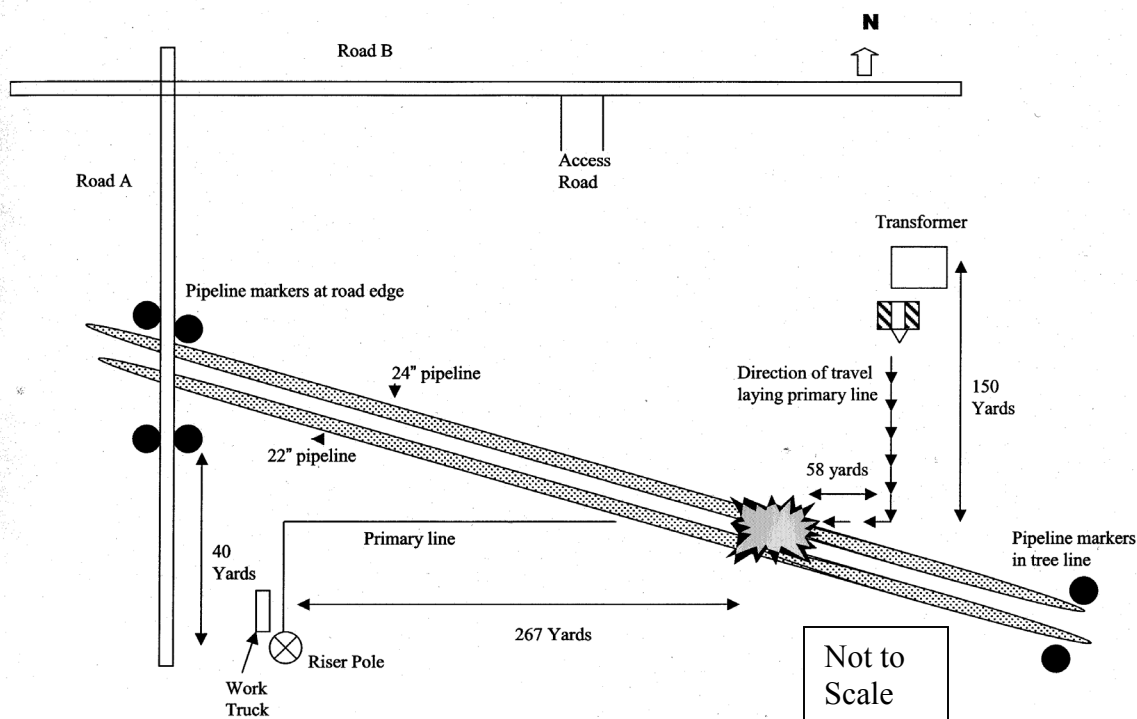
DIAGRAM A

MISS DIG is a non-profit entity that processes requests for the marking of underground utility lines and structures prior to construction. The MISS DIG ticket response inquiry indicated the street address on Road B (Diagram A) as the staking location. The MISS DIG ticket response indicated that two natural gas distributors, two cable companies, one electrical distribution company, two phone companies and the county road commission may have had underground facilities present. Three companies positively responded as indicated on the ticket; one cable, one telephone and one natural gas distributor (who contacted MISS DIG indicating no pipelines in the construction area). The natural gas distributor whose pipeline was struck did not positively respond, and the associated response box was blank, as were the boxes for one phone company, one cable company and the county road commission.

The location of the incident was an active cornfield. The work crew consisted of two journeyman linemen (Coworker #1 and Coworker #2) and the decedent. The crew started the day getting all the material for the job loaded on three trucks. Coworker #1 and the decedent left the shop at around 7:45 a.m. and arrived at the jobsite around 8:15 a.m. Coworker #1 was the lineman in charge (job foreman). Coworker #2 arrived at the jobsite about 15-20 minutes after Coworker #1 and the decedent (Diagram A).

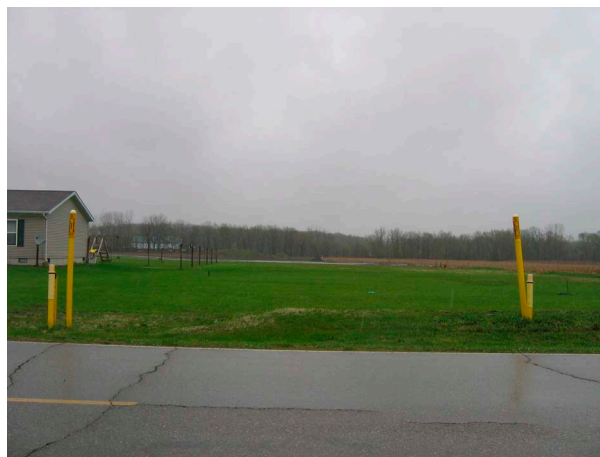
Following their training, electrical company personnel looked for and recognized utility MISS DIG flags, but did not appear to look for other markings for underground facilities, such as the high visibility yellow markers for the two underground, high-pressure, natural gas pipelines. Although the markers were in plain sight on Road A, apparently they were missed (Figure 3) or the workers may have thought that the lines were deeper than the level they were digging. Employers should include in their excavation training a segment that requires workers to look for all utility markers in addition to MISS DIG flags and to not assume lines are deep.

Figure 3. High visibility yellow markers on Road A

- Employers conducting excavating or tunneling operations should ensure employees receive hazard recognition training pertaining to utility markers.

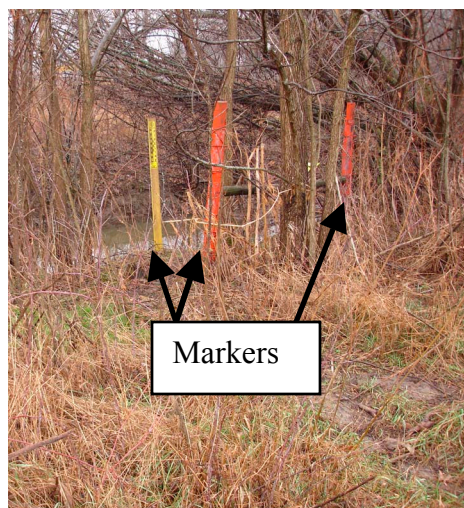
MIOSHA personnel, upon walking the field where the excavation was being performed, noted additional utility markers in the tree line.

Figure 4. Markers in tree line

the field where the excavation was being performed noted additional utility markers in the tree line (Figure 4). Prior to performing any excavation work, the crew should perform a walkthrough of the area to note any potential hazards or previously missed utility markers.

- Employers conducting excavating or tunneling operations should instruct and ensure employees conduct a thorough site inspection to determine if all potential underground utilities are marked prior to beginning digging operations.
