MIFACE INVESTIGATION #06MI209

SUBJECT: Heavy Equipment Operator Dies After Being Pinned Between the Boom and Cab of an Excavator

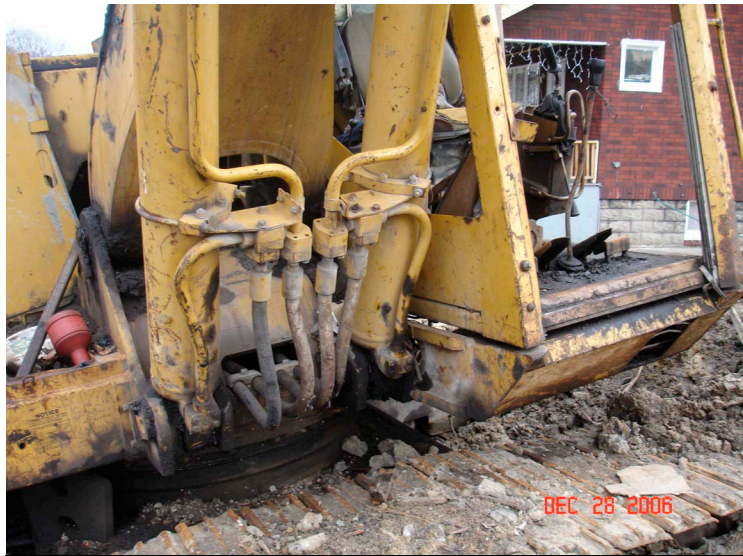
Figure 1. Position of excavator boom and cab at time of incident

Model 225 DLC excavator. The excavator cab was positioned perpendicular to the tracks of the excavator with the boom in an upright position (Figure 1). The cab window adjacent to the excavator boom was broken. The decedent jumped onto the excavator tracks under the raised boom and leaned through the cab window. His torso/arm contacted the excavator boom joystick-type control lever and the boom lowered pinning the decedent between the boom and the cab frame. Emergency response was called and arrived and transported the decedent to a local hospital where he was declared dead.

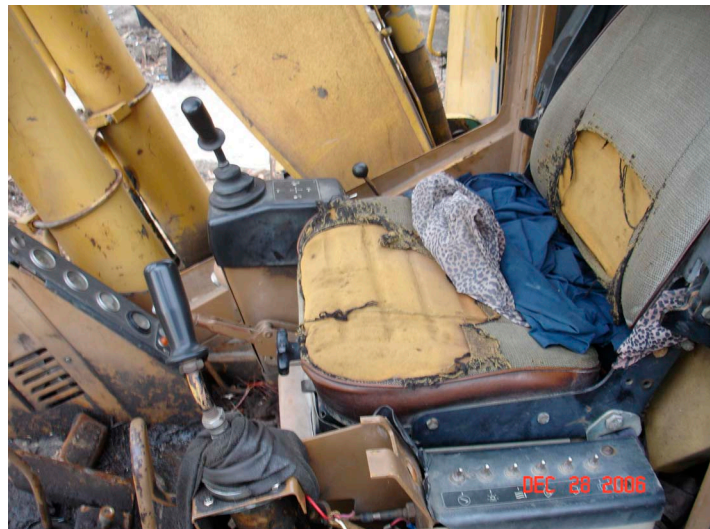
The site contractor had purchased the Caterpillar 225 DLC excavator involved in the incident in new condition in 1989. Figure 2 illustrates the condition of the excavator at the time of the incident. According to the site contractor, the excavator's maintenance schedule was determined by the number of days of service.

Figure 2. Cab condition and location of controls
