# MIFACE INVESTIGATION REPORT: #07MI073

## SUBJECT: Journeyman Lineman Run Over by Off-Road Vehicle While Directing the Vehicle onto a Transport Trailer

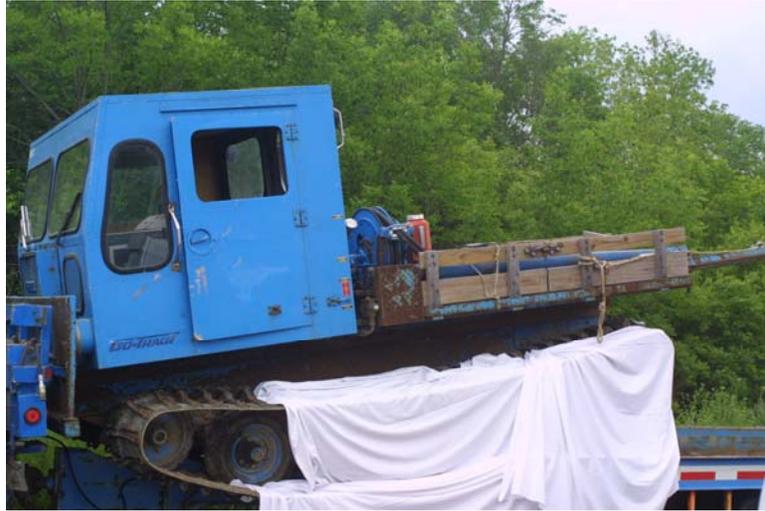
Figure 1. Final position of Go-Tract against truck

At this point, it appears that the decedent stepped back, and while looking to the back of the truck, tripped and fell onto the tongue of the trailer. Coworker #1 tried to stop the vehicle. While keeping the clutch fully depressed, Coworker #1 attempted to knock the gear lever from first gear into neutral with his right hand/arm. The Go-Tract continued to move forward, and then traveled over the decedent, who was laying on his back on the trailer tongue (Figure 3). The machine came to rest on the trailer tongue against the rear of the utility truck (Figures 1 and 4).

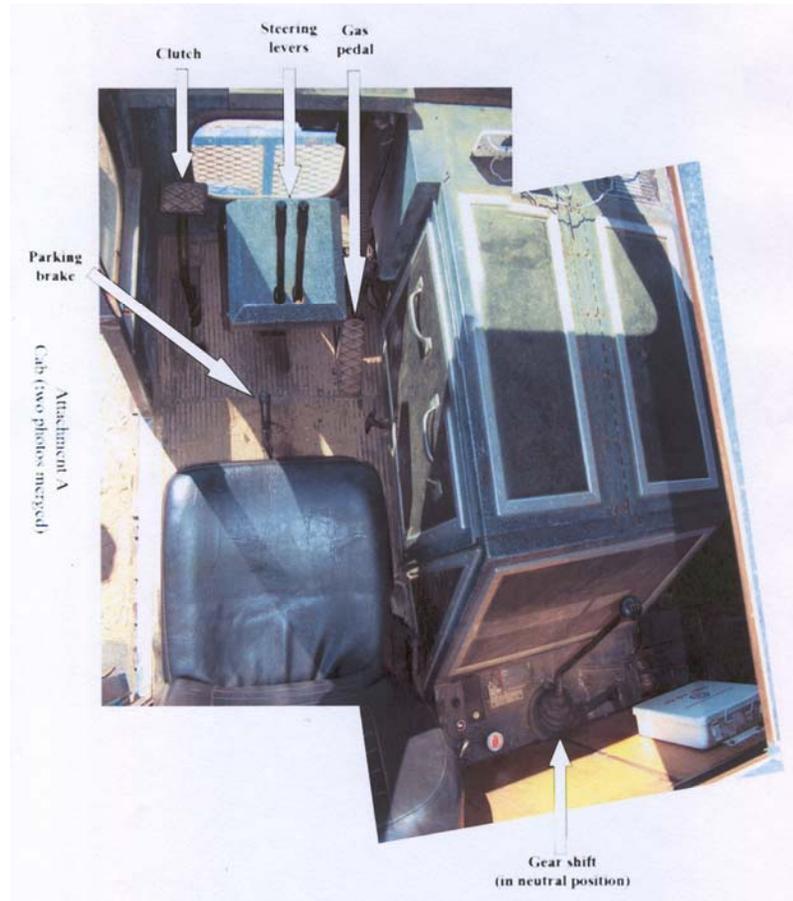
The Go-Tract operating controls are identified in Figure 2. A key was used to start and shut off the engine. There were two foot pedals; left for the clutch and right for the gas. A parking brake lever was located under the operator seat. Two hand levers were used to steer the machine. The gear selector lever was located to the far right and slightly behind the driver’s position. Because the lever was not easily

Figure 2. Picture of Go-Tract operator compartment

accessible, the driver had to turn his head and place and reach slightly behind to place his hand directly on the lever to move it. The position of the operator in relation to the

gearshift lever made it awkward to reach the lever when the unit was in first gear. The clutch was the primary means of controlling forward and reverse motion (working with the weight of the vehicle) as well as being used for stopping the vehicle (but not as a vehicle brake).

accessible and visible to the operator. Although the Go-Tract key would have turned off the engine and stopped forward movement, it was not used. An engine-kill switch mounted on the unit might have allowed the operator to stop the machine quickly. An engine-kill button mounted where it is easily accessible, visible and clearly labeled, would allow a quick method of stopping the machine's movement.

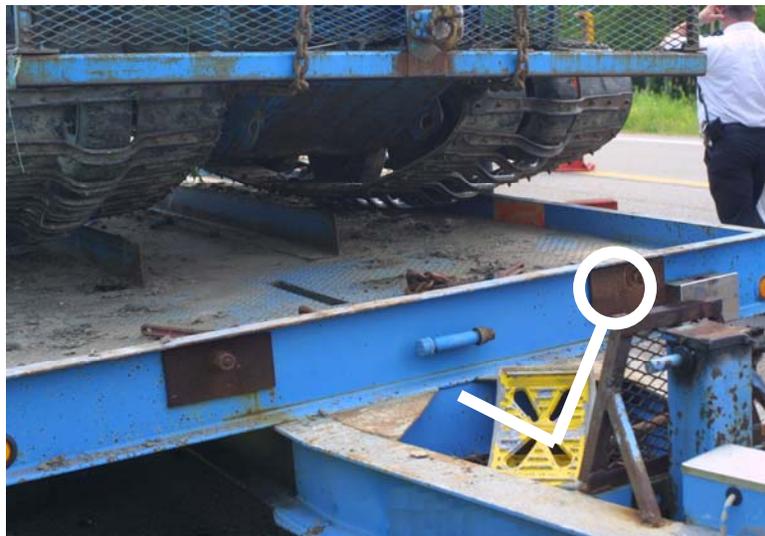
Figure 3. Position and location of decedent at time of incident.

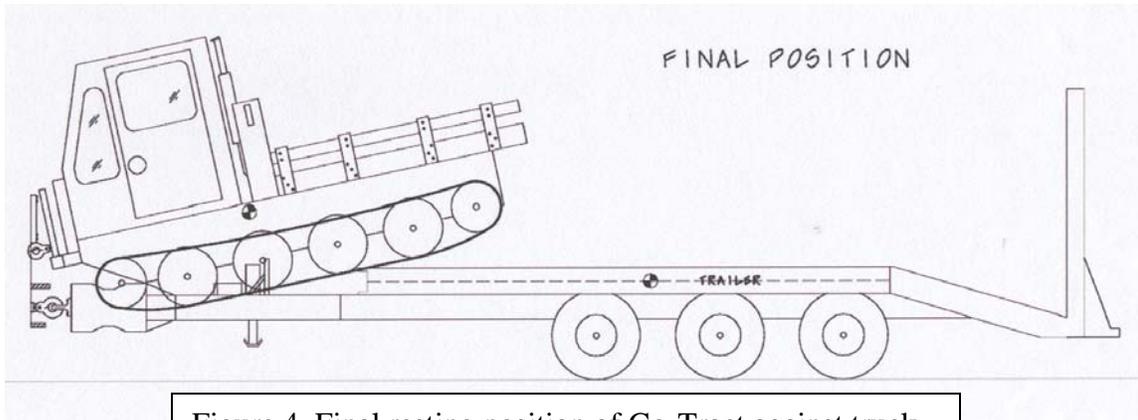
Figure 4. Final resting position of Go-Tract against truck

When emergency response, the police, and company personnel arrived, the Go-Tract was in first gear. The parking brake was not set as required by the operating manual, most likely due to the emergency situation. All remedial actions had to wait on the medical examiner's arrival to pronounce the decedent dead at the scene. A wrecker was contacted and arrived to lift the Go-Tract from the decedent and trailer.
