# MIFACE INVESTIGATION REPORT: #07MI121

## Subject: Laborer Painting Christmas Trees Electrocuted

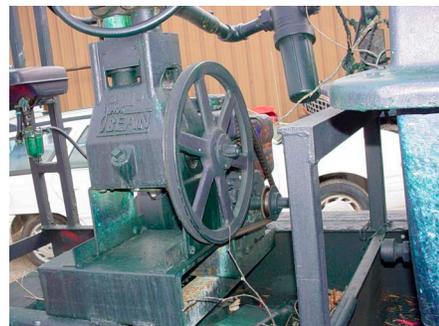
Figure 2. Unguarded belt, pulley and flywheel on the stake truck

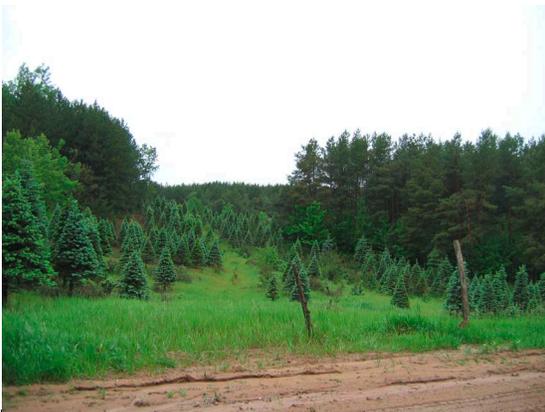
Figure 8. Two-track road and field entrance/exit recommended by employer

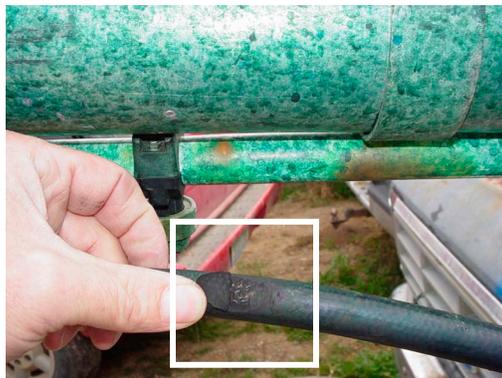
Figure 12. Burn mark on hose
