MIFACE INVESTIGATION REPORT: #07MI122

Subject: Farmer Killed When He Became Entangled in Implement Drive Line/Posthole Auger

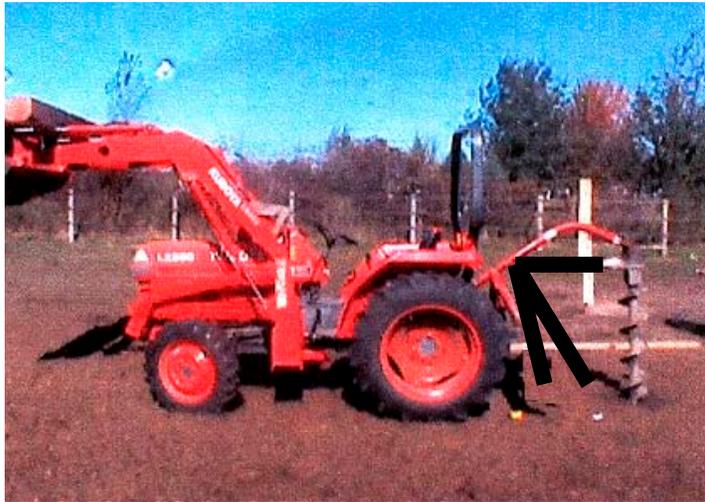
On October 13, 2007, a 56-year-old male farmer was killed when he became entangled in a posthole auger connection to the arm of the tractor attachment on his equine operation. The decedent and his spouse had been setting fence posts for a new area for their horses. The spouse left the decedent to look for their grandchild. As she was returning to the work area, she heard her husband cry out. She ran to the tractor and found him entangled in the auger. She stopped the tractor and attempted to untangle him, but was unable to do so. She attempted to call 911 using her cell phone. Unable to get a signal, she ran to their home and used the landline to call for emergency response. Returning to her husband, she found him not breathing. Emergency response arrived, and he was declared dead at the scene.

Figure 1. Tractor, posthole auger, and raised bucket arms supporting fencepost. Decedent's wrapped position around PTO shaft outlined in black

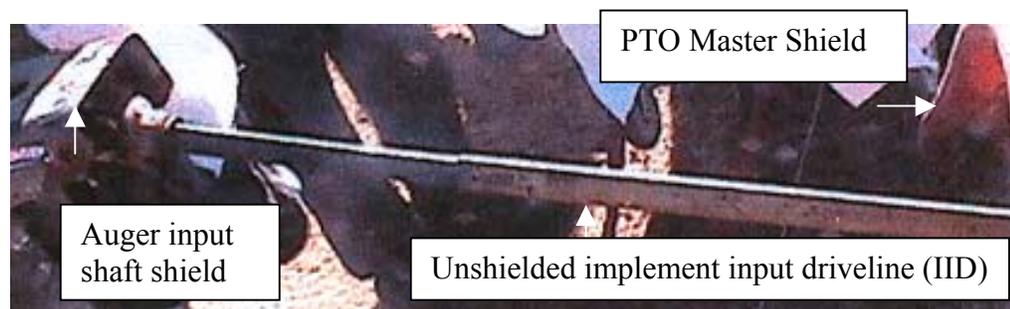
The tractor being used to power the posthole auger was a 4-wheel drive, Kubota L 2350. It was equipped with a front bucket, that was used to transport the fence posts and a power take off (PTO) shaft at the rear of the tractor. The PTO system had some, but not all of the recommended guards. Guarding consisted of a PTO master shield for the tractor PTO stub and an auger input shaft shield on the implement (Figure 2). The responding police agency stated in the police report that a safety guard that is used to cover the power take off shaft (*i.e. implement input driveline (IID)*) MIFACE clarification) appeared to be missing.

Figure 2. PTO System involved in incident

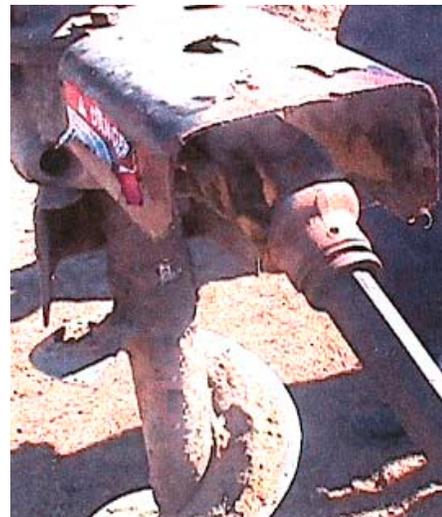
The length of the shear pin used to connect that auger to the output shaft of the gearbox was unknown. A pin that is too long or has protrusions could snag clothing and with the absence of guarding, the potential for an entanglement in this area of the posthole auger increases.

His wife indicated that when emergency response personnel untangled him from the auger PTO shaft, she noted that the drawstring had become entangled in the gearbox area. It is unknown how the decedent

Figure 3. Auger gearbox/driveline where decedent's hood drawstring became entangled

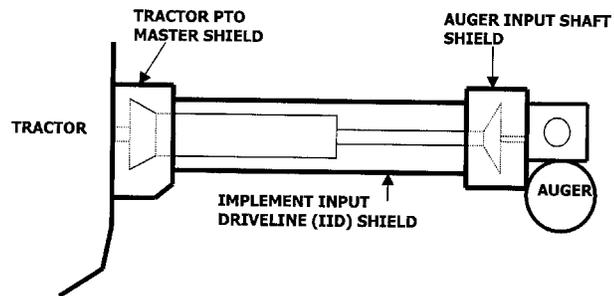
Drawing 1. Recommended PTO System Shielding

PTO system shielding comprises three major areas: PTO stub shaft (tractor), implement input shaft shield (auger, in this incident) and implement input driveline (IID) shielding (Drawing 1). Contact with any moving machinery parts such as the auger, couplings, or driveline can lead to an entanglement, especially if guarding is missing, out of position, or not properly maintained. In this incident, it appears that there was no guarding around the implement input driveline, which may have contributed to this incident.

- Posthole auger drive elements should be guarded with all shielding in place and functional.

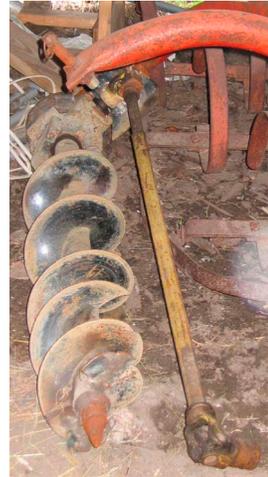
The decedent's wife stated that after the death of her husband another family member had removed the auger input shaft shielding so that the wife would not have to see the aftermath of the incident. The PTO master shield was in place and the implement input driveline shield (Figure 4) was not present at the time of the MIFACE site visit.

Posthole augers are rotating pieces of machinery and pose entanglement risks (Figure 4). Although commonly used, their hazards need to be recognized.

Figure 4. Auger and unprotected IID in barn

- Consider other options to perform the work, such as a power post driver.

There are several equipment options for an individual who would like to be able to dig a posthole. Hydraulic post drivers can be attached to a tractor or attached to another power source to “pound” the post into the ground. As with any piece of equipment, the manufacturers’ instructions should be followed to avoid injury when in use. There are also powered one-man posthole augers that are contained in one unit.
