# MIFACE INVESTIGATION REPORT: #07MI136

## SUBJECT: Hotel Assistant Manager Dies Due to a Fall from a Ladder During Installation of Wood Trim

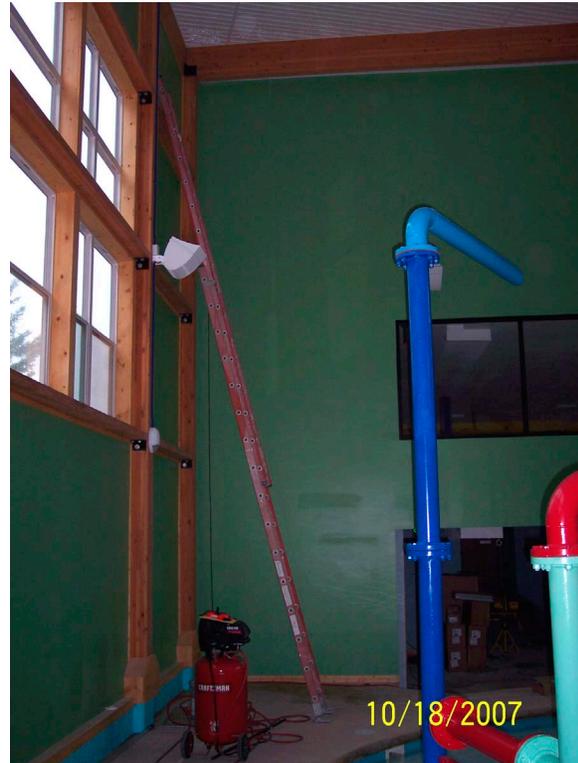
Figure 1. Police photo of incident scene one day after incident

The responding police department performed a re-enactment of the work the decedent was performing to show the nail gun’s air hose and hose slack, location of ladder, and height of the decedent’s fall (Figures 1 and 4).

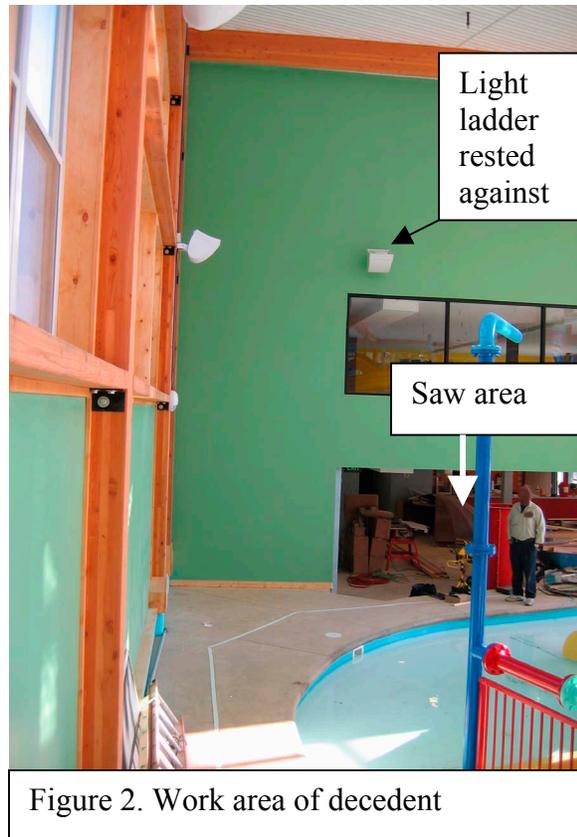
Co-owner #1 was called away from the saw area by Co-owner #2. While Co-owner #1 and Co-owner #2 were in another area of the jobsite, it appears the decedent placed the fiberglass ladder, extended to 24 feet 3 inches, against the west wall near the junction of the west wall and the north wall. He took two pieces of stained trim to the renovation area and left the remainder of the stained trim in the saw area (Figure 2).

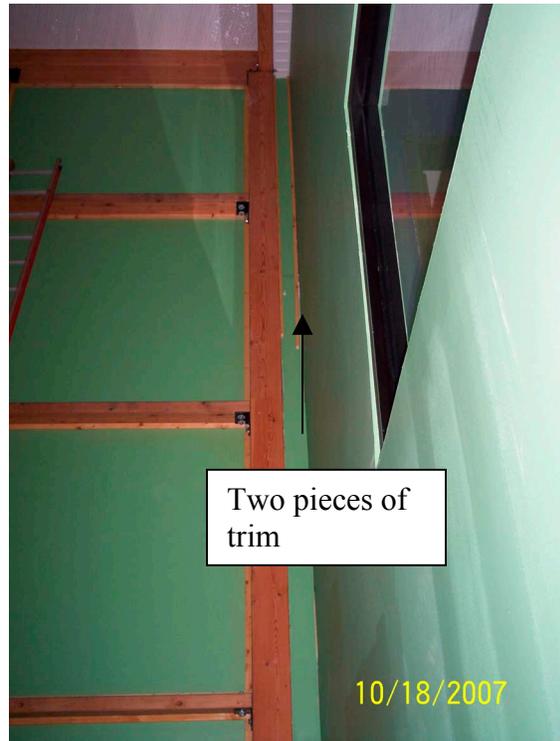
The sequence of events leading to the fall was unwitnessed. The decedent placed the base of the ladder approximately five to six feet away from the west wall. He ascended the ladder carrying the nail gun and trim to the wall/ceiling junction. Using the nail gun, he nailed two pieces of trim (Figure 3). The last nail on the trim was located 23 feet, 1 inch from the floor. Based upon the last nail position, it was estimated that the decedent fell approximately 20 feet to the concrete floor.

Figure 3. Placement of trim on west wall.

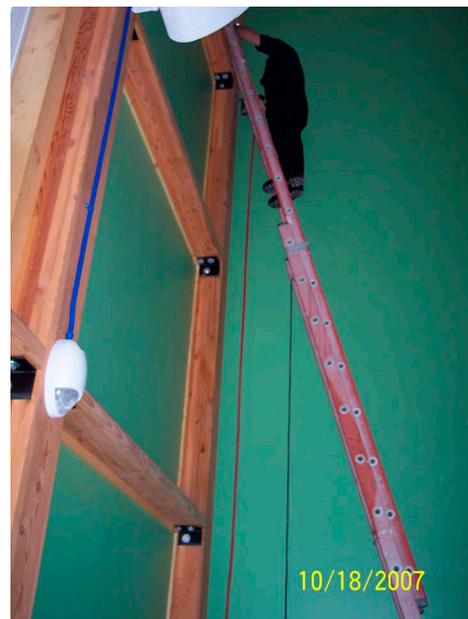
Figure 4. Police photo of postulated position of decedent on the ladder at the time of the fall

- Employers should review ladder inspection, placement, and safe use procedures with all employees, including experienced employees.

Many safety experts recommend that a ladder should be used primarily to climb to or from a work area, not as a work platform. In this case, the employer was limited in his options to use an alternative work platform such as an aerial lift or scaffold because of the location of the pool and saw area. Safe ladder use requires a worker to maintain a three-point connection (two hands/one foot or two feet/one hand) and his/her shoulders within the side rails. In this case, the decedent was not able to maintain a three-point connection because he was required to use both hands to hold and nail the trim into place.
