MIFACE INVESTIGATION REPORT: #08MI001

SUBJECT: Pipe Technician Killed by Coke Oven Gas Pipe Explosion

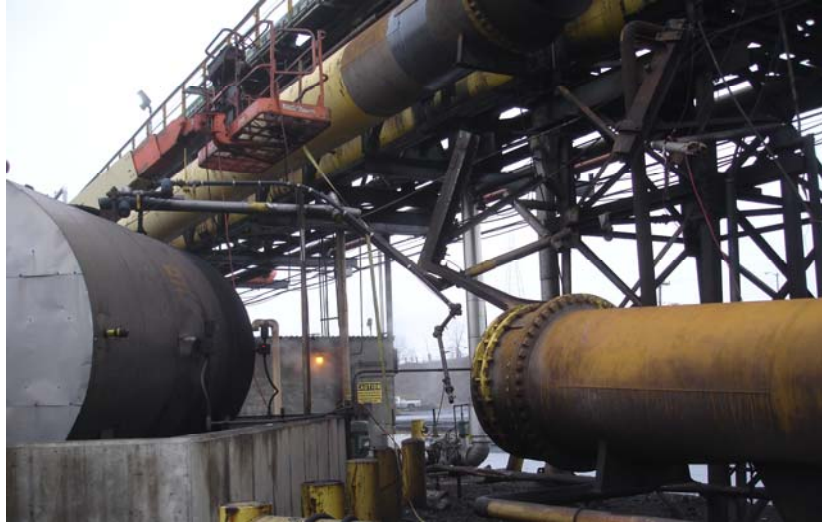
On January 5, 2008, a 27-year-old male pipe technician was killed when he was struck by pieces of pipeline and explosion forces from a 54-inch coke oven gas (COG) pipe that exploded during repair activities. The site owner had subcontracted the company for whom the decedent worked to perform pipeline repairs. A bypass pipeline had been constructed on a 42-inch live COG pipe to an unused 54-inch COG pipe to allow for repairs in the future on the 42-inch COG pipe.

Figure 1. Incident Scene. 54-inch pipeline blown apart, area where patch repair occurred, and man lift used to elevate workers to pipeline repair area

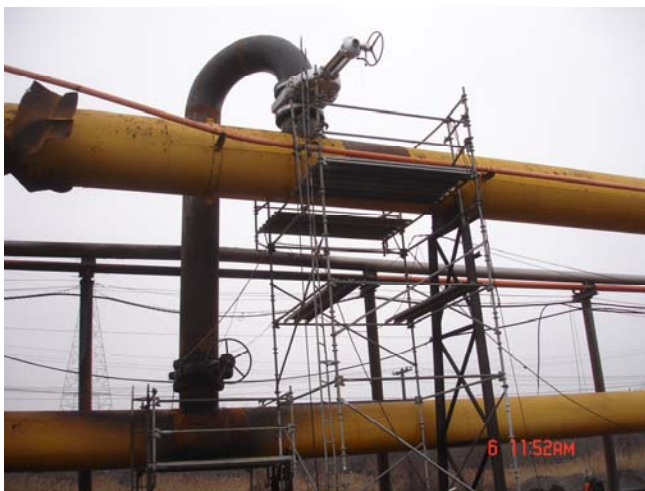
The 54-inch line had been connected to the active 42-inch COG pipeline via two bypass piping sections, each with an isolation/gate valve at the connection end. The decedent's employer hired subcontractor A to perform the hot tap operation on the live 42-inch pipeline. The pressure in the line was reduced from the active line pressure of 200 inches water column, so the gate valve and bypass piping could be installed and connected to the 54-inch pipeline. The site owner was responsible to purge the 42-inch line. The 30-inch hot taps to bypass the fuel over to the 54-inch pipe to the north and then another 30-inch

Figure 2. Example of bypass piping

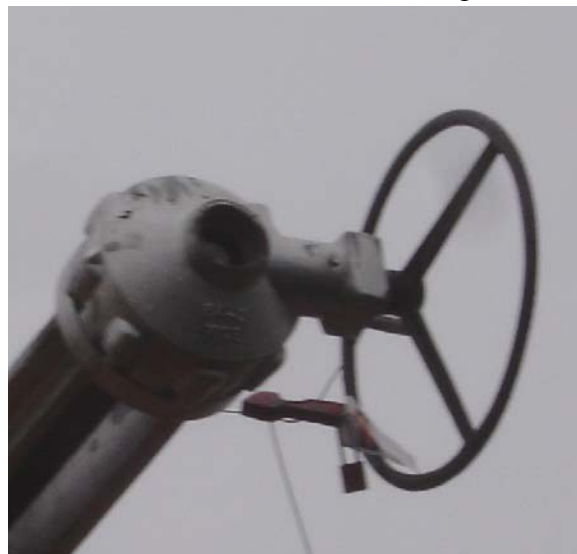
In the late afternoon on the day before the incident, the subcontractor hooked the last section and gate valve to the 54-inch dead pipeline. The four isolation/gate valves were in the closed position and only the locks of the site owner were in place (Figure 3). One of the decedent's coworkers tested the 54-inch line for flammable gas using the site owner's air monitor. Results were negative for flammable gasses. The crew supervisor installed the site owner's locks on the bypass valves at south end of the 54-inch pipe and placed the control keys for the locks in lock-

Figure 3. Site owner lock on valve

Although it is known that flammable gases must have been present in the 54-inch pipeline, the mechanism of how the gases got there is unknown. The site owner did not apply the site owner locks. The decedent's employer applied the site owner locks, whose lockbox for the keys was in one of the site owner's trailers. It appears that all pertinent valves were closed and locked out using the site owner locks. It is unknown if at some time these locks were removed and the valves opened and then shut and relocked. The decedent's employer did not place their locks on the valves to ensure the valves stayed closed. If the decedent's company had placed their locks on the valves and kept the keys in a secure area in their trailer, this would have provided an added assurance that the valves would not be opened without the knowledge of the decedent's employer's workers.

- Employers who are performing work on machines or equipment where unexpected energization, start-up or release of stored energy could occur and cause injury should always place their own lock(s) on the machinery/equipment if their workers are scheduled to be the first to perform work.

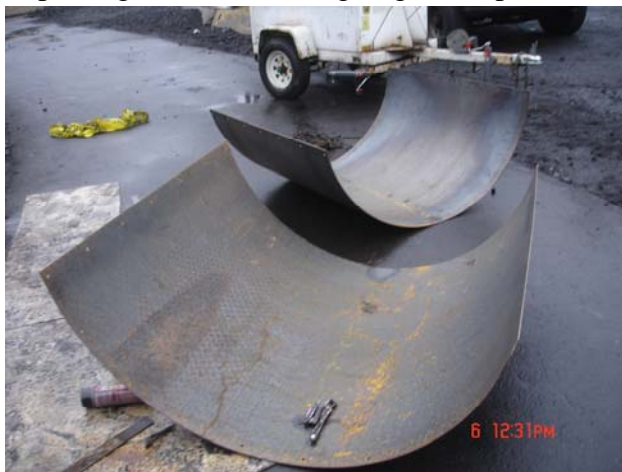
Figure 4. Gasketed steel cladding

Three gasketed steel cladding patches were to be installed on the 54-inch pipeline to cover leaks (Figures 4 and 5). The crew foreman and the ground man worked on activities while on the ground under the pipeline. The decedent and his two crewmembers on top of the pipeline were making patch repairs on the 54-inch pipeline by bolting the gasketed steel cladding to the pipe using pneumatic drilling tools. The work crew did not bleed, purge, or perform air monitoring of the 54-inch line prior to beginning the day's repair activities. The carbon monoxide (CO) monitors the crew wore on their jackets did not indicate any exposure to CO was occurring while they were performing the work. The crew completed one patch installation and then stopped for lunch at approximately 12:00 p.m.

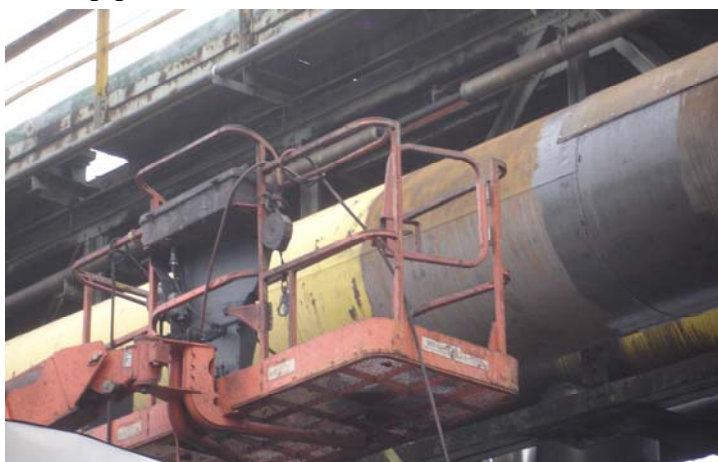
Figure 5. Gasketed steel cladding patches and man lift

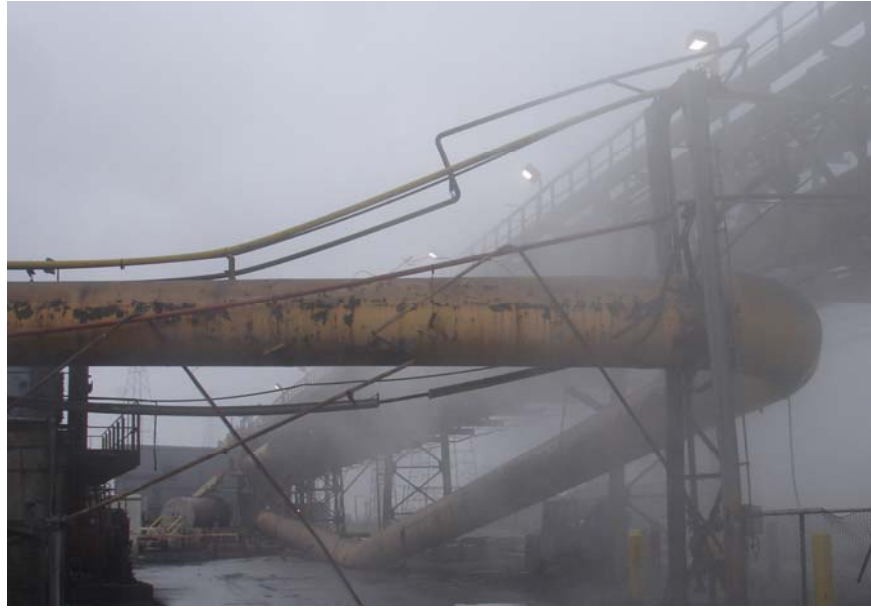
Approximately 45 minutes later, as Coworker #2 and the decedent were tightening down the patch bolts and Coworker #1 was tapping a hole, the pipe and ironwork began to shake. The explosion occurred south of the crew's location. When the pipe exploded it pressurized the line and the pressure was too great for a nearby expansion joint that blew

Figure 6. Incident scene shortly after explosion and fire

apart. The north piece of 54-inch pipe fell to the ground. The pressure release caused a large cloud of dust (Figure 6). A loud noise was heard by all of the crewmembers. The force of the explosion caused the decedent to be blown backwards with tremendous force, causing life-ending injuries.

The company owner did not consider the pneumatic drilling being performed on the 54-inch line as “hot work”. Coke oven gas can contain hydrogen and methane, ammonia, carbon monoxide, carbon dioxide, ethane, ethylene, benzene, oxygen and nitrogen, hydrogen sulfide, water vapor, cyclopentadiene, toluene, naphthalene, hydrogen cyanide, cyanogen, and nitric oxide. Sparks from contact of the pneumatic drill and the metal

pipeline may have initiated the explosion. If the line had been tested at various areas of the pipeline, the flammable gas may have been detected and this incident avoided.

- Employers should always treat pipes as “active” and test pipes for explosive gases before initiating and/or continuing any work on the pipe after a period of inactivity.

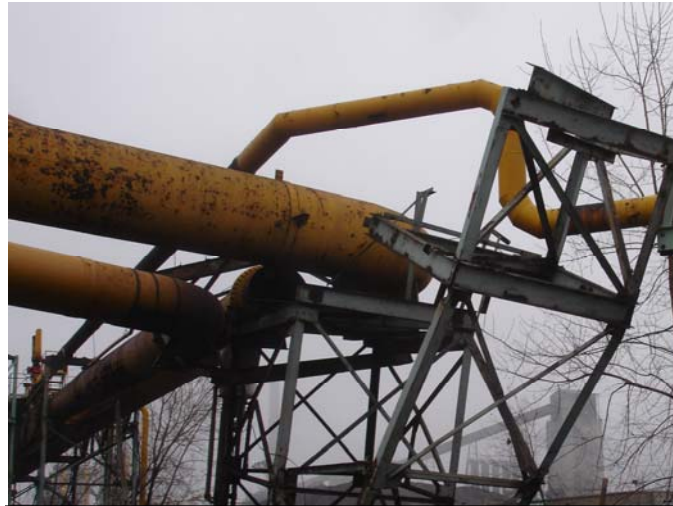
The site owner's area utilities manager walked the area after the explosion and found all four bleeder valves in the closed position. He also noted that the four main gate valves were in the closed position and were cabled and locked. The force of the explosion caused a blank to travel down the length of the 54-inch pipe and break through the end of the pipe (Figure 7). The blank fell to the ground.

Figure 7. End of pipe where blank exited
