MIFACE INVESTIGATION REPORT: #08MI003

SUBJECT: Steel Mill Supervisor Pulled From Catwalk by Contact with Belt Conveyor

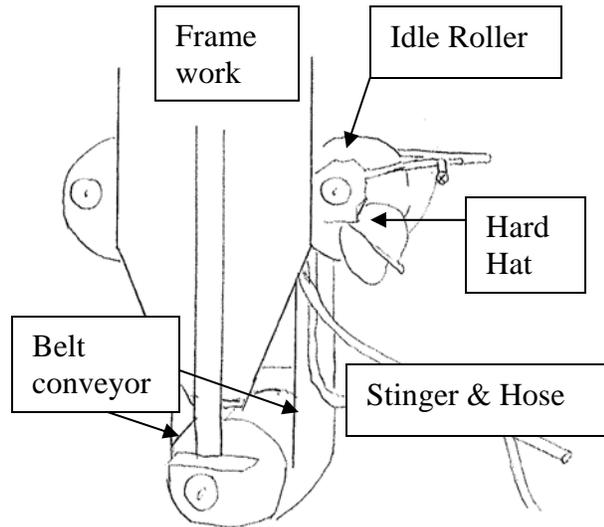
Drawing 1. Belt conveyor drawing illustrating resting point of decedent's hard hat and location of stinger/air hose

The incident was unwitnessed. It appeared that as the decedent passed under the low beam and conveyor belt with the stinger/air hose unit on his shoulder, the air supply hose and/or stinger were caught in the conveyor belt/tensioner north idle roller. The movement of the belt caused the hose and stinger to be pulled between the conveyor belt and idle roller. Unable to react quickly enough, the decedent was also pulled from the catwalk and struck the structural support of the tensioner system. The decedent struck the support with sufficient force to wedge his hardhat between the tension roller and support framework before his body dropped over the railing to the floor below.

decedent had fallen and was lying face down. The air hose and stinger was found between the conveyor belt and the tension roller at the topside of the tension roller. The stinger was bent around the roller and several feet of hose was looped under the conveyor belt north of the roller. The air hose shut-off valve was bent. The decedent's hardhat was caught between the east edge of the idle roller and support frame with his helmet liner and respirator hanging from the hard hat.

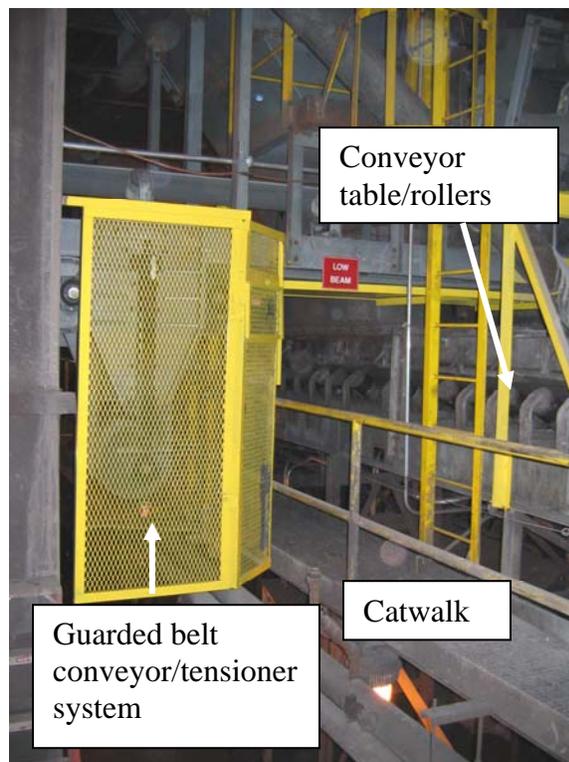
Figure 1. Overview of work area

above the charger room floor. Access to this conveyor was provided by stairs leading to a catwalk that ran parallel to the conveyor table/rollers. The catwalk was approximately 132 inches above the floor. The catwalk had a standard 42-inch barrier (Figure 1). The belt conveyor into which the decedent was pulled was 22 inches wide. This conveyor first traveled parallel to the catwalk and then turned and traveled in a perpendicular direction above the catwalk. At the location where the catwalk passed under the belt conveyor, a warning sign identified a low beam approximately 66 inches above the catwalk. At the low beam area, the tensioner for the belt conveyor turned downward from above the catwalk. The tensioner system was 25 inches from the catwalk rail (Figure 2). At the time of the incident, the belt conveyor and tensioner system was unguarded.

Machine guarding is required by MIOSHA General Industry Safety and Health Safety Standard, Part 14, Conveyors, Rule 1442 (2): *A nip point at a pulley shall be guarded by an enclosure or barrier constructed to prevent access by an employee's body members or loose clothing.* After the incident, the employer had installed a fixed metal guard to shield the area and prevent employee contact with the conveyor belt/tensioner system (Figures 1

and 2). The guard was designed and installed so an employee could not reach behind it and get caught in the in-running nip point.

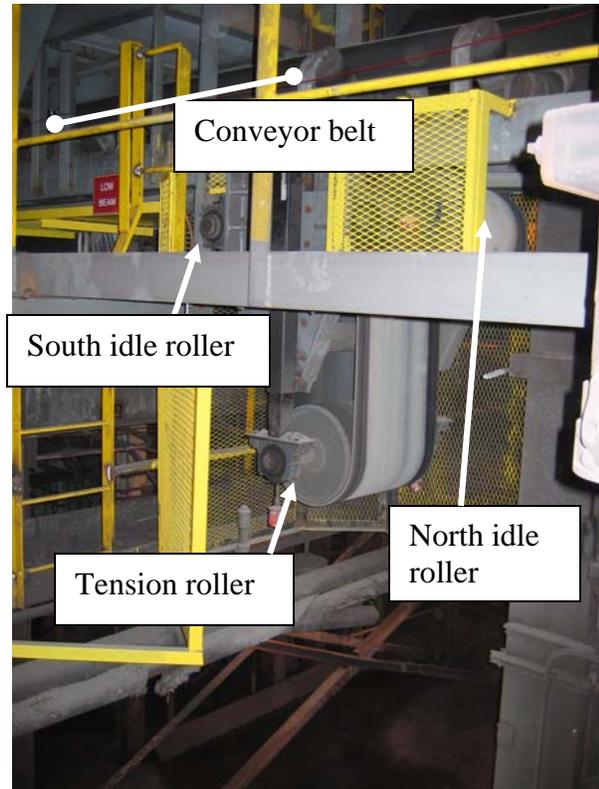
Figure 2. Conveyor belt tensioner system and catwalk work area

There were two idle rollers above and on each side of the tension roller. The north idle roller was involved in the incident. The tension roller was located at the bottom point between the two idle rollers. The tension roller was adjustable for the amount of slack created when the conveyor belt stretched.

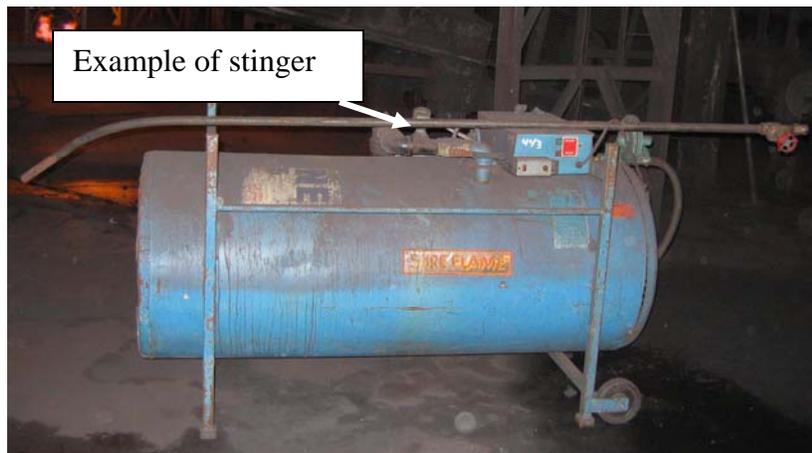
Figure 3. Tornado heater with example of stinger resting on top

it would not be necessary to turn off the belt conveyor because the crew would not be near the tensioner. The building supervisor accompanied the crew to the area where the conveyor and catwalk were to be cleaned of coke rocks and debris. The building supervisor then shut off the conveyor table to be cleaned but left the belt conveyor operational. Because of the time of year, the tornado heaters being used to heat the building were contributing to the noise level in the building (Figure 3).
