MIFACE INVESTIGATION REPORT: #08MI009

SUBJECT: Journeyman Mason Died After Stepping Backward Off a Raised Mobile Scaffold

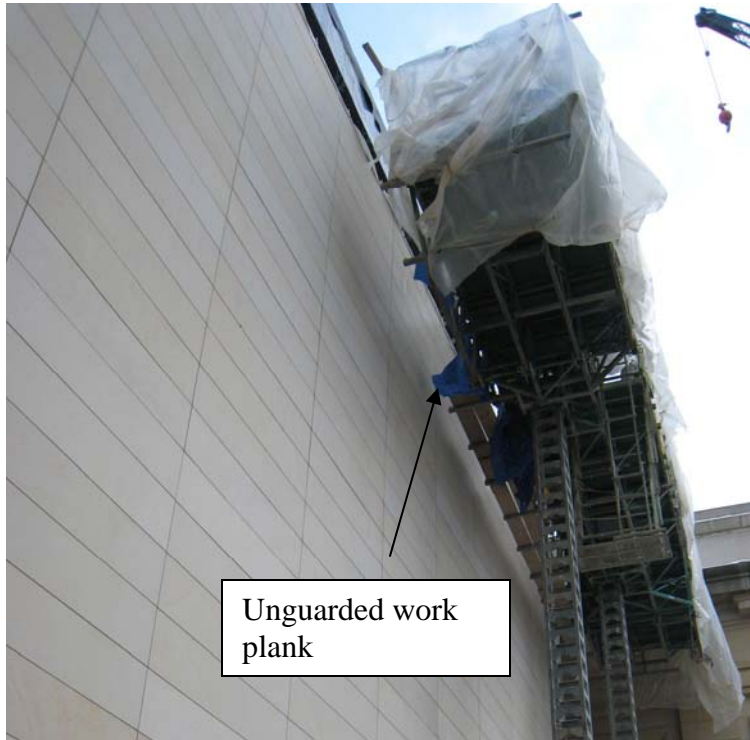
On the winter of 2008, a 32-year-old male journeyman mason died as a result of falling from an unguarded working surface of a Hydro Mobile 2 scaffold raised to 35 feet. The scaffold had recently been lowered and moved to its present location. The competent persons erecting the scaffold did not re-install the guardrails at the ends of the working platform nor install the proper planking prior to raising the scaffold. The scaffold was repositioned in a north-south direction and then raised to 35 feet above the ground. The decedent was installing backing rod and his coworker was caulking. The two workers worked in a south to north direction, moving backwards on the work platform. The decedent fell from the unguarded edge (Figure 1) to the concrete surface below. Emergency response was called, and the decedent was taken to a local hospital. He died in the emergency room.

Figure 1. Unguarded north work plank on raised Hydro Mobile 2 scaffold

- Employers should ensure that all required components of a scaffold are properly installed prior to employee use.

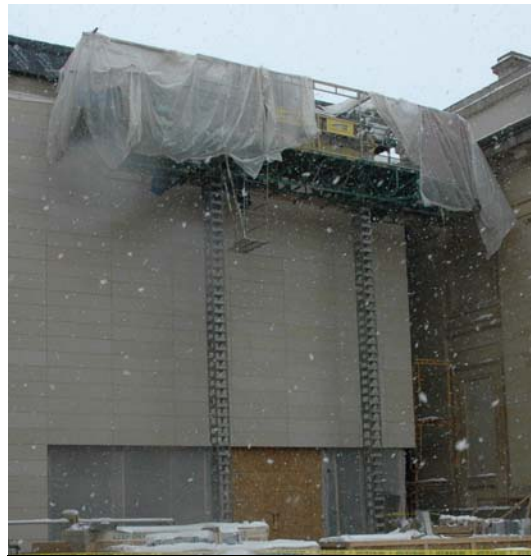
Once the move had been made, the Hydro Mobile 2 was fastened to the building in a north-south position and the work planks re-installed. Plastic sheeting covered the scaffolding at the top, which had been raised to 35 feet (Figure 2). The working foot planks that were attached to the outriggers did not extend the continuous length of the scaffold thus did not fully plank the scaffold work area (Figures 3 and 4). The work planks were less than six inches away from the construction wall.

Figure 2. Repositioned Hydro Mobile 2 scaffold

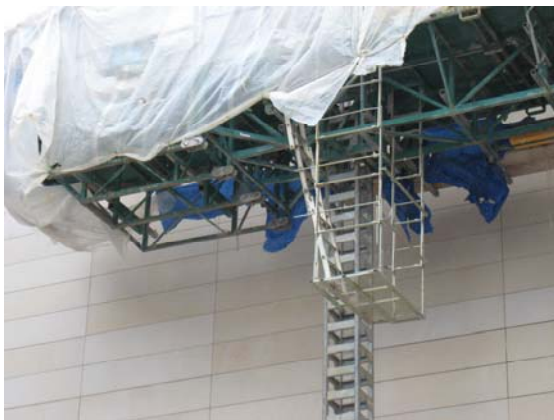
Guardrails were not installed on ends of the employees work platform.

Employees work platform was not fully planked.

Figure 3. North working plank not fully planked nor guarded

It appears that while the decedent was bending over and walking backwards to install the backer rod, he stepped off the end of the unguarded work plank and fell 35 feet to the concrete grade below. His coworker, who had his back to the decedent, heard something. He turned around and witnessed the decedent falling from the scaffold.

Lack of appropriate guardrails on the north and south ends of the working planks of this 35-foot high scaffold was a significant factor in this incident. Had the scaffold in this incident been properly guarded, the decedent would, most likely, not have fallen to his death. Proper assembly procedures include, but are not limited to, the installation of guardrails and working foot planks. MIOSHA defines a competent person as a “person who is experienced and capable of identifying an existing or potential hazard in surroundings, or under working conditions, that are hazardous or dangerous to an employee and who has the authority and knowledge to take prompt corrective measures to eliminate hazards”. The competent person would be responsible for ensuring that scaffolds are properly assembled.

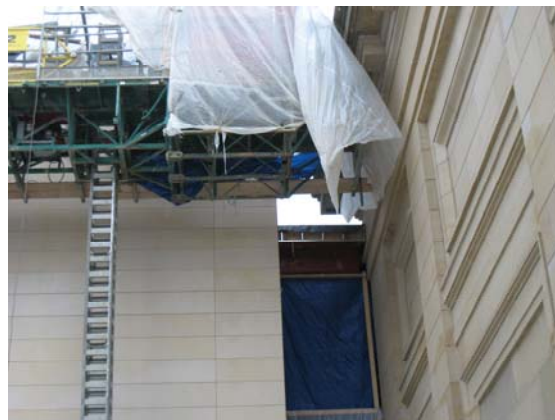
Figure 4. South working plank not guarded

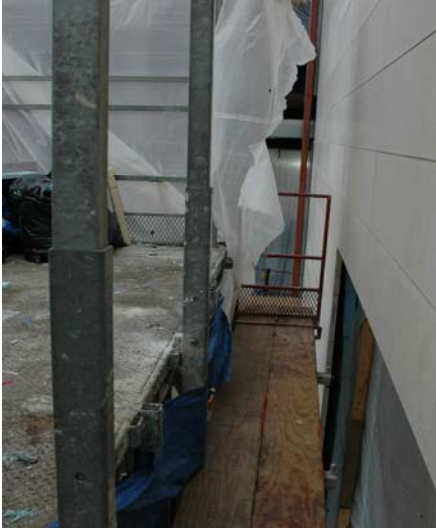
Figure 5. Guardrail installed on north end of working plank after incident

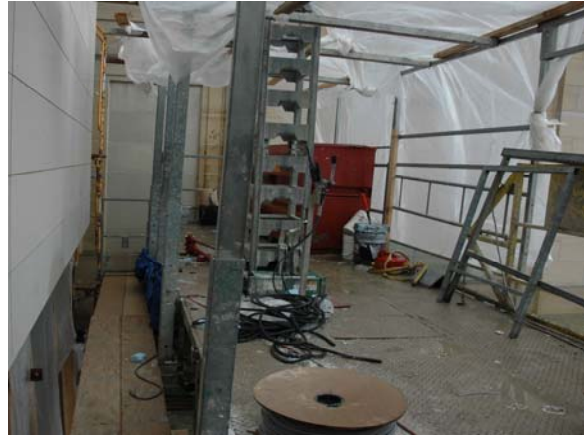
Figure 6. Guardrail installed on south end of working plank after incident
