MIFACE INVESTIGATION REPORT: # 08MI010

SUBJECT: Manufacturing Traffic Supervisor Dies When Struck By Forklift

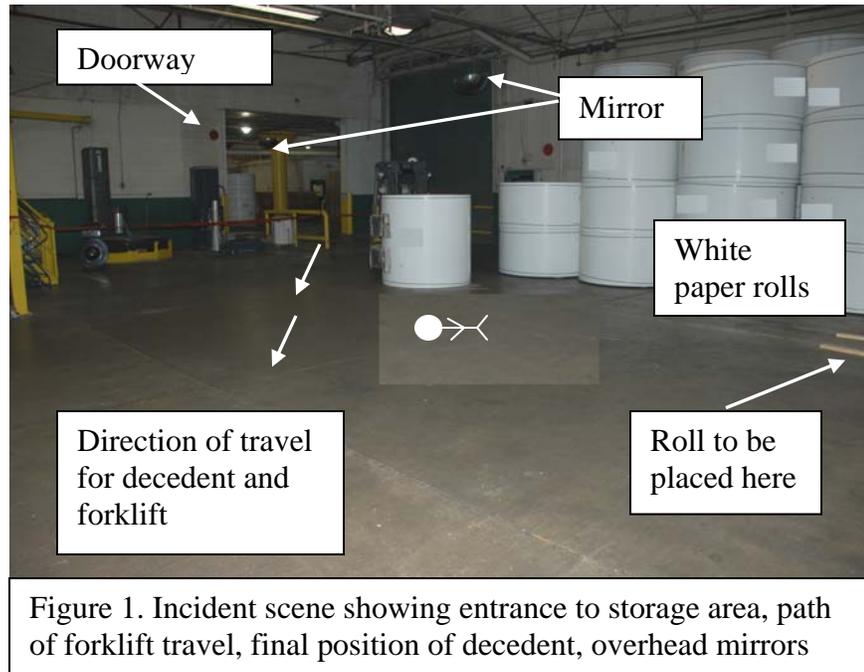
On March 3, 2008, a 59-year-old male traffic supervisor, who was wearing a white hard hat, died when he was struck by a Yale clamp truck that was transporting a paper roll that was approximately 59 inches tall and 50 inches wide. The decedent, who was not using the designated pedestrian aisleway,

was walking through the forklift travel area of the paper roll storage warehouse on his way to the shipping and receiving offices. The driver, who had entered the roll storage area through the doorway, was traveling in a forward direction (not trailing the load). He intended to place the roll in its appropriate place on 2- by 4-inch pieces of wood. The clamp truck/paper roll struck the decedent. The driver looked to his right on the ground and could see the decedent's body to the right of the truck's right tire. He immediately backed up and called for emergency assistance. Emergency response arrived. The decedent was declared dead at the scene.

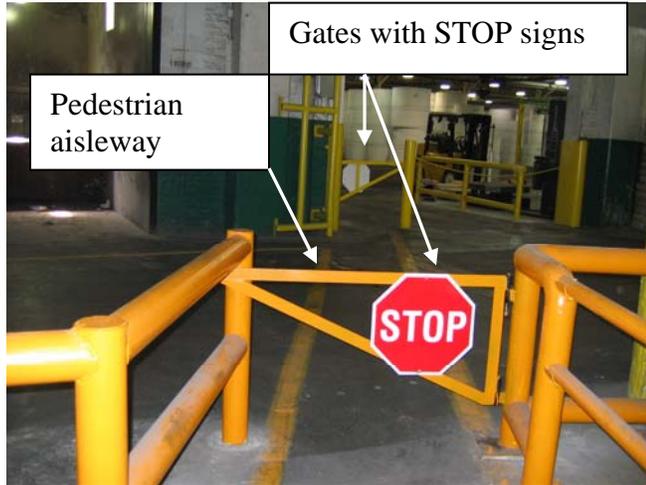
Figure 2. Building modifications made after incident, looking from supervisor's office toward roll storage warehouse

Figures 2 and 3 show the structural modifications made to the incident scene area after the incident. The company installed an overhead hanging STOP sign at the entrance to the roll storage room, and added pedestrian protections, including a marked a pedestrian aisleway in the main corridor, gates with posted STOP signs at the entrance to forklift travel areas, and a chain that must be removed by the forklift operator before entering the roll storage area.

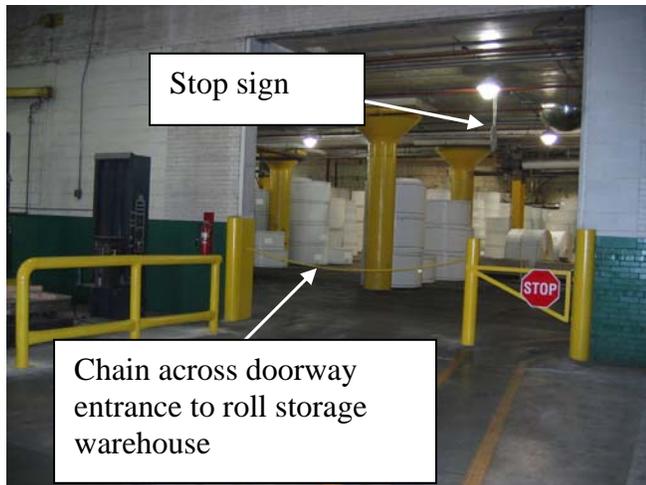
Figure 3. Building modifications looking from roll storage warehouse towards supervisor's office

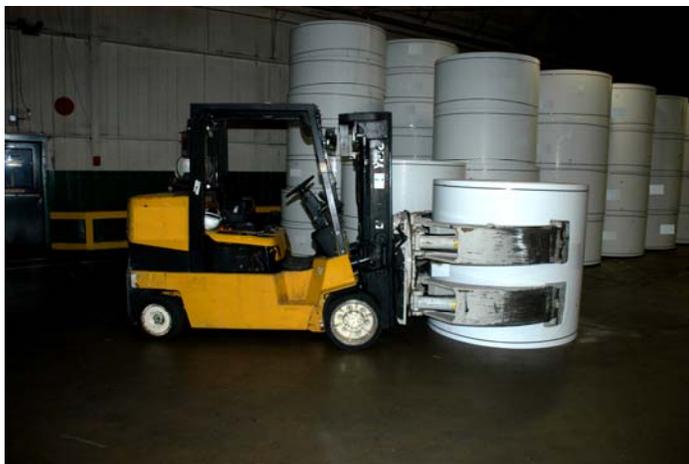
A 7,700 pound capacity Yale clamp truck with a 7,500 pound capacity clamp attachment was involved in the incident. The truck had a functioning horn and head-lights mounted just under the overhead guard. The headlights turned on when the truck was started. After the incident, no mechanical issue was found concerning the truck. The truck with clamp attachment was transporting a 59 1/2 inch tall by approximately 50-inch wide paper roll weighing 4,847 pounds from one area of the plant to a roll storage area.

Figure 4. Yale clamp truck with paper roll involved in incident

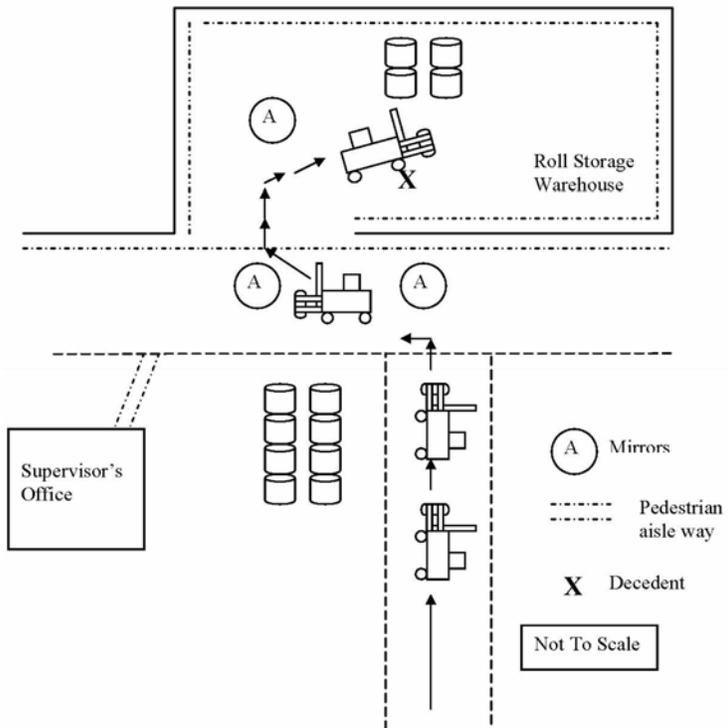
Drawing 1. Overview of incident scene showing Yale clamp truck travel path

designated storage location, indicated by 2- by 4-inch wood planks in one of the paper storage rows (See Figure 1 and Drawing 1). The police report stated that the forklift driver indicated it was the company's policy to honk the horn on the forklift every time the forklift came to a mirror. The driver indicated he had complied with this policy and honked his horn at all of the aisle intersections and at the entrance to the roll storage area. The driver had been carrying the paper roll between 6 inches and 12 inches from the floor. The top of the paper roll was estimated to have been 66 to 72 inches above the floor.

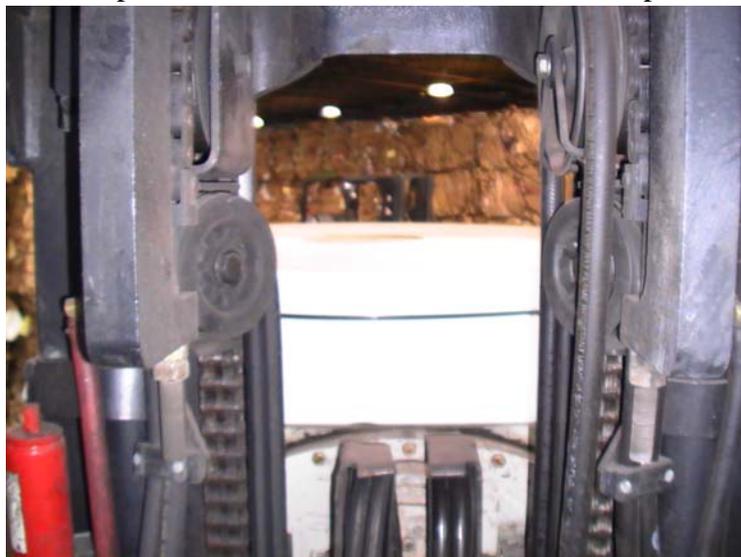
To simulate the forklift operator's line of vision, the firm representative raised the paper roll to six inches above the floor. Figure 5 was taken by the MIOSHA compliance officer as he positioned himself in the forklift to the approximate line of vision of the forklift driver. The officer observed that the roll obstructed forward vision – as the officer looked over the roll, the officer could not see the floor for the first 20 to 30 feet.

Figure 5. Simulated forklift driver forward view when seated in seat.

The decedent was 5 feet 6 inches tall, which placed the top of his head at the same height as the top of the roll if the roll was carried 6 inches above the floor. If the roll had been carried at 12 inches above the floor, it would have been 6 inches above the decedent's head.
