MIFACE INVESTIGATION REPORT: #08MI040

SUBJECT: Municipal Truck Driver Dies After Being Backed Over by Dump Truck

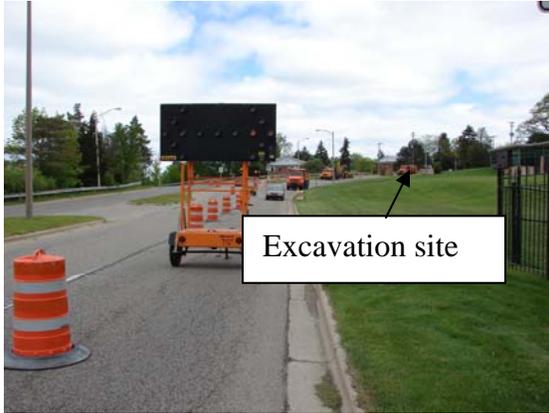
repair project, the southwest lanes had been divided into one westbound lane and one eastbound lane. One of the two northeast lanes had been closed approximately 200-300 feet west of the excavation and traffic diverted through a median access. (Drawing 1 and Figures 2 and 3). The following traffic control devices were on site: detour signs, traffic drums, barricades, advance warning signs, and flashing arrows.

Figure 2. Incident roadway looking northeast at lane taper

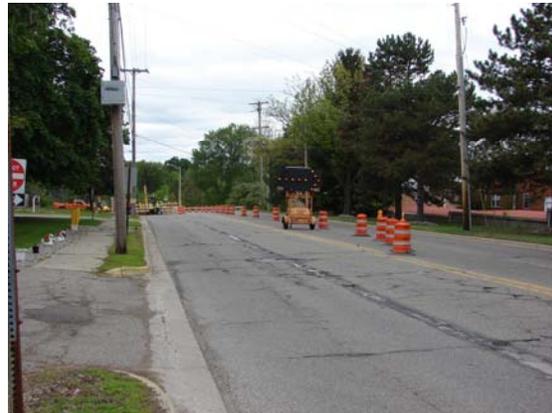
Figure 3. Looking west towards excavation site from south side of eastbound lanes of 4-lane roadway

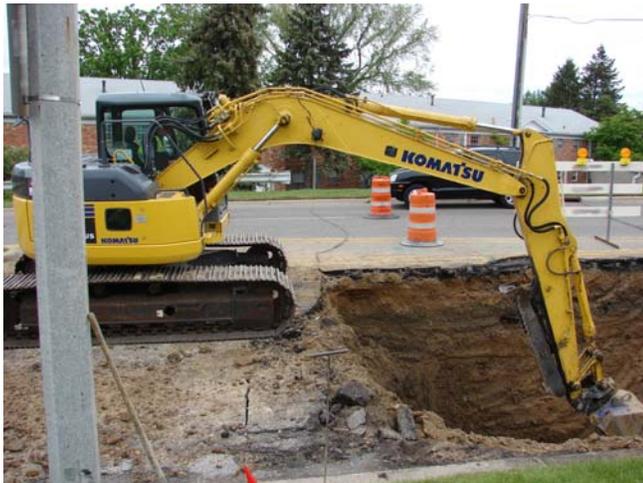
The excavation site encompassed both of the northeast bound lanes (Figure 4). The work crew for the sewer repair included an equipment operator, two laborers, a supervisor, and two truck drivers working in tandem, one of whom was the decedent. As one dump truck was filled, the other was to wait west of the site and back to the excavation when the truck being filled pulled away.

Figure 4. Excavation site

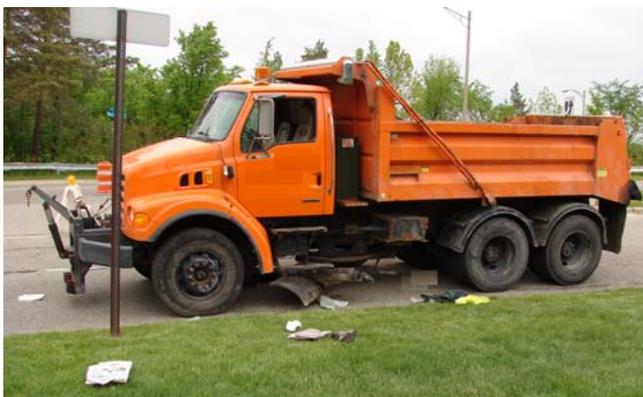
The truck involved in the incident was a 2003 three-ton tandem axle Sterling dump truck (Figure 5). The truck had been inspected that morning and no defects were identified. After the injury the responding police and the safety director evaluated the truck for related defects; none were found. The city safety director and the responding police heard the truck's back up warning signal as the vehicle was tested. The responding police determined that the truck's mirrors were positioned so that with little head movement the driver

Figure 5. Sterling dump truck involved in incident

could observe both sides of the vehicle to the rear as well as out and away from the vehicle.

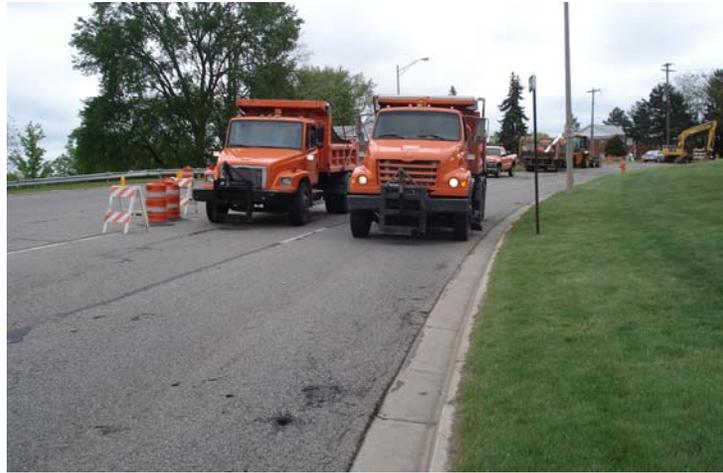
Figure 6. Dump truck positions after decedent was struck

The decedent's coworkers at the excavation site, hearing the backup alarm of the tandem axle truck and noting the decedent's location behind the truck and out of view of the backing driver, began to yell warnings to the decedent. As they ran toward the backing truck, the decedent apparently heard his coworkers yelling, stood up and acknowledged his coworkers. He was then struck and knocked down by the truck and run over by the dual rear wheels (Figures 6 and 7).

- Employers should ensure that written backing protocols are in place and that designated individuals are assigned as spotters to direct backing construction vehicles on construction sites.

- Employers should ensure that workers who are on foot stay out of the work area where heavy equipment is operating and in clear view of operators.

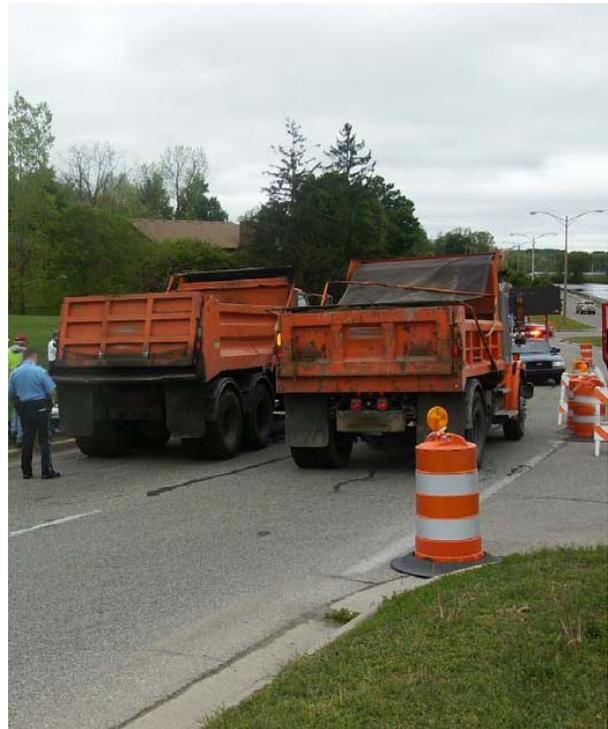
Figure 7. Final resting points of trucks

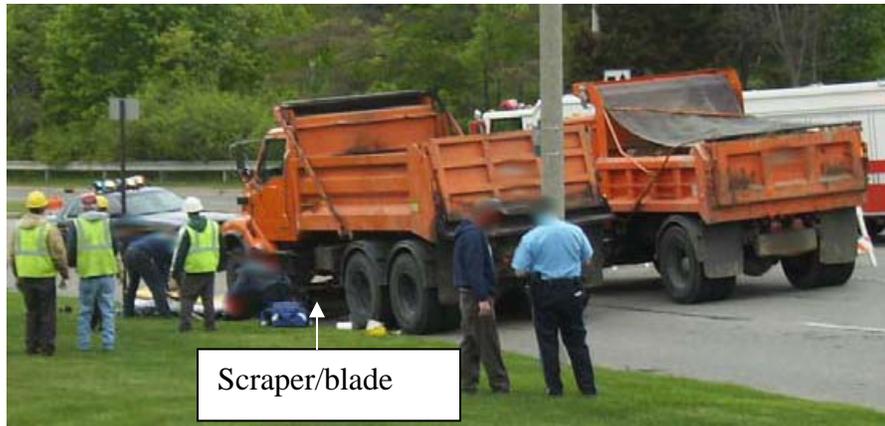
The truck driver felt a bump and then stopped, exited the truck, and noted the workers from the excavation site running toward him. The truck had dragged the decedent approximately four to five feet. Coworkers called for emergency response. The decedent was alert and calm when the paramedics extracted him from under the truck/scrapper blade (Figure 8).

Figure 8. Resting positions of dump trucks and emergency responders attending to injured worker

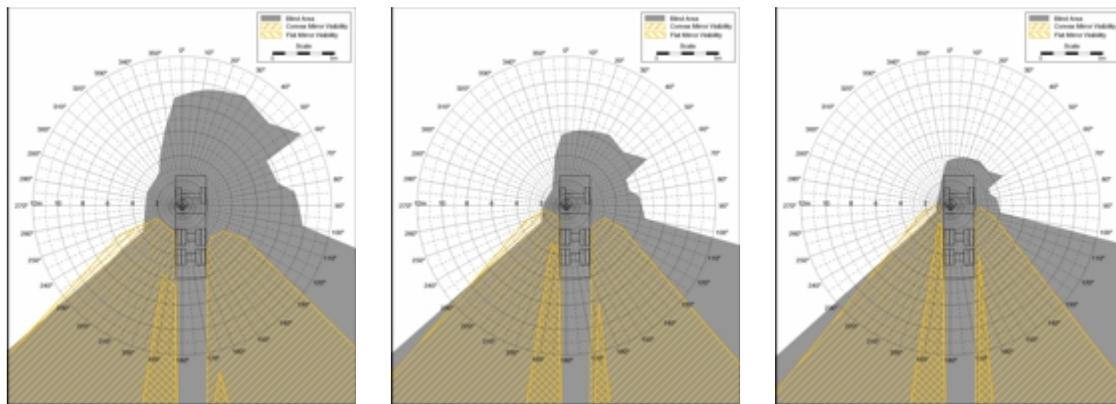
Areas around construction equipment that cannot be seen from the operator's position are considered blind areas or blind spots. Caterpillar Inc, under contract to NIOSH, developed detailed diagrams to assist in the visualization of the blind areas around various construction vehicles and equipment. For each construction vehicle tested, three different diagrams were developed to represent the ability of the vehicle operator to see an object at three different elevations: ground level, 900 millimeters (3 feet), and 1500 millimeters (mm). The diagram depicting the 900 mm plane represents the average height of a channelizing device, e.g. construction barrels that are commonly used in road construction. The diagram depicting the 1500 mm plane corresponds to the height of a 4-

foot 11-inch person. The NIOSH Highway Work Zone Safety website can be accessed at <http://www.cdc.gov/niosh/topics/highwayworkzones/>. Click on Construction Equipment Visibility to view a list of construction equipment and their corresponding blind area diagrams. Also on this website are the test procedures for developing the Blind Area Diagrams to assist safety personnel or instructors in developing their own Blind Area Diagrams. The following diagrams copied from the NIOSH website illustrate the blind spots of a Sterling 9500 three-axle dump truck.

- Employers should utilize the National Institute of Occupational Safety and Health (NIOSH) Safety and Health topic Highway Work Zone Safety topic page to provide employee training concerning blind areas for construction equipment.

- Heavy equipment owners should consider equipping vehicles with devices to detect the presence of individuals or objects behind the vehicle.
