MIFACE INVESTIGATION REPORT: #08MI169

SUBJECT: Air Museum Volunteer Died From Complications of a Head Injury Sustained After Falling From an Aircraft Tug

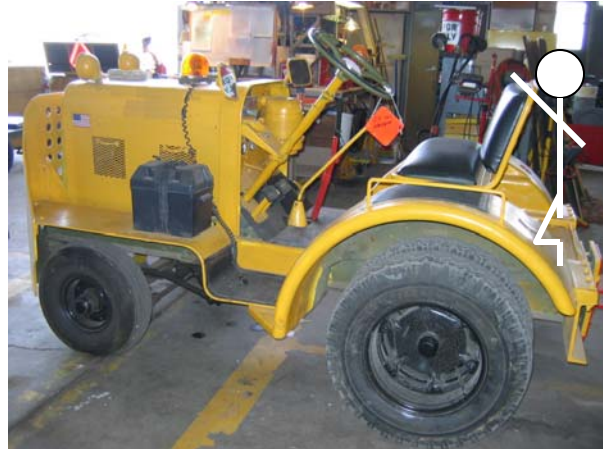
Figure 1. Aircraft tug and squatting position of decedent on back of tug

On the day of the incident, the ramp crew noted that an aircraft turned back toward the ramp. The decedent's ramp crew responded to assist the aircraft. Two individuals were seated in the front seat and the decedent was positioned on the back of the tug, squatting in the storage area. He was facing the driver's side; his right side was leaning against the back of the front seat. He held onto the seat frame for balance. The 10- to 11-foot tow bar was attached to the back of the tug.

It is postulated that while the tug was accelerating, a gust of wind caught the brim of the decedent's baseball cap and lifted the cap off his head. The decedent stood up from his squatting position in an attempt to grab his cap. He lost his balance and fell from the tug, and landed on the driver's side of the tug. He fell onto his side, then back, and struck the left side of his head on the pavement. The decedent was knocked unconscious from the impact. The tug stopped prior to reaching the end of the 10- to 11-foot tow bar.

- Air museum staff should update the Ramp Crew Safety Manual to:
 - Adopt a “No Seat – No Rider” policy,
 - Comply with requirements of MIOSHA General Industry Safety Standard, Powered Industrial Trucks, Part 21 and
 - Include industry best practices.

The front seat provided space for two passengers. The manual does not contain a statement prohibiting more than two passengers (riders) on the tug (No Seat – No Rider policy). The work practice observation evaluation form also did not address a trainer observing more than two individuals riding on the tug.

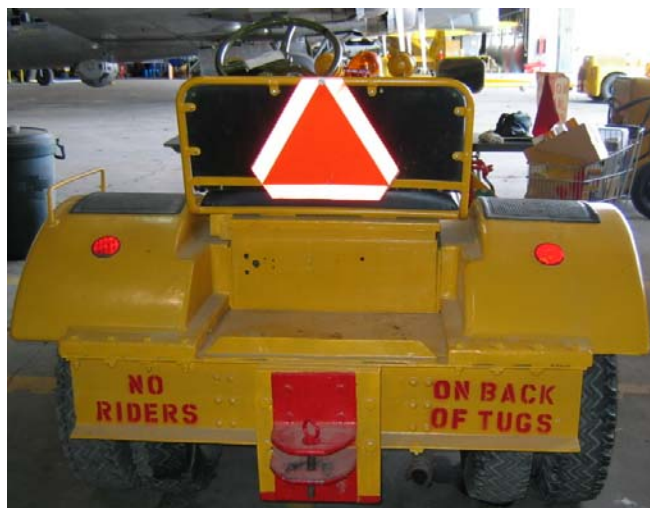
The aircraft tugs can either push or pull an aircraft to a designated area using a tow bar appropriate for the aircraft. The tug had a front seat designed for two passengers. At the back of the tug is an area for storage of equipment, such as wheel chocks and signaling wands, and the

Figure 2. Back of aircraft tug showing storage area and rider warning

attachment point for the tow bar. The tug did not have a suspension system or seat belts for the front seat passengers. The tug operated at a speed less than 5 mph.

Air museum personnel have spray painted the back of each tug with "No Riders on Back of Tugs."

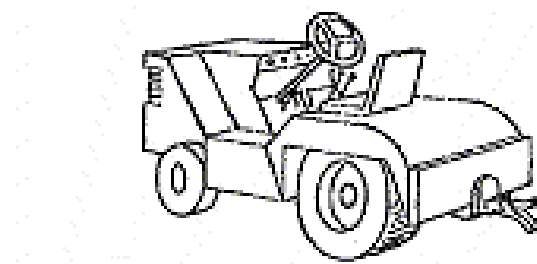
Drawing 1. Industrial Tractor,
MIOSHA Part 21, Appendix A,
Figure 5

MIOSHA General Industry Safety Standard, Powered Industrial Trucks, Part 21 provides safety rules for the care and use of powered industrial trucks and operator safety. The aircraft tug is considered to be an “industrial tractor” by MIOSHA. An industrial tractor is a “truck designed primarily to draw one or more non-powered trucks, trailers or other mobile loads.” Part 21’s Appendix A, Figure 5, and reproduced as Drawing 1 illustrates the type of vehicle included in this definition.

MIFACE recommends that the Ramp Crew operational division review the MIOSHA Powered Industrial Truck standard and update the Ramp Crew safety manual, including the observational checklists to include the missing MIOSHA requirements.
