MIFACE INVESTIGATION REPORT: #10MI006

Subject: Maintenance Supervisor Killed by Fall While Changing Light Bulb

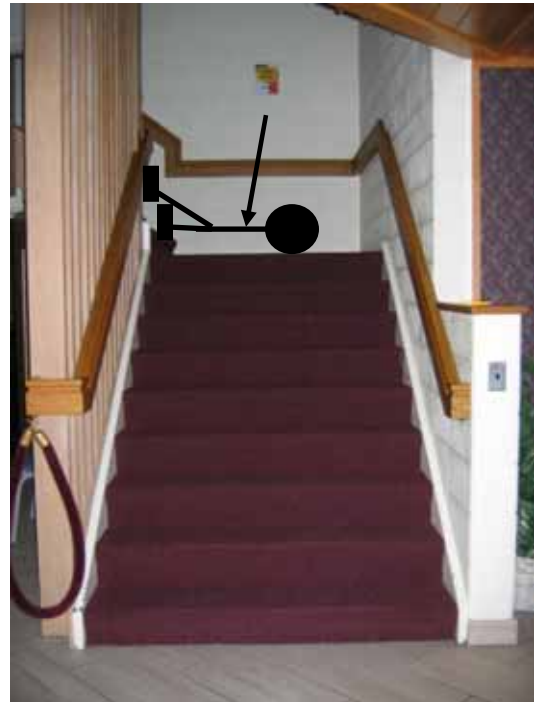
Figure 1. Standing in lobby, looking at first set of risers to landing. Arrow shows decedent's position on the stairway landing.

A church employee entering the sanctuary lobby at approximately 10:30 a.m. observed something in the shadow of the landing. The stairway was dark and when he activated the light switch he found the decedent lying on his back, with his left foot on the second stair of the 13-step stairway leading to the second floor and his right foot on the first step (Figure 1).

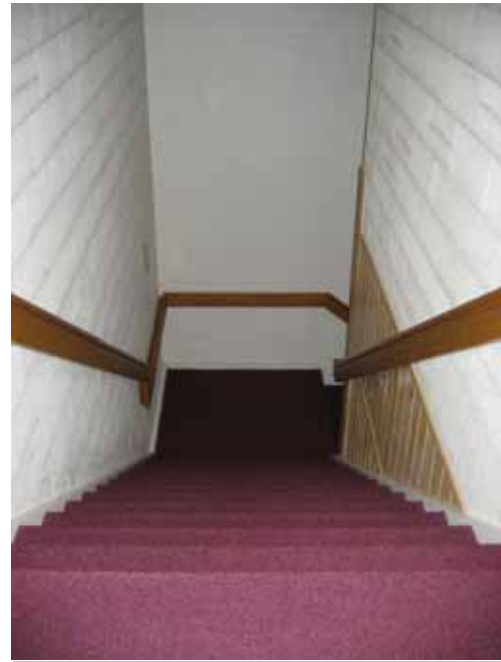
Figure 2. Standing on second floor landing, looking down 13 steps to the landing

If all of the stairway lights are "On", then the land/stair edge is plainly visible. If the stairway lights are off, the stairway is dark and it is difficult to see the edge of the second floor landing. MIFACE recommends that the church mark the stair edge using a recessed step or wall light or yellow marking tape.

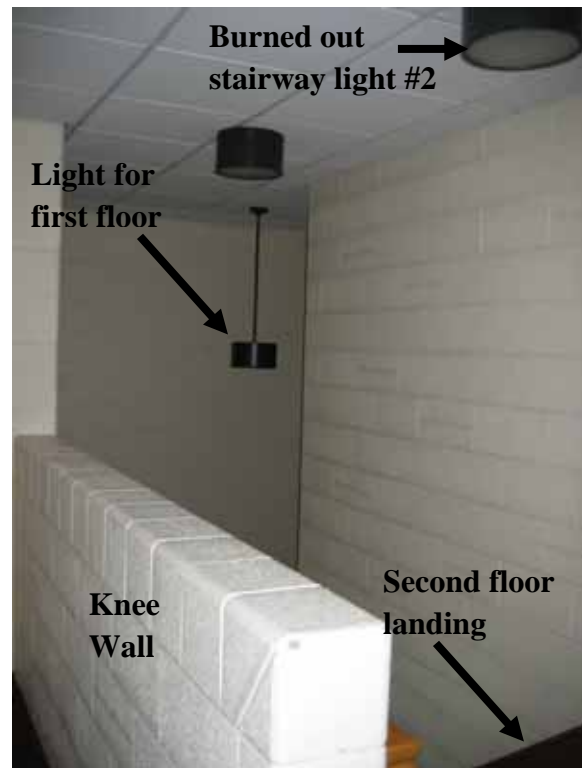
Figure 3. Standing on second floor landing, knee wall and burned out light

The business manager came to the scene after being notified by the person who found the decedent. The business manager noted that the stairway light (#2) from the east, was burnt out. He ascended the stairs to the second floor landing and discovered the stepladder leaning on the knee wall approximately five feet to the east of the extinguished light.

The stairwell lights illuminating the stairway to the second floor were high above the stairway and extremely difficult to access. To safely access the set screws to remove the clear base and change the lights illuminating the stairway, the use of a properly sized articulating ladder or a scaffold designed to be used on stairs was necessary. Both the ladder and scaffold require the individual to receive specialized training. In the case of the scaffold, the training must include proper erection and disassembly of the scaffold. Additional approaches could include contacting the building designer to investigate other lighting options, such as accessible wall sconces; lights that could be raised and lowered to permit ease of bulb maintenance, or hiring a bonded and insured outside contractor to provide fixture maintenance.

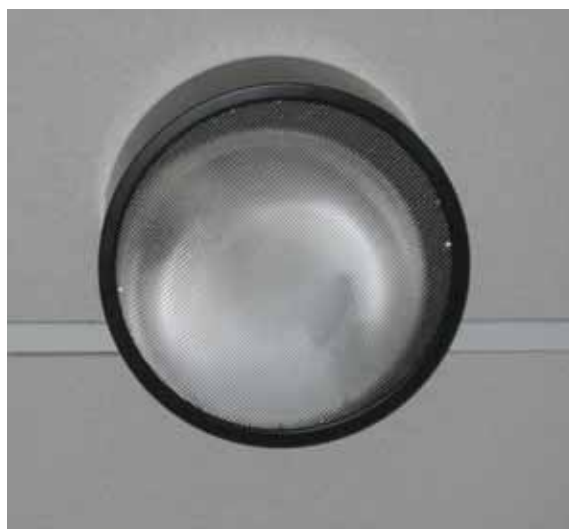
Three lights lit the stairway. A suspended light illuminated the first floor landing and two ceiling lights lit the 13 step stairway to the second floor landing. The On-Off switches were located at the base and the top of the stairway. Natural light from the lobby somewhat lit the bottom eight steps (Figure 1). The light bulb closest to the second story landing (stairway light #2) was burned out. This light was located approximately three feet from the knee wall (Figure 3). Set screws held the removable base clear cover of the light to the fixture (Figure 4).

Figure 4. Burned out light in incident

Although the use of longer duration bulbs such as compact fluorescent bulbs does not eliminate the risk, the use of these bulbs would reduce the frequency of performing this task and accordingly reduce overall risk to employees.
