MIFACE INVESTIGATION REPORT: #10MI019

SUBJECT: Farmer Died When He Fell From a Ladder

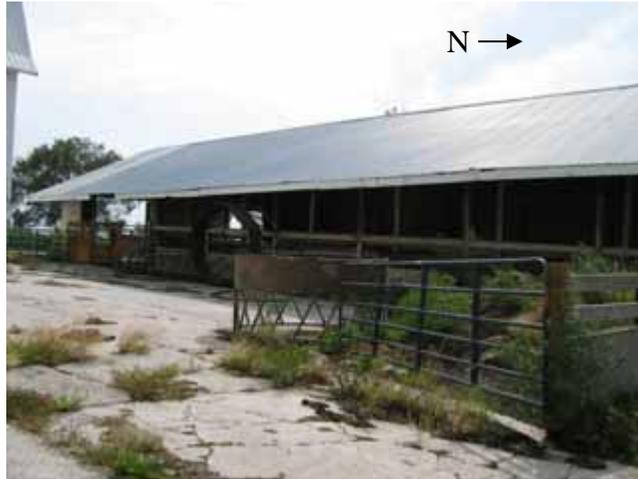
In the Winter of 2010, an 83-year-old male farmer died when he fell from a ladder in a cattle pen while he was replacing boards for a heifer pen (Figure 1). The decedent had noted that the nominal dimension oak lumber (2x4s, 2x6s) boards on the fence between the concrete cattle courtyard and the heifer pen “gave way” when pushed against. The fence was located on the north side of the heifer pen. The event was unwitnessed. Cattle were in the courtyard. The decedent disassembled an extension ladder and

Figure 1. View of incident scene

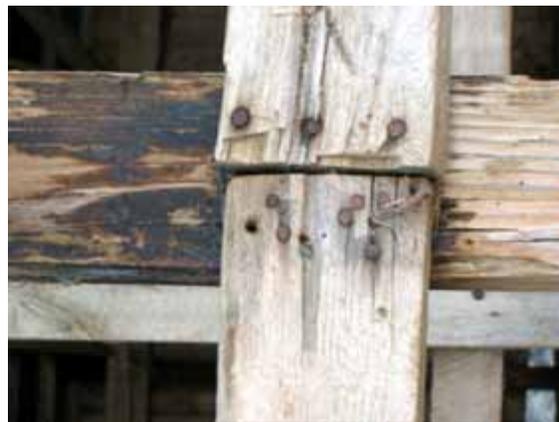
Figure 2. Fence board/post where some pilot holes had been drilled.

was 64 inches above ground level. The boards separated the heifer pen from the cattle courtyard. These boards “gave way” and were not attached securely (Figure 2). He gathered his tools; a fairly new battery operated drill and his favorite ladder, the 12-foot top section of an extension ladder that had been separated from the ladder base.

Figure 2 shows that nails were used to secure the fence lumber to the post. Nails offer shearing strength however drilling the wrong pilot size hole could allow easier nail withdrawal and less security than screws of the appropriate size and length. In hardwood lumber, correctly sized pilot holes are usually recommended prior to any nail or screw.

- When using fasteners like nails or screws, drill appropriately sized pilot holes and use appropriately sized fasteners.

Construction deck screws as well as nails could have been used by the decedent to reinforce the fence connection to the support post. When deciding on which nail to use, remember that a nail's strength is based on its length and its diameter. Given the proper length, the nail can be driven far enough into the supporting member so the nail has its maximum allowable lateral strength. The strength of a properly placed nail is also dependent on its diameter as this affects the quantity of wood fibers that can bear against its surface. The "wider" the nail (greater diameter), the more wood fibers can bear, the stronger the connection. The nail length selected should be approximately three times the thickness of the board. A nail driven perpendicular to the grain should penetrate the lumber a minimum of 12 times its diameter. Building codes often call for at least half the length of the nail.

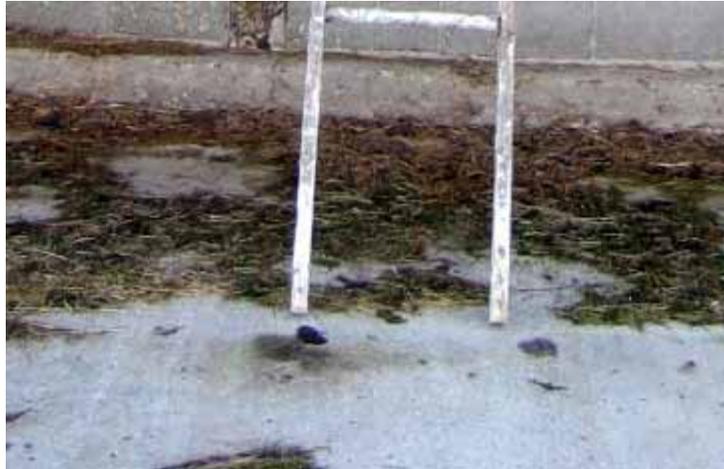
Figure 3. Ladder used by decedent with no safety feet

Extension ladders should not be separated. Using the upper section without angled feet defeats the function and safety of a modern extension ladder. Old wooden extension ladders, such as the one the decedent had separated, may not have the latest adjustable safety foot. Ladder safety feet increase the ladder's "grip" on the ground and are found on the newer versions of extension ladders.

- Follow safe ladder work practices; extension ladders should not be separated and use ladders equipped with safety feet.

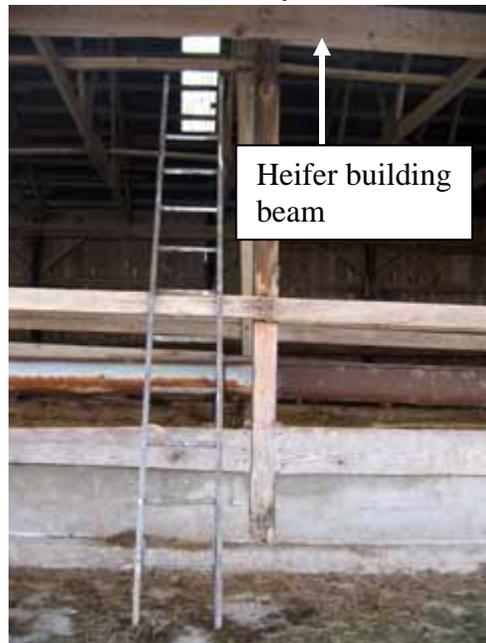
Figure 4. Ladder placed under (not supported) by the building beam and against fence railing

5. The top of the extension ladder segment was not placed against the heifer pen beam, thus supported only by the 2x4 fence board. The extension ladder segment had a straight cut and did not have safety feet so the ladder base was not flush with the concrete. The ladder base may have kicked out more easily as he was working and applying pressure to the drill (Figure 4).

<p>Ladder placement not against heifer pen building beam.</p>	<p>To enhance safety, in addition to a properly angled ladder, four-point contact should be maintained. It is unknown if the decedent placed the ladder against the building beam. If he did not, then there would not be the necessary four-point contact with the working surfaces and this could have contributed to the ladder kicking out.</p>
<p>Maintaining three-point contact with the ladder.</p>	<p>Safe ladder use requires a worker to maintain a three-point connection (two hands/one foot or two feet/one hand) and his/her shoulders within the side rails. He may have had to use two hands to control the drill.</p>

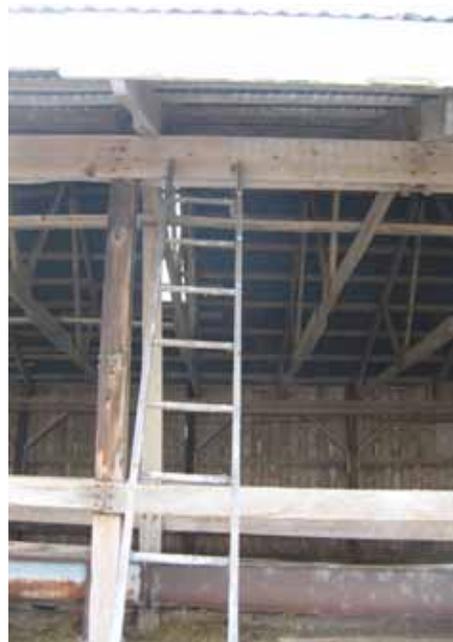
Figure 5. Top of ladder resting against the upper beam of barn
