MIFACE Investigation Report #10MI038

Subject: Heavy Equipment Operator Killed When Ejected From Cab

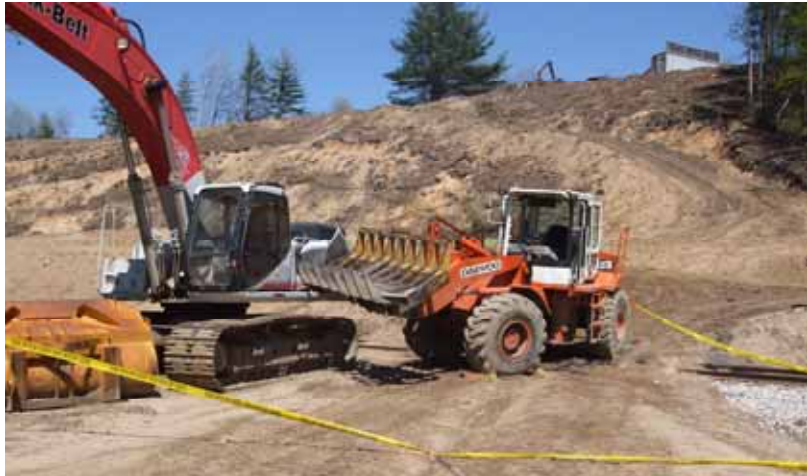
Figure 1. Overview of incident site

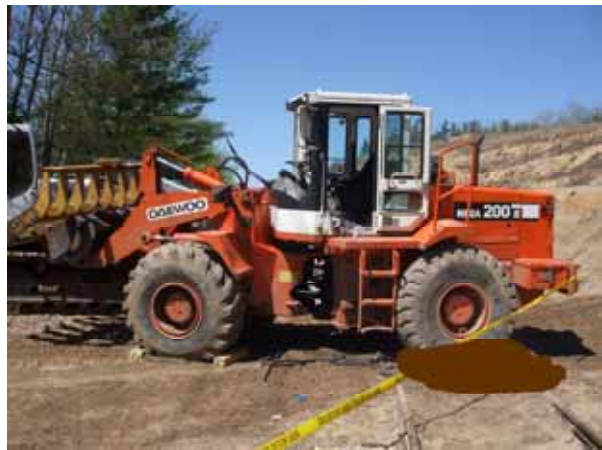
Figure 2. Daewoo loader at bottom of hill

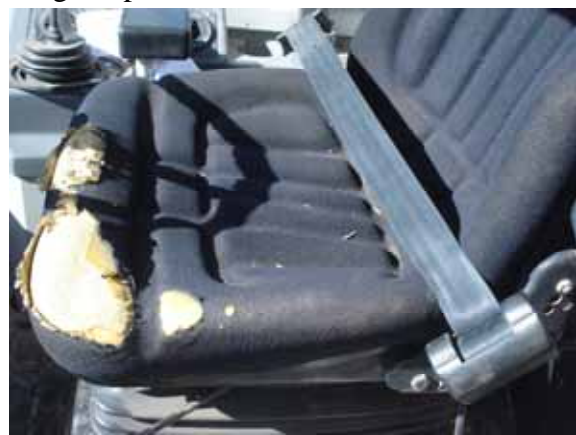
Figure 3. Functional seat belt

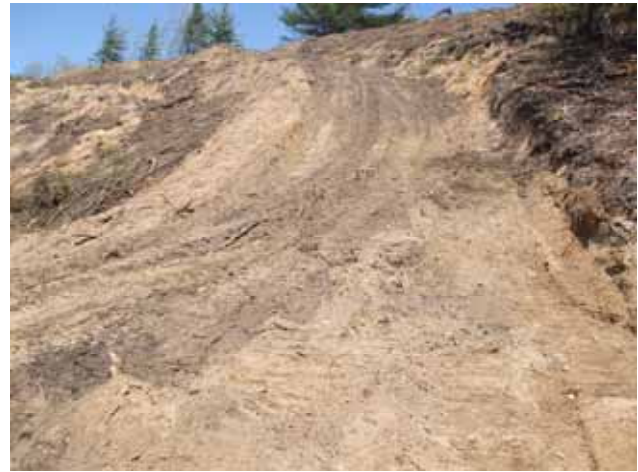
Figure 4. View of hill from base of hill

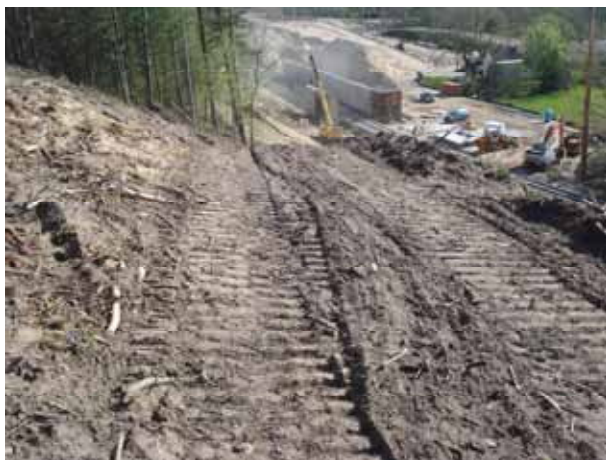
Figure 5. View of hill from top of hill

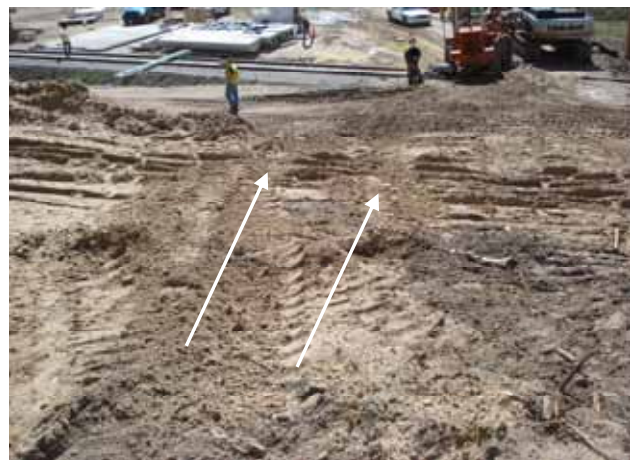
Figure 6. View of hill from slope/side of hill. Arrows show path of loader.
