MIFACE Investigation Report: #10MI075

Subject: Farmer Run Over By Tractor During Idle Adjustment

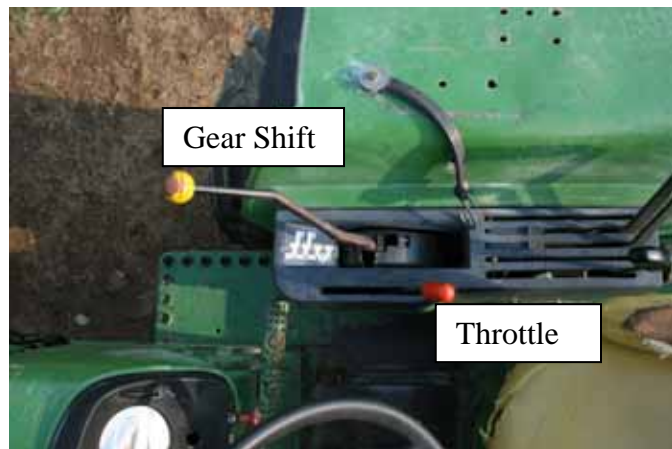
Figure 4. Gear shift and throttle identified. Picture taken from operator's seat.

the tractor's gear level, the operator pulled the gear lever backward toward the driver. From the position where the decedent was working on the tractor it would be possible for him to access both levers from the ground. Because the decedent was standing on the ground facing the tractor, the activation direction of the levers was reversed – the throttle lever activation would be toward him and the gear shift lever activation away from him. The throttle is identified by a red, cylindrical handle and the gear shift has a yellow, round ball handle (Figure 4).

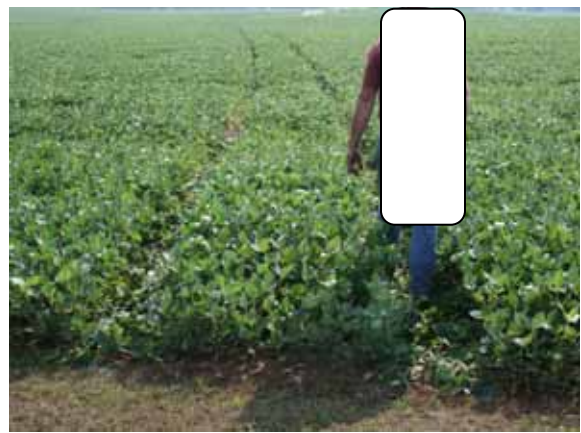
Figure 6. Path of tractor out the south door and arcing into field

Figure 7. Path of tractor across north/south road and into/out of field

Tire tracks on the floor led out the south door and the tractor began drifting to the southwest into a cornfield, and then arced to the north, crossing the road (north barn door faced this road) and continued into the field across from the barn. The tractor continued its arced path of travel through this field, and

then passed between two houses, crossed a north-south road, and finally came to rest against a tree approximately one-third of a mile from the barn (Figures 6 and 7).
