MIFACE Investigation Report #10MI122

Subject: Farmer Pinned Under Driver's Side Front Tire of a Front-end Loader

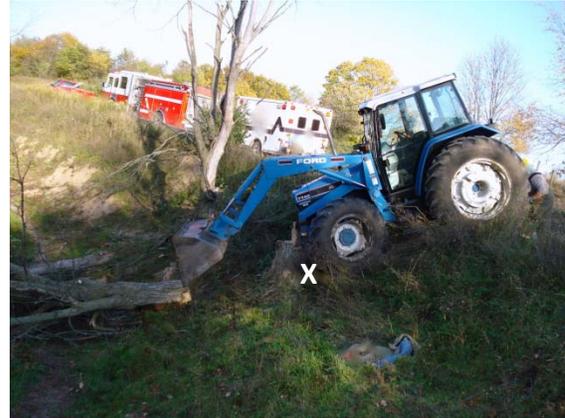
Figure 1. Position of decedent and tractor after tractor moved forward and down the embankment.

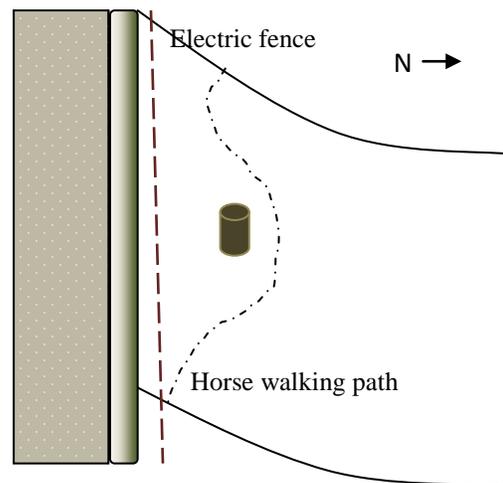
Drawing 1. Incident Scene

The north side of the driveway had a steep drop off which then leveled out to the horse pasture. The packed sand driveway had an area approximately 5 feet wide between the edge of the driveway and the beginning of the slope down to the pasture. The driveway had a two- to four-inch area of soft sand between the packed sand area and the grass at the leading edge of the slope. The 24-inch diameter dead tree involved in the incident was located on the slope approximately seven feet from the driveway's edge.

An electric fence (red dashed line) was installed along the length of the driveway and was positioned between the driveway and the incident dead tree. A walking path had been created by the horses on this sloped area that was several feet below the electric fence and followed the path of the driveway and then veered north of the dead tree. His wife indicated that he had previously expressed concern that this tree would fall and injure the horses.

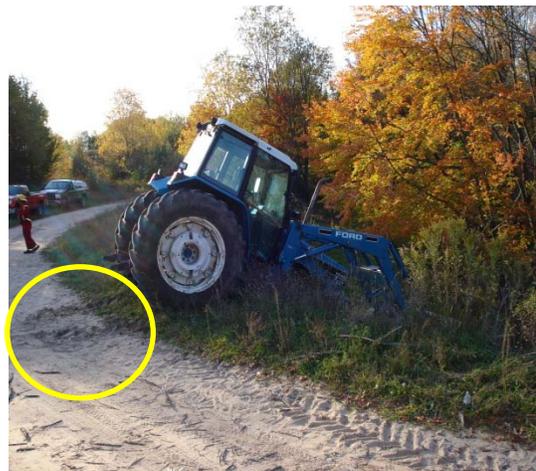
The decedent was facing the stump with his back to the tractor working under the raised bucket. It appears that when the decedent completed his cuts on the tree and the tree fell, the tractor rolled or fell forward over the edge of the driveway's drop off (Figure 2). The tractor tire marks are located within the yellow circle on Figure 2. The decedent, still holding the chain saw in his right hand, did not have enough time to react. The rolling/falling tractor was stopped by the stump of the tree the decedent had just cut, causing him to be pinned under the driver's side tractor tire. The medical examiner report indicated that there were skid marks from the back tires on the sandy driveway (See Figure 2).

Figure 2. Driveway configuration and tractor position after moving forward when tree fell.

The use of the tractor equipped with a loader bucket was not designed nor intended for use as an assist for applying pressure to assist in a tree felling activity, and thus was a misapplication of tractor use. It is unknown how much "push" or force was placed upon the tree by the tractor and bucket. If the force was substantial, stored kinetic energy was released when the tree fell, which could have forced the tractor over the edge of the driveway.

When agricultural equipment is positioned on or near an incline, the equipment may move/roll down the slope, creating a hazard for downhill workers. If equipped, the operator should lower the tractor bucket to the ground, lock the brakes together and set the brake lock or, if equipped the park lock, and turn the engine off. If the equipment must be left running, then the park brake should be set with the transmission in neutral.

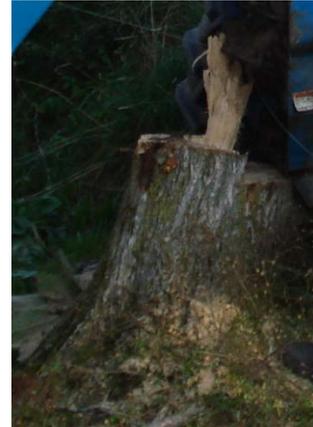
Remove the tractor from this task and the work activity was tree felling. Although experience can be a great teacher and a necessary element in skill development, misguided experience can foster poor technique and enhance bad habits. The decedent had experience, but his work practices, such as lack of wearing appropriate personal protective equipment (gloves only), and his felling technique (notch, backcut and hinge wood) did not adhere to consensus or MIOSHA standards for tree removal.

Figure 3. Locations of cuts made on tree stump

Figure 3 shows the tree stump of the tree felled by the decedent. It appears that the decedent made the undercut on the tree on the side of the tree facing the road and the back cut on the tree on the side of the tree facing the pasture.

A proper notch (undercut) and back cut directs the tree's fall and the hinge wood (holding wood) keeps the tree under control and in its directed fall path. If appropriate felling techniques had been utilized, the need for the tractor/bucket would not have been necessary, and this tragedy could have been avoided.

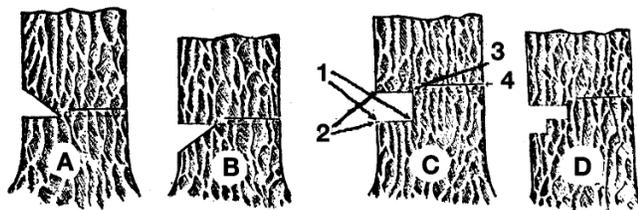
Illustration 1. Figure 1 of MIOSHA General Industry Standard Part 53 showing approved undercuts

- An undercut shall be large enough, about 1/3 the diameter, to safely guide the tree and reduce the possibility of the tree splitting.
- A back cut shall leave sufficient hinge wood (the distance between notch and back cut) to guide the tree's fall in the desired direction and to hold the tree to the stump during most of its fall. A back cut shall be about 2 inches (50.8 mm) above the undercut and as level as possible.
