MIFACE Investigation Report #10MI137

Subject: Carpenter Died From Extension Ladder Fall

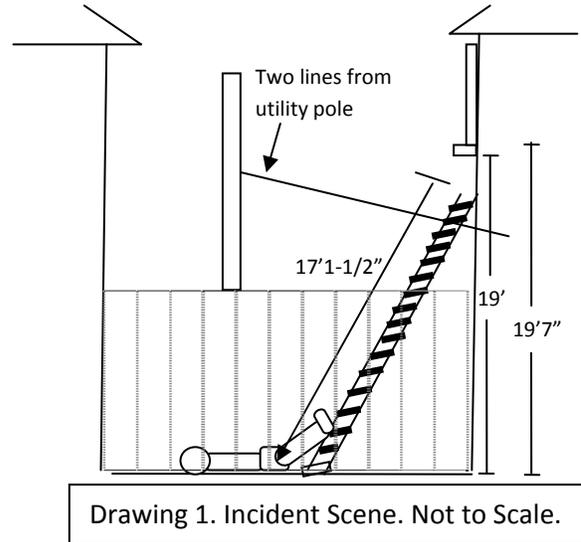
In the fall of 2010, a male carpenter in his 50's who worked for a home restoration company died when he fell an estimated 13 feet (exact height unknown) onto a concrete driveway from a 20-foot aluminum extension ladder. The decedent was performing window repairs at a residence. The decedent used a neighbor's 20-foot aluminum extension ladder rather than the company-issued 28-foot fiberglass ladder located on the work truck. Two lines from a nearby utility pole entered the home at this location. One of the two lines was a cable TV line and the second line was thought to be a phone line but this could not be confirmed. He placed the ladder against the outside of the home under the entering lines to reach a second story window located 19 feet 7 inches above the ground. The ladder was extended to its working height of 17 feet and positioned 4 feet 6 inches from the wall. The ladder was rated for a 200 pound individual; the decedent weighed 231 pounds. The lines were located between the decedent and the ladder. The decedent had an unwitnessed fall. The decedent lived directly next door to the jobsite and was scheduled to have computer work done at his home on the day of the incident. When the computer repair person arrived and did not find the deceased at home, he called his cell phone. The repairman heard the decedent's cell phone ringing. He followed the sound to the incident location and found the decedent on the driveway. He called for emergency response. The ladder was propped against the home and an unidentified line had been disconnected from the home (Drawing 1). The decedent was declared dead at the scene.

The decedent fell backward from the ladder and was found lying on his back with his right foot on the second ladder rung (Drawing 1). In his hand he was holding either nails or screws (one police officer described he was holding nails and one police officer described he was holding screws). A hammer and a pry-bar were lying on the driveway near the decedent's head. The ladder was still propped against the home. The cable line had been detached from the home. The decedent was declared dead at the scene.

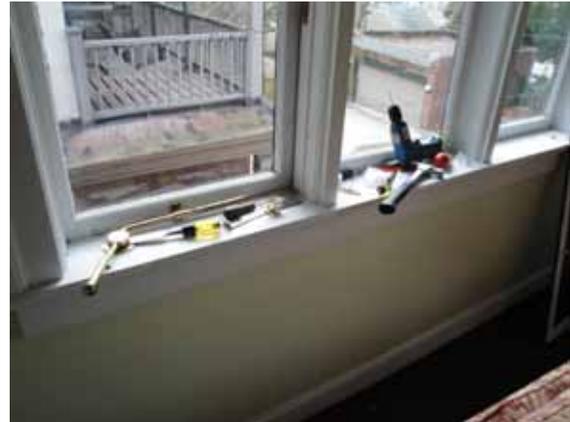
Figure 1. Overview of incident scene

Figure 2. Work performed inside of home

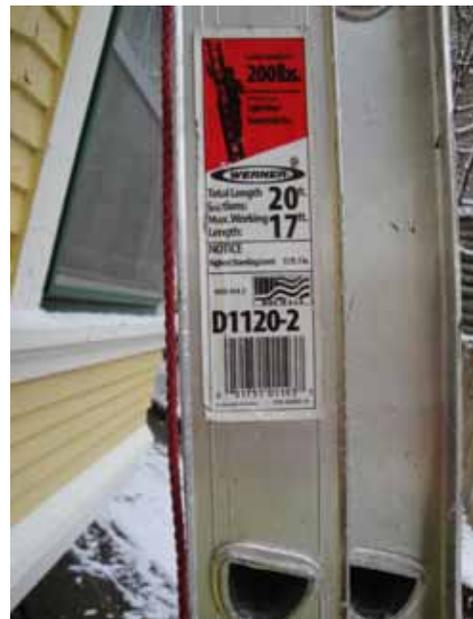
To access the second story window, the decedent did not use the company-issued 28-foot fiberglass extension ladder stored in the ladder rack on the top of the company owned vehicle. Rather, he borrowed a Type III, 20-foot aluminum extension ladder from a neighbor to reach the second story window located 19 feet 7 inches above the ground. The owner stated that the decedent did not like to use the fiberglass ladder because it was too heavy and awkward to retrieve and place onto the ladder rack on the roof of the van. The decedent placed the aluminum ladder 4 feet 6 inches away from the house and fully extended it to its maximum working length of 17 feet. The maximum standing height of the ladder was 13 feet 1 inch. The maximum reach was 19 feet, assuming a 5-foot 6-inch person with a 12-inch vertical reach (the decedent was six

Figure 3. Incident Ladder label. Ladder at ladder owner's home.

feet tall). The ladder was rated for an individual weighing 200 pounds or less; the decedent weighed 231 pounds.

- Employers should ensure employees using ladders receive training on safe use of the ladder.
