# MIFACE Investigation Report #10MI200

## SUBJECT: Farmer's Head and Neck Crushed Between Semi Trailer and Loading/Unloading Chute

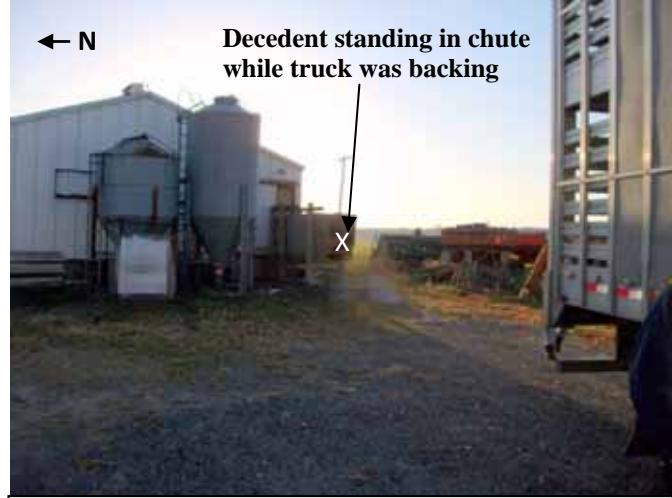
Figure 1. Overview of incident scene.

- Rock pile in backing area
- Design of backing area causing truck to come in on an angle
- Chute design
- Decedent in path of backing vehicle and not in full view of semi driver
- No spotter

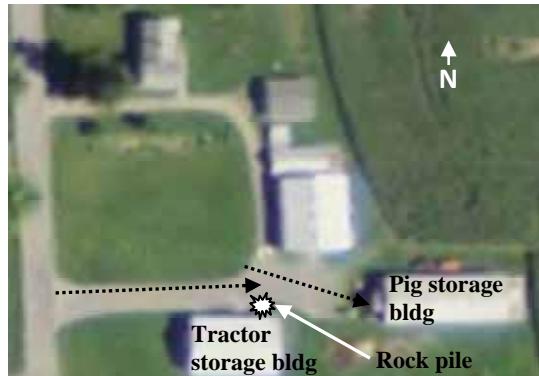
30 years according to the family member. Due to the rock pile location, the driveways had been widened by approximately 10 feet and the mailbox moved to accommodate loading and unloading the semi-tractor/trailer. The layout of the farm's driveways, location of the rock pile and the angle of the chute extending from the pig storage building presented a backing issue for the semi driver. It was necessary for the driver to back the semi at an angle, which made it more difficult to align the trailer with the chute (Figures 2, 3 and 4).

Figure 2. Google Map® satellite view of incident location. Dotted arrows show path of backing semi.

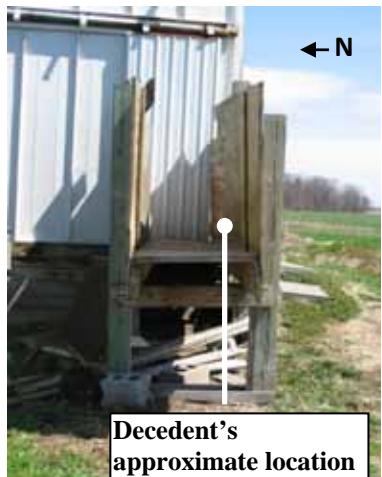
Figure 3. Chute angle from pig building

The event was un-witnessed and the sequence of events is unknown. The semi driver indicated in the police report that the decedent was standing on the chute floor, on the south side of the chute (Figures 3 and 5). The driver indicated he could see only the decedent's hand waving him back to the chute during the backing process.

The family members indicated that the driveways had been widened to accommodate the backing process, but the MIFACE researcher and the family did not discuss if there had been a consideration to re-design the pig chute to minimize the backing angle of the semi tractor/trailer or altering the access driveways to permit a straight backing to the existing pig chute. Each of these options may have facilitated a safer and easier loading/unloading process.

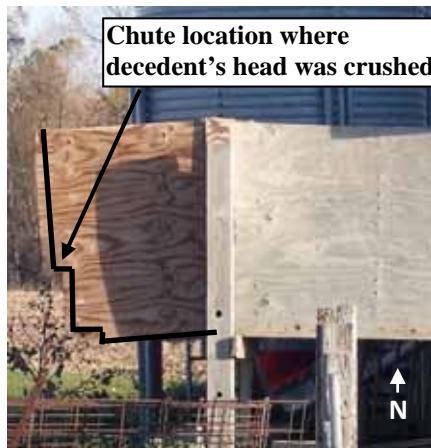
The loading/unloading chute floor was 41 inches from the ground and 27 inches wide. It was constructed to permit pigs to enter the building via a door on the west side of the pig storage building. The chute had been constructed to angle slightly north to accommodate the rock pile in front of the tractor storage building (Figures 3 and 5). At each side of the chute wall below the level of the chute ramp was a 4.5- inch cut-out to allow for a tight alignment of the trailer to the chute (Figure 4).

Figure 4. Chute construction

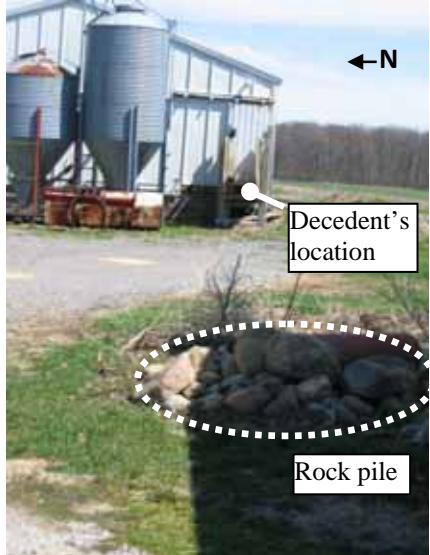
Figure 5. Standing next to tractor storage building, looking east.

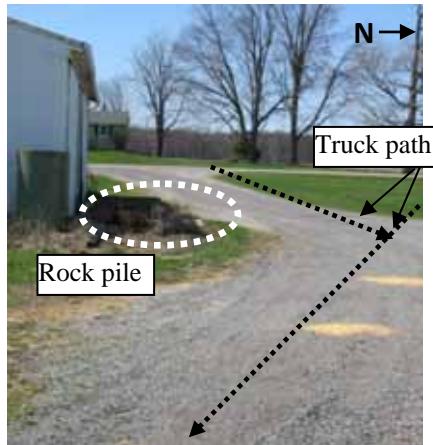
The semi-tractor/trailer was backing to the southeast (Figure 6). It was sunny. The sequence of events causing the decedent to place his head between the chute wall and the backing trailer is unknown. When the driver felt the trailer bump the ramp, he set the parking brake, exited the cab, and walked back to the chute. Observing the decedent's head and neck pinned between the chute and the corner of the driver's side of the trailer, he ran back to the tractor and pulled the unit forward. The driver exited the cab, called for emergency response and then returned to the decedent. The driver indicated that while he was moving the tractor forward and calling for emergency response, the decedent fell from the chute floor to the ground. The police report indicated that the decedent was laying on his right side when emergency responders arrived. He was declared dead at the scene.

Figure 6. Standing in front of pig storage building chute. Truck path indicated by arrows.
