MIFACE Investigation Report #11MI059

Subject: Hispanic Farm Laborer Struck by 550-gallon Water Tank When Wood Support Structure Collapsed

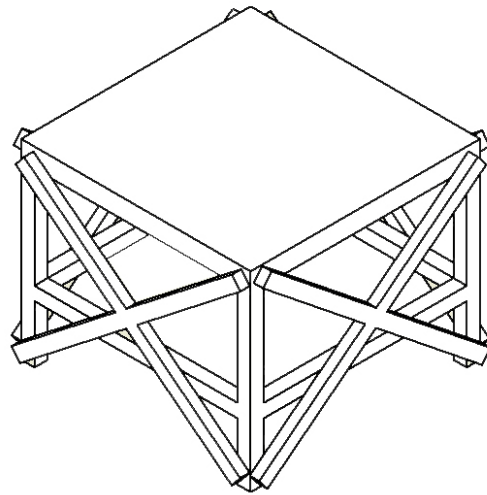
Illustration 2. Bracing pattern necessary to provide stability

All four sides of the structure need diagonal bracing. The bracing should create an X pattern on the structure. This pattern will have one member in compression and one in tension at all times under the loading. The bracing needs to be fastened using screw or bolt through fasteners with washers. Each fastener should be of appropriate size for the load. Normally the floor is nailed to the frame. If not, then there should also be an X type of bracing in the horizontal plane. Just setting this wood structure on level ground requires X type of bracing of the posts at the ground contact point. This X type of bracing on the level ground helps to stabilize vertical posts. If using traditional pole barn construction techniques for a structure like this, the vertical posts should be set below the frost line with pads below the vertical posts of the correct size of materials for the anticipated load.
