# MIFACE Investigation Report: 12MI059

## SUBJECT: Land Owner Pinned by Tractor Bucket When Working in Ditch

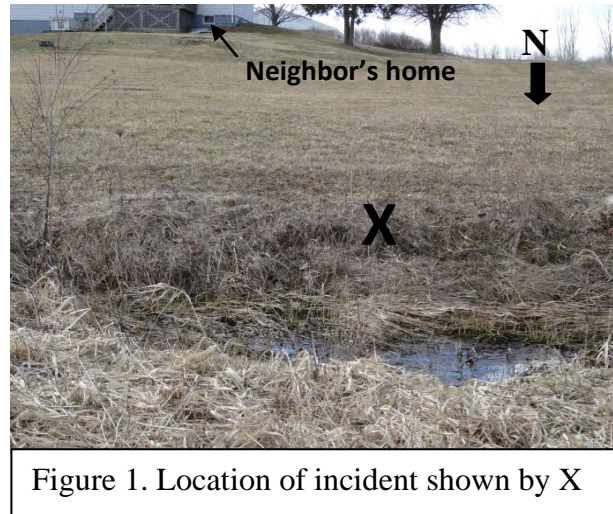
In summer 2012, a male land owner in his 70s died when his Massey Ferguson Model 65 tractor equipped with a front end loader bucket slid down a drainage ditch bank, pinning him between the bucket and the opposite ditch bank. He was clearing the ditch of weeds and small trees, for both drainage purposes and in preparation of repair to the culvert providing access to a field adjacent to his home that he rented to a farmer. The decedent placed the tractor on the south side of the ditch, near the ditch edge, with the bucket located over the ditch (See Figure 1 and Drawing 1). He

- Improper tractor operation –tractor left running, no brake application, bucket raised on sloped area near ditch when he dismounted
- Misuse of the tractor’s loader bucket
- Working on the ground in the travel path of the tractor

- Tractor operators should read and understand the manufacturer’s operator’s manual(s) to ensure safe work practices, such as safe tractor shutdown, using wheel chocks to prevent tractor movement, and not working under an unsupported raised hydraulic bucket, are followed when using the tractor and attachments.

- Before initiating a task, conduct a site assessment to determine hazards and appropriate work practices to minimize identified hazards, including topography challenges, equipment location and working on the ground in the travel path of equipment.

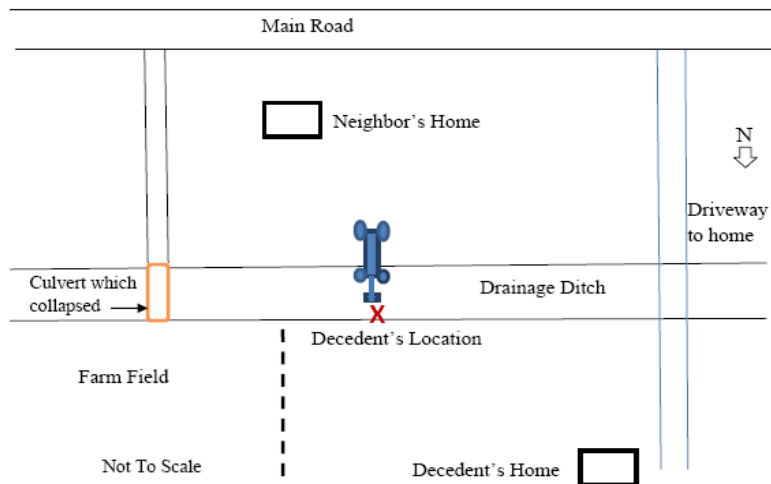
Drawing 1. Drawing of incident scene. Not to Scale.

The decedent was a land owner who rented 10-15 acres of land to a local farmer to plant and harvest corn. Abutting the farm land he rented was a drainage ditch. The culvert to access the farm land crossed the ditch and was accessed via a two-track path from the main road. The drainage ditch separated two properties – the decedent's front yard to the north and a neighbor's back yard to the south (Drawing 1).

On the day of the incident, his wife was working at the front of their home while the decedent continued to clear the ditch. He drove the tractor down the driveway and to the south side of the ditch, placing the tractor near the edge. The distance of the front wheels of the tractor to the edge of the ditch was unknown. Although fairly flat at the location of his work, the back yard had slight downward slope to the ditch. It is postulated that he used the same work practice as he did the previous week when working with his wife: dismounted, left the tractor in neutral, did not set the parking brake, did not block the tractor wheels, attached the chain to a poplar tree and the other end of the chain to the metal V-shaped piece on the bucket.

The actual sequence of events leading to his death was not witnessed and is unknown. It is postulated that the tractor vibrated causing movement toward the ditch due to the slope or when attaching the chain from the tree to the bucket, he pulled down on the bucket, facilitating tractor movement toward the ditch. The decedent's wife happened to look back toward the ditch. She saw the front of the tractor leaning into the ditch. She ran toward the ditch, yelling for help. A neighbor, who was inside the home with her boyfriend, heard the decedent's wife yelling and crying for help. When she looked out the window, she saw the decedent's wife by the tractor in the ditch. She yelled for her boyfriend to help assist the decedent's wife and she called 911.

There were several site topography issues for this work operation: the slope of the land leading to the edge of the ditch, the location of the tree at the bottom of the ditch and the soft ditch shoulder. All of these issues would need to be taken into account in developing a strategy to remove the trees/weeds from the base of the ditch. The decedent knew of these hazards prior to the incident,

The decedent was downhill from and working in the travel path of the tractor and under the raised bucket. Working with his back to the tractor did not give him sufficient warning that the tractor was moving downhill and to retreat from the tractor's travel path in time.

The tractor was being operated in a stationary position and did not have chocks/blocks for the wheels. Wheel chocks capable of holding the tractor in position should be utilized to prevent tractor movement.
