## MIFACE Investigation Report: #13MI091

### Subject: Painter Died When Elevated Scissor Lift Tipped to Side When Tire Entered Pavement Depression

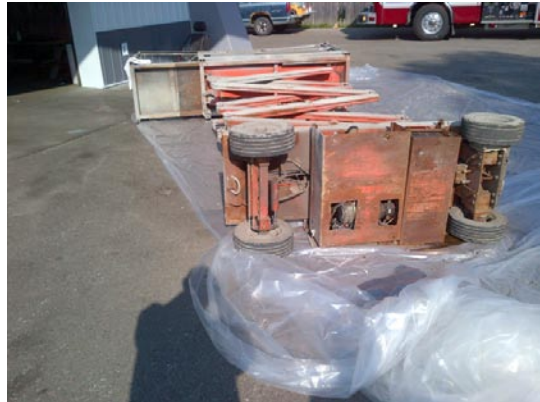
In the summer of 2013, a male painter in his 30s died when the tire of the elevated Skyjack 3220 scissor lift in which he was working entered a depression in a parking lot caused by a recessed storm drain and tipped to its side (Figure 1). The decedent and his coworker were elevated approximately 15 feet in the scissor lift while they painted a building's eaves/fascia. To protect the ground from paint overspray, the workers laid opaque plastic on the asphalt pavement. The plastic covered a storm drain grate, which was recessed 4½ inches. The workers noticed an area that had been missed during their painting work, so the lift had to be moved back to the

Figure 1. Incident site showing overturned scissor lift

it from paint splatter while painting. The plastic also covered the storm drain grate. The decedent and his coworker did not mark the location of the grate and could not view the grate through the plastic (Figure 1). The decedent positioned the lift and elevated himself and his coworker approximately 15 feet to begin painting (Figures 3, 5). The workers were not required to be tied-off because the lift had guardrails which were compliant with MIOSHA regulations.

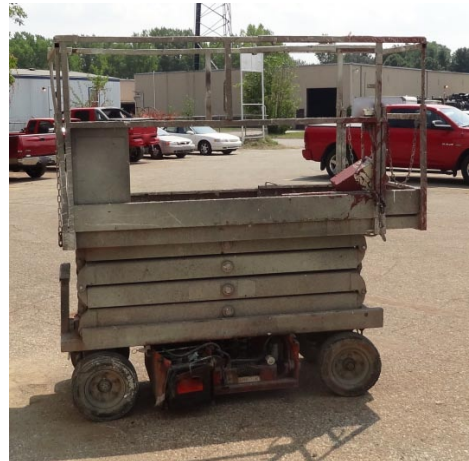
The company owned and maintained scissor style self propelled work platform (scissor lift) involved in the incident was a Skyjack 3220. The lift had been used during spray painting operations and the control box and other informational labels on the machine were covered with paint overspray making them illegible (Figure 2). The safety director indicated that platform controls operated the scissor lift as designed and there were no operational issues with the lift. It is unknown if the lift had tilt sensing equipment installed by the manufacturer.

Figure 2. Scissor lift involved in the incident

The lift had been used during spray painting operations and the lift and control box were covered with paint overspray making the informational labels illegible and the indicator lights indiscernible. These conditions may not have had a direct impact on the incident; however, the general condition of the machine indicated a lack of appreciation for maintaining equipment in safe working condition. Employers should ensure that equipment receive regular preventative maintenance and service according to the manufacturer’s recommendations to ensure it is in good working condition.

- Employers should maintain equipment in accordance with the manufacturer’s recommendations.

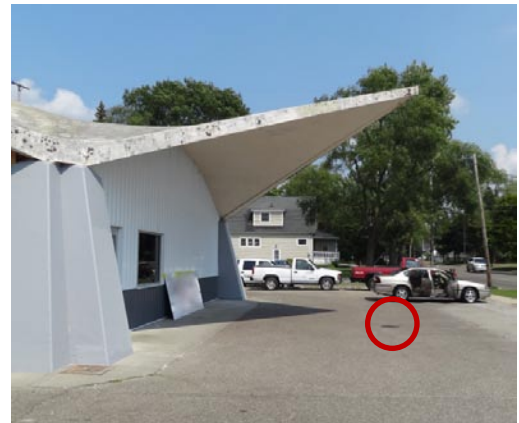
The incident site was a building with four concrete overhang points that extended approximately 25 feet away from the building. Under each overhang point was a round wastewater storm drain. The overhangs were approximately 16 feet in elevation at the building and approximately 21 feet in height at the tip of the point (Figures 3 and 5).

Figure 3. Example of building construction. Circle indicates drain location under tip of overhang

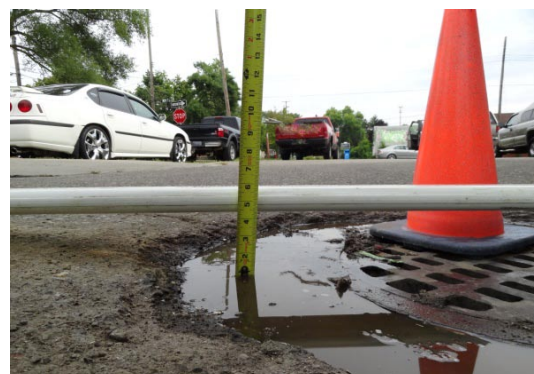
The pavement around the wastewater storm drain involved in the incident had deteriorated and the grate recessed into the asphalt approximately 4 ½ inches (Figure 4). The pavement sloped toward the drain to provide parking area drainage.

Figure 4. Storm drain cover/pavement condition at incident

- Elevated driving must only be done on a firm level surface.
- b) The storm drains and their associated deteriorating surrounding pavement had been identified as a work site hazard by management and discussed with the decedent. Management did not implement any engineering controls, such as covering the drain with material to withstand the weight/load of the scissor lift and/or barricading the drain. The corrective action to minimize the hazard posed by the storm drain depression taken by the decedent and his

- Assure work areas are inspected for hazards and take corrective actions to eliminate the identified hazards before and during operation of an aerial lift.

An inspection of the work area is critical when operating a scissor lift due to the mechanical dynamics of an elevated scissor lift aerial working platform. Possible hazards to consider include but are not limited to drop-offs or holes, including those concealed by water, ice, mud, etc.; slope(s); bumps and floor obstructions; debris; overhead obstructions; high voltage conductors; inadequate surface and support to withstand all load forces imposed by the aerial platform in all operating configurations (including wind and weather conditions) or other unsafe conditions. When hazards are identified, corrective actions should be taken to minimize the identified

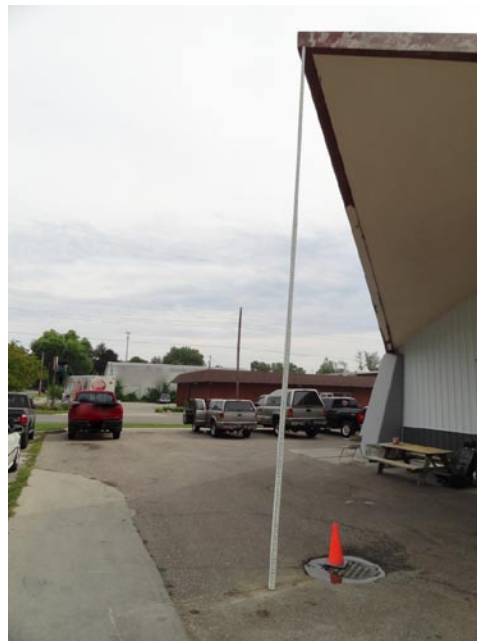
Figure 5. Incident scene following equipment removal
