MIFACE INVESTIGATION REPORT #13MI102

SUBJECT: Airport Manager Killed When Homemade Drag Struck Him While Smoothing a Runway

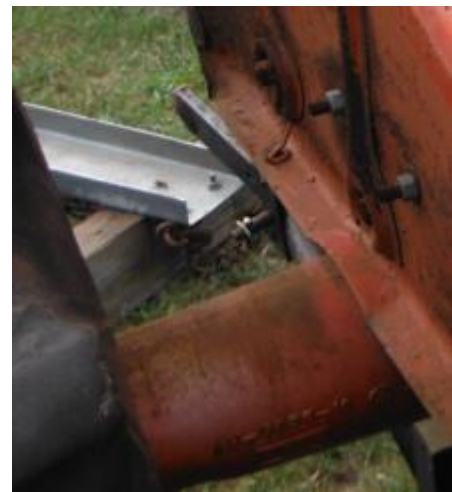
The decedent was operating a non-ROPS equipped Allis Chalmers D17 tractor. The leveler he used was identified as a ‘drag’. The decedent constructed the drag using two 4-inch by 6-inch by 14-foot treated wood posts attached to five 8-foot steel channel beams. The drag was attached to the tractor using heavy duty chains attached to the lift arms of a three-point hitch, with the 14-foot posts positions

Figure 2. Attachment point of chain to wood and lift arm of three point hitch on decedent’s right side

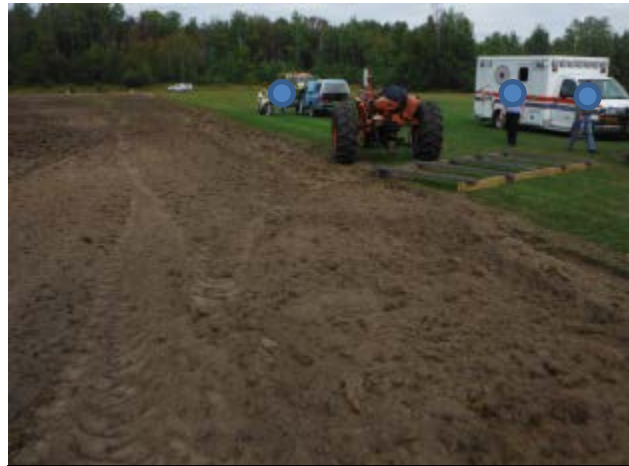
Figure 3. Overview of incident scene looking north.
