MIFACE Investigation Report: #14MI052

Subject: Truck Driver Died When He Was Struck By a Vehicle in a Hit-and-Run Incident

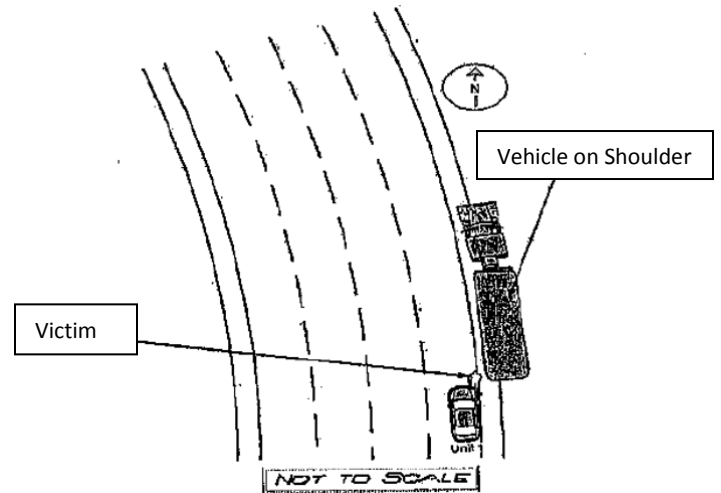
Drawing 1. Police depiction on crash report of incident location.

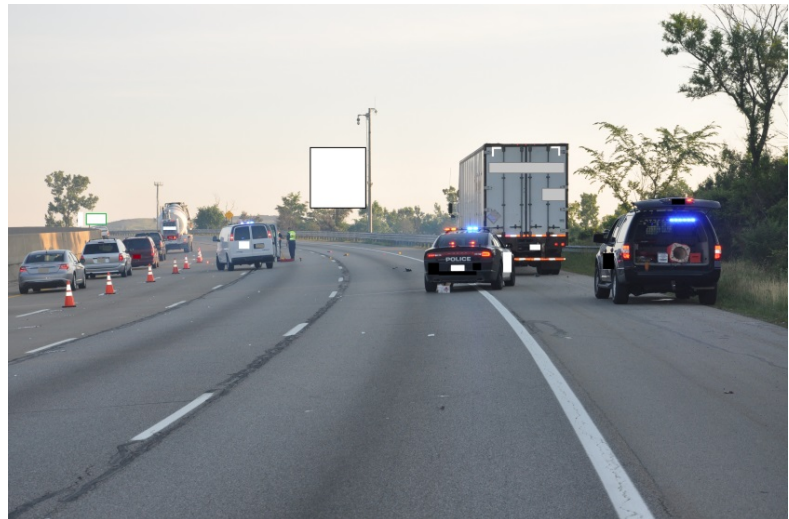
Figure 2. Overview of incident scene. Scene depicts roadway curve and truck position on road shoulder.

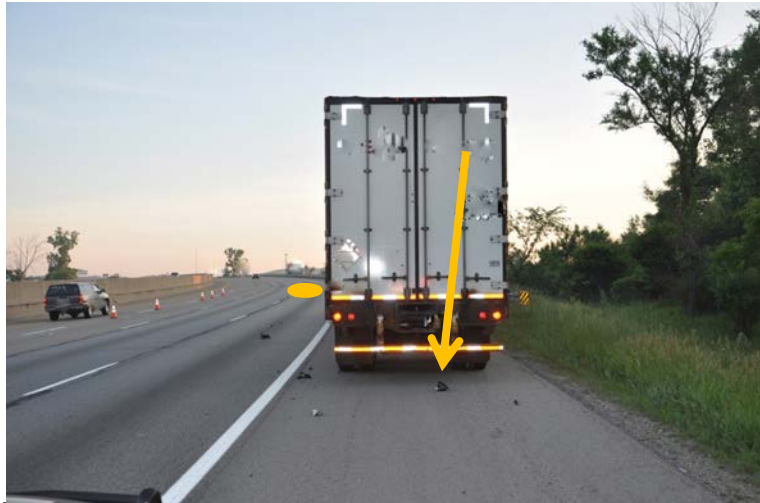
A possible incident scenario was developed: At approximately 4:40 a.m., after parking the semi-tractor/trailer unit, placing the unit in park, leaving his headlight lit, he activated the emergency flashers and exited the cab (See Figure 3). He was wearing a light colored shirt and light khaki pants. He was not wearing a high visibility vest/coat. He checked the electrical connection to the trailer and then

Figure 3. Truck location on shoulder. Yellow arrow identifies mirror location. Yellow circle identifies decedent’s location on roadway after being struck by the car.

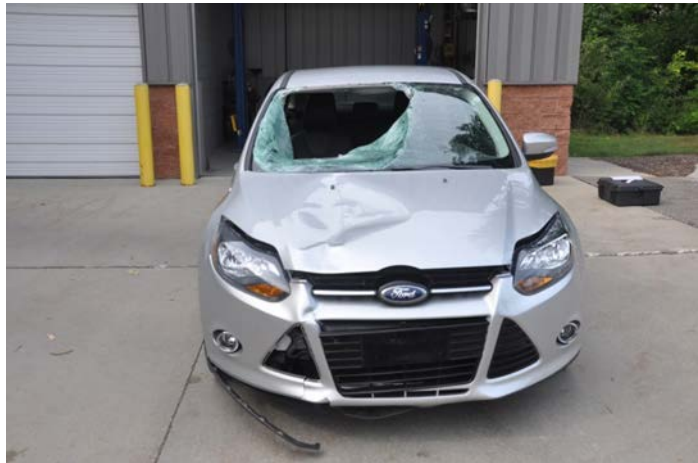
Figure 4. Vehicle damage after striking the decedent.

The driver did not stop at the scene of the crash instead returning home and placing his vehicle in his garage. The responding police alerted local car dealerships of the damage to the vehicle and requested the dealerships notify them if a car was brought in with similar damage (See Figure 4). A month after the incident occurred, the vehicle driver had his damaged vehicle towed to a local dealership for repair. The dealership notified the police and the driver was arrested, charged and found guilty of leaving the scene of a fatal crash.

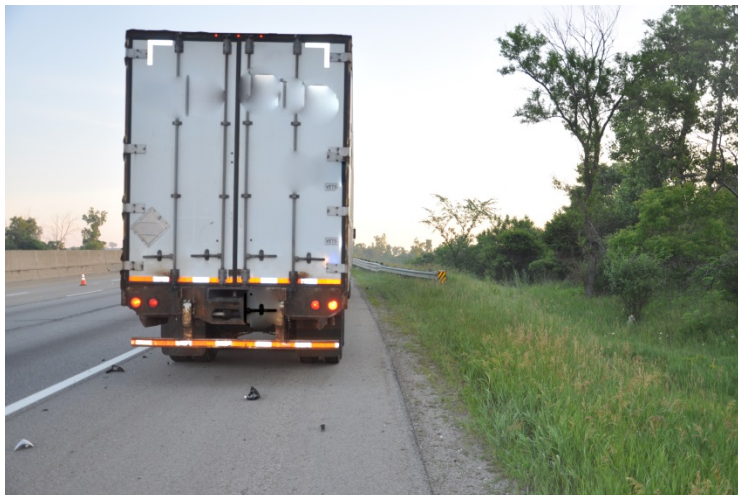
Figure 5. Tuck parked on roadway showing room to walk on non-active roadway side to access the rear of the trailer.

- When possible, after exiting the tractor, minimize exposure to oncoming traffic by walking around the cab (face traffic) and then walking on the non-traffic side of the trailer, keeping the tractor/trailer between you and active traffic. If not possible to minimize exposure to traffic, park the truck/trailer as far to the right as possible to maximize space between truck/trailer and oncoming traffic.

between the truck driver and oncoming traffic. MIFACE recommends that drivers approach the cab door from the front of the truck to minimize exposure time and enable the driver to face the traffic instead of walking back to the truck cab. Additionally, the driver should look around the corner of the cab before stepping out on the road shoulder.
