# MIFACE Investigation Report: #14MI095

## SUBJECT: Food Pantry Volunteer Pinned by a Table Against a Wood Cabinet When the Table was Struck by Backing Vehicle

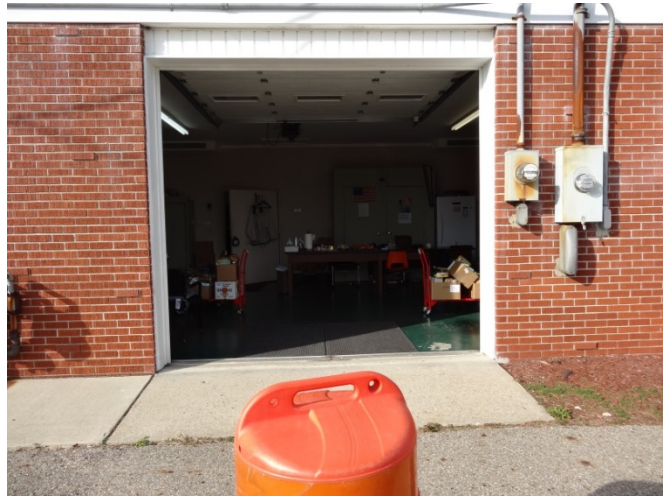
In fall 2014, a food pantry volunteer in her 60s died when a sports utility vehicle (SUV) backed into a table, causing the table to pin the volunteer against a wood cabinet (Figure 1). The decedent and another volunteer were sitting in folding chairs behind the table, which was located approximately 12-15 feet from the overhead door opening. A third volunteer was sitting on the table. The SUV driver was driving the vehicle for the first time. To access the food pantry distribution area, the vehicle was backed up a slightly inclined concrete apron. The driver stated to the responding police department that, as he was backing up the concrete apron to the garage, his foot slipped off the brake pedal, hit the gas pedal, and accelerated in reverse. Other food pantry volunteers, who could see what was happening, yelled to the driver to stop the vehicle. The driver was unable to stop the vehicle before it struck the volunteer sitting on the table. The vehicle had enough momentum to push the table to the back wall. The decedent was pinned by the table against a wood cabinet. Emergency response was summoned as her fellow volunteers initiated CPR. Emergency response arrived, continued resuscitative efforts while the decedent was transported to a nearby hospital. She was declared dead upon arrival to the emergency room.

Figure 1. Overview of incident scene with remediation barrel placed in front of the garage door. Table positioned in front of cabinet and freezer as it was at the time of the incident.

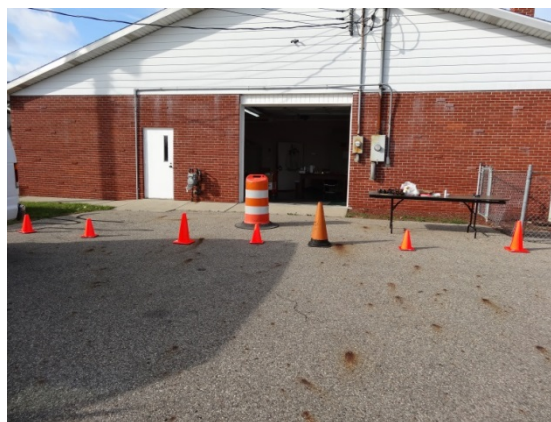
Figure 2. Overview of remediation to prevent backing into the distribution area

- Vehicles are not permitted to back into the distribution area and the overhead door entrance is blocked with cones and a construction barrel (Figure 2).
- An area outside of the building is designated for vehicles to park.
- Volunteer staff brings food items to the vehicles using carts (Figure 3).

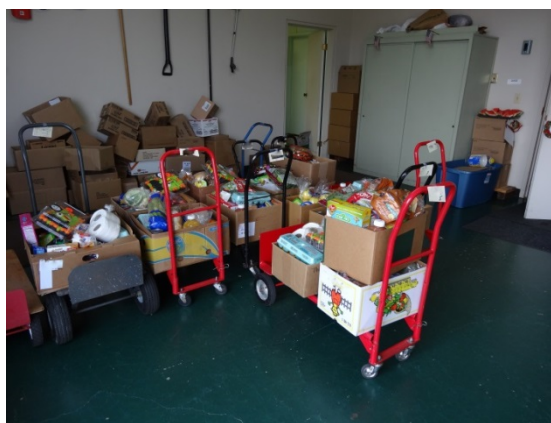
Figure 3. Carts now used to bring food to the clients

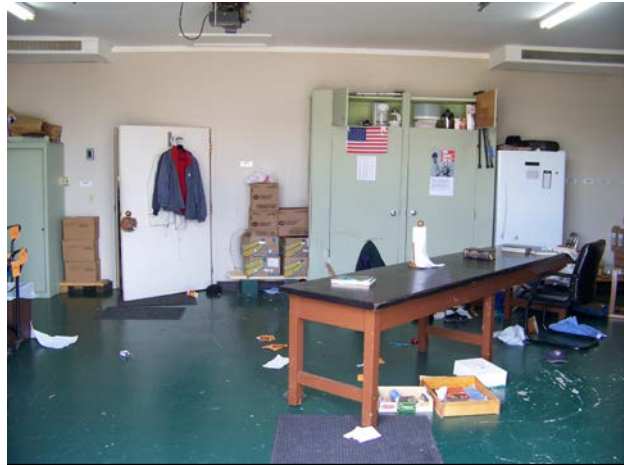
Figure 4. Incident scene with table pulled away from the west wall so emergency care could be given

The decedent's coworkers moved the table and began CPR while waiting for emergency responders to arrive. Emergency responders assumed care, and transported the decedent to a local hospital where she died.

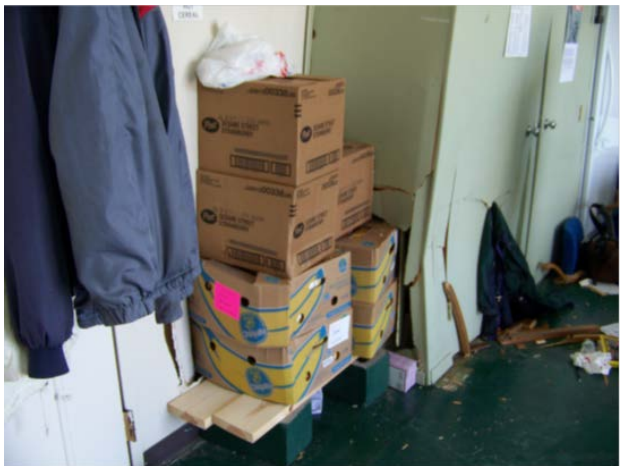
Figure 5. Damage to the west wall by the force of the table being pushed by the SUV

The responding police department noted damage on the bumper and hatchback consistent with hitting the table. The area of the wall at the back of the garage where the refrigerator and cabinets were located was pushed into the building. The police department personnel lined the table up with damage to the refrigerator cabinet and boxes along the back wall – the table lined up with all of these items.

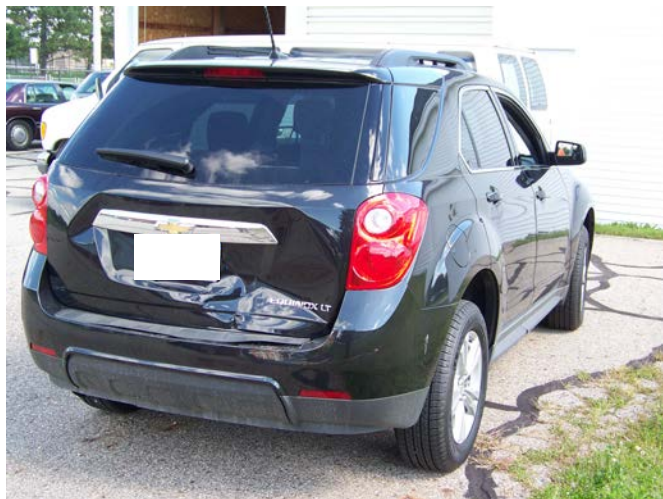
Figure 6. SUV involved in the incident. Note damage to the rear of the vehicle.
