MIFACE Investigation Report: #14MI118

Subject: Farm Worker Died When Unsupported Combine Head Fell Onto Him During Repair Activities in a Bean Field

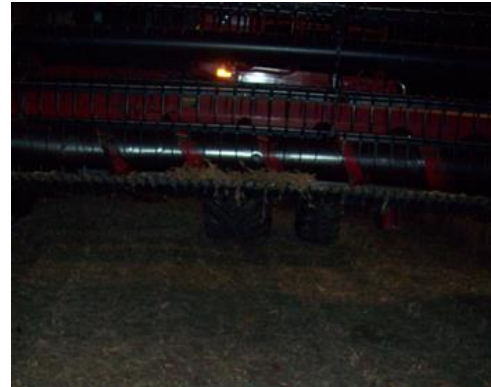
Figure 1. Combine and header involved in incident in field.

Three combines were in one field and the decedent was working alone in a nearby soybean field, out of visual distance from his coworkers. He was making his first pass. Rain had washed out an 8-10 inch deep portion of the field near a ditch. The combine head rammed this washout, causing the head to move upward and stick in the raised position, approximately 4 feet above the ground.

The decedent exited the combine and left the combine running. He did not take the combine head out of “automatic” control. He went under the raised combine head with a crescent wrench without providing secondary support (header safety stop) to prevent the head from lowering when repairs were completed. There was a pair of work gloves on the ground by his body along with a bungee-type strap. Although the event was unwitnessed, two hypotheses were developed: 1) He may have been attempting to make an adjustment directly to the combine head to lower it from the raised position (Figure 2) or 2) he was striking the floating sensing “rod” which was stuck in the raised position to free the head (Figure 3). When the combine head released from its raised position, it fell onto the decedent, pinning him on his side against the dirt.

- Workers should always use all safety devices, such as hydraulic cylinder safety stops, that machines are equipped with to prevent injury and exposure to hazards. If cylinder safety stop is not available, block the raised combine head with a material, which will not crush under the weight of the unit.

Modern machines, including farm equipment are designed and equipped with a variety of effective safety devices, such as hydraulic cylinder safety stops. These devices protect workers while the machines are being used and during maintenance and repair of the machines. In this incident, the hydraulic cylinders that controlled the height of the combine header were equipped with a hydraulic cylinder safety stops. When moved and locked in its lowered position the safety stop would prevent the header from lowering due to a release of the bar, which controlled the adjustable floating head. Before crawling under the raised header the decedent did not lower and lock the safety stop or provide other secondary support, such as placing material under the raised head which will not crush under the weight of the unit should it come down. In this case, if the safety stop had been locked in place or secondary support provided this fatality would have been prevented.

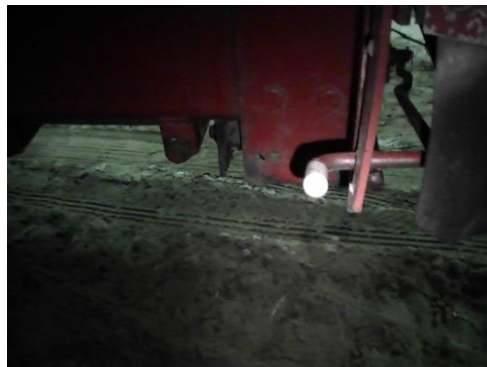
The machine involved in the incident was a 1990 Case International combine, Model 1680. Attached to the combine was an approximately 30-foot long header with an automatic floating cutter, which allowed the head to raise and lower by sensing ground height while preventing the sickle guards from digging into the ground and picking up debris. The combine head had a control button that could be operated by the driver from inside of the cab.

Figure 2. Sensing adjustment to the combine head.

- Calibrate header for each harvest site, evaluate ground site conditions and adjust harvesting procedures accordingly.

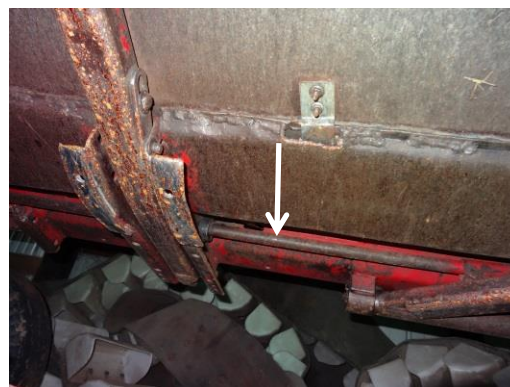
Figure 3. Arrow pointing to sensing rod he may have been trying to unjam.

- Use appropriate equipment shut off procedures when dismounting the equipment.

The operator's manual should be consulted to determine the safe operating practices and procedures for the combine and any attached implements. Machine operators should shut down both the machine and the engine before inspecting or working on harvesting equipment. Operators should always disengage all power, shut off the engine and take the key. If the

combine had been turned off and the header's automatic control shut down, when the decedent freed the head from its "stuck" raised position, it most likely would not have fallen onto him, assuming there was not a problem with the hydraulic system.
