MIFACE INVESTIGATION #06MI004

SUBJECT: 29-Year Old Male Hispanic Landscape Laborer Dies When Nine Foot Deep Trench Collapses

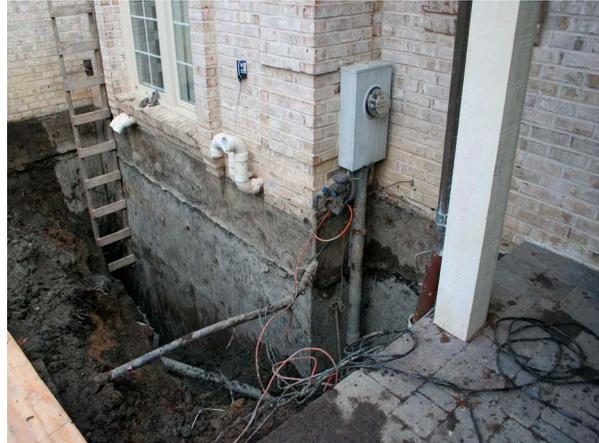
On February 1, 2006, a 29-year old male Hispanic landscape laborer died when the two-foot wide, sixteen-foot long and nine-foot deep trench he was working in collapsed and covered him with soil. The victim and four other laborers had been hand digging the trench over a two-day period at a private residence. The victim was kneeling to inspect a broken drain pipe at the bottom of the east end of the trench. At approximately 3:00 p.m., a laborer on top of the trench saw a crack in the soil and yelled to the victim. The wall collapsed and the victim was completely covered with soil in seconds.

Figure 1. Photograph of trench after cave in.

Although water was not accumulating inside the trench at the time of the fatality, the employer should have taken precautions to ensure water did not contribute to the collapse of the trench. Because the employer was attempting to correct a leak in the home's basement, the soil surrounding the home was most likely damp. Damp soil is heavier and less stable. These soil conditions can contribute to the collapse of the trench wall.

- Employers should ensure that employees working in excavations are protected from cave-in by an adequate protection system such as shoring, sloping or excavation box designed in accordance with MIOSHA Construction Safety Standard, Part 9: Excavation, Trenching and Shoring, R408.40941.

The company owner did not select nor implement any preventative measures to protect workers from the trench collapse. To protect workers from the danger of wall collapse, the MIOSHA Excavation, Trenching and Shoring Standard requires that an excavation, five feet or more in depth (unless soil conditions mandate protection in excavations less than five feet) be protected from cave-in. R408.40942 of the Excavation standard details what must be evaluated during an excavation to protect workers inside the excavation. The angle of repose and the design of the supporting system for a side of an excavation shall be based on the evaluation of all the following factors: (a) depth of cut and type of soil, (b) possible variation in the water content of the material while the excavation is open, (c) anticipated changes in the material due to exposure to air, sun, water or freezing, (d) load imposed by structures, equipment, overlying material or stored materials, and (e) vibration from traffic, equipment or blasting.

The selection of preventative measures is based on this evaluation. Methods such as angle of repose, sloping and benching, tight sheeting/sheet piling or trench boxes and shields may be used to protect personnel in the excavation. Sloping involves positioning the soil away from the excavation/trench at an angle that would prevent the soil from caving into the trench. Shoring systems are structures, such as a metal hydraulic, mechanical or timber that provide support to the walls of the trench and prevents cave-ins. If either adequate sloping or shoring had been used in this incident, the fatality may have been prevented.
