REPORT#: 23MI119

REPORT DATE: 11-20-2024

Entanglement in a Round
Baler

Farm Worker Found Entangled in Round Baler

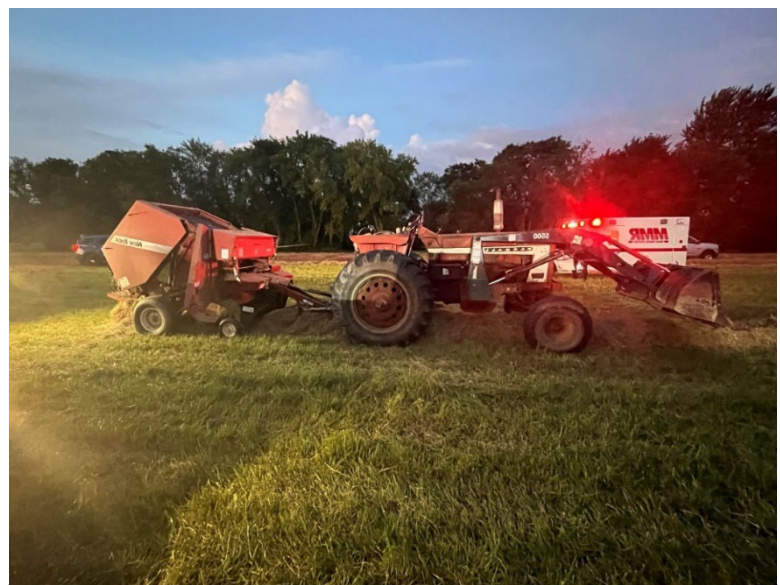
Photo 1: Tractor and baler as found during EMS response.
(Photo source: responding police department.)

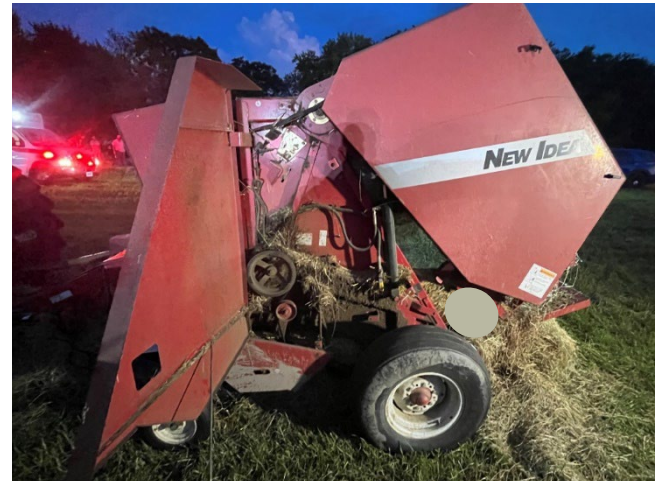
Photo 2: New Idea Model 4584 baler with inspection door found open. (Photo source: responding police department.)

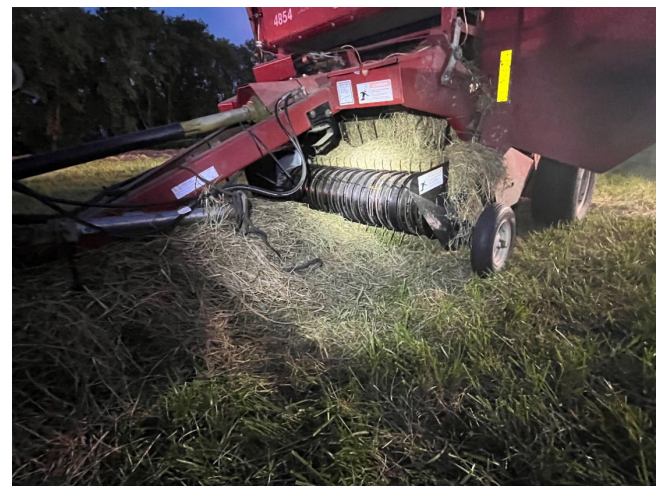
Photo 3: New Idea 4854 baler pickup entry. (Photo source: responding police department.)

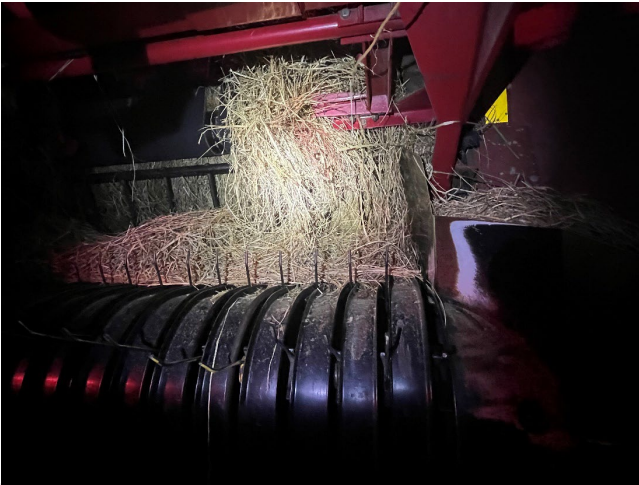
Photo 4: New Idea 4854 baler entry looking into baler pickup entry from front.
(Photo source: responding police department.)

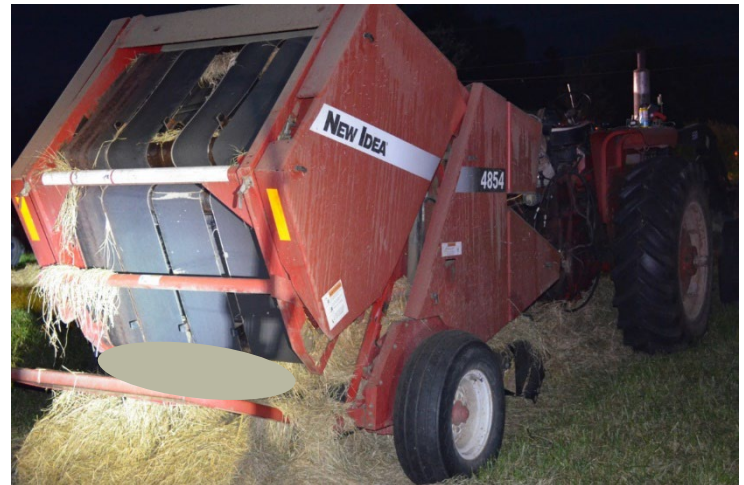
Photo 5: New Idea 4854 baler rollers and belts. View is from right rear.
(Photo source: responding police department.)

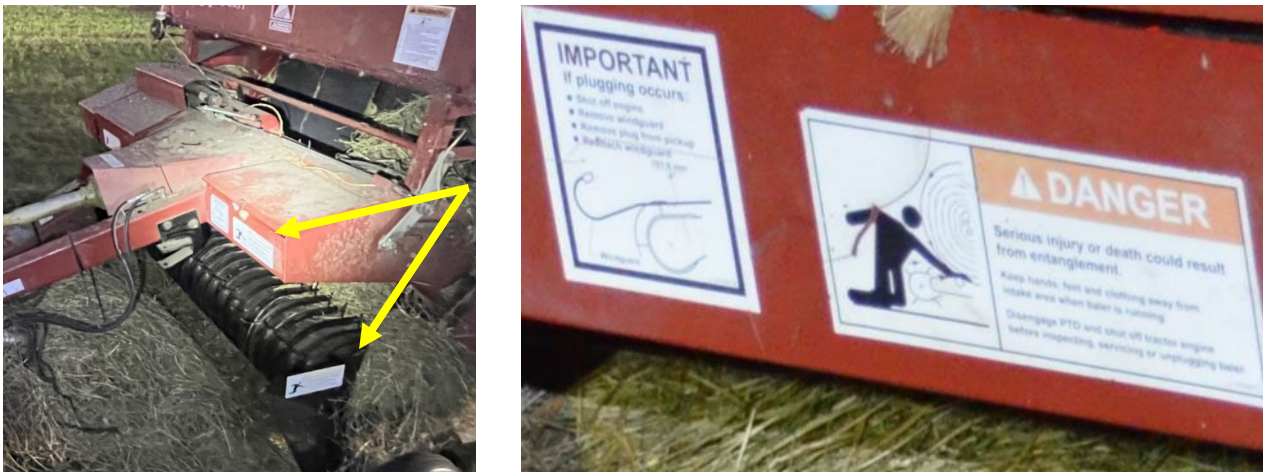
The baler in this incident was clearly labeled near the in-running nip point with a danger warning and recommended precautions. The tractor was found running on high idle with the PTO engaged to the baler. At an intake rate of 3-4 feet per second, reflexes of the worker can't be relied on to safely perform, without injury, clearing or adjustment at the in-running baler pickup roller splines. It should be noted that the in-running pick-up tines are normally unguarded in terms of physical guarding. The intake tines are normally guarded by location when the operator is in the seat of the tractor.

Photos 8/9: (Left) The location of the warning labels on the hay baler. (Right) An enlargement of the top warning label. (Photo source: responding police department.)

For prevention, in the absence of equivalent means to safely unclog, MIFACE requires following MIOSHA Part 53 regulations and manufacturer warnings. Specifically, ALWAYS disengage the PTO and shut down the tractor when unclogging, maintenance, or adjustment is needed.
