REPORT#: 17MI208

Marina Owner Drowned in Six-foot Deep Water in Marina Slip

Michigan Fatality Assessment and Control Evaluation (FACE) Program

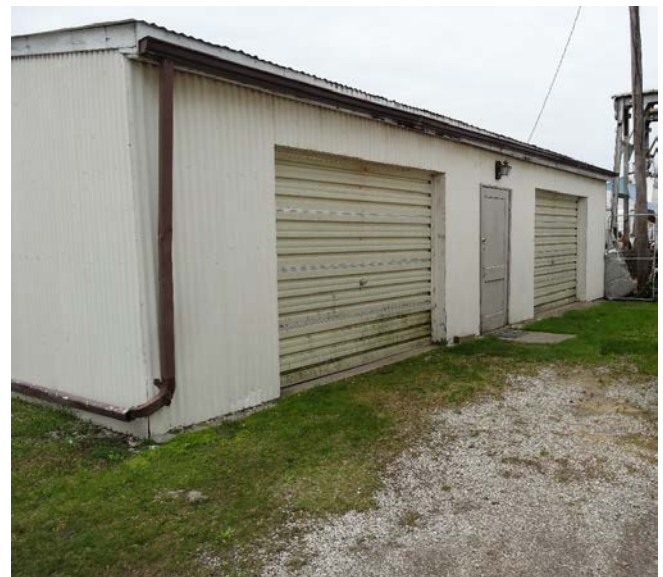
Photo 1. Marina building

The marina was located on a river. The marina consisted of a single level building that was fenced in (Photo 1). Access to the boats from the roadside was provided by two overhead doors and pedestrian doors. The inside of the building, including the walkways between boats were cluttered. There were five marina slips of different sizes (approximately 10-12 feet wide) to accommodate different boat sizes.

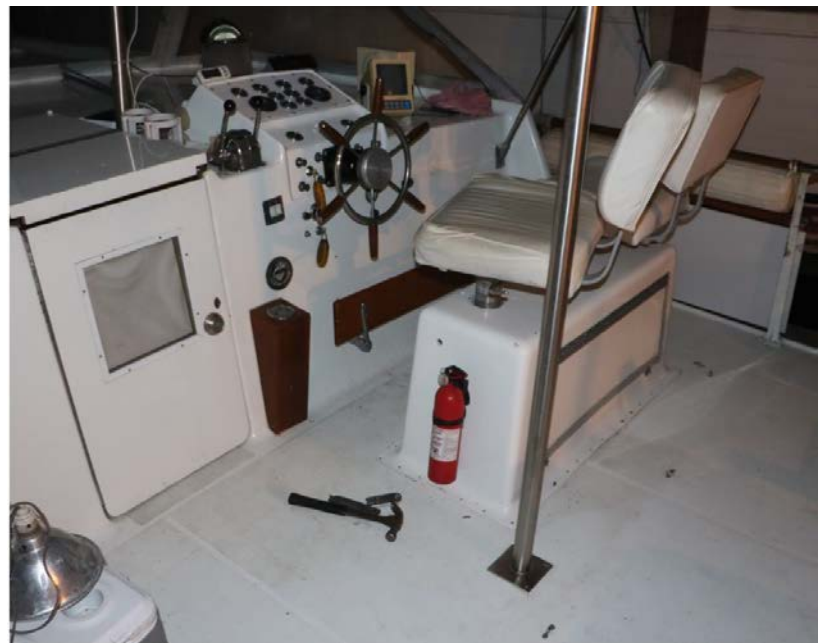
Photo 3. Boat A where sheriff found tools, keys in ignition and work light

Sheriff pictures taken at the scene show Boat A in slip 3 with tools on the deck, keys in the ignition, a work light, and the side deck access doors open on each side of the boat (Photos 3 and 4). In slip 4, on a horizontal plank running across the slip width holding a boat aloft there is an empty coffee can. The sheriff pictures taken at the scene show the same coffee can location as the MIFACE picture (Photo 6).

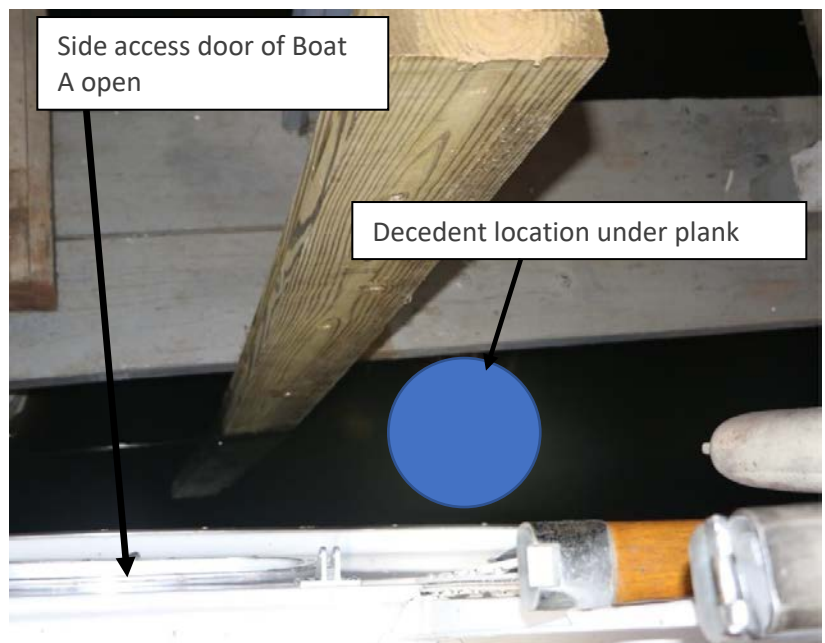
Photo 5. Boat A, open access door, location of decedent in water

The sheriff arrived and found the decedent, unresponsive and floating upright, in the water under the planks between Boat A and Boat B (Photos 5 and 6). The crown of his head was visible. He was not restrained in any way under the water. For reasons unknown, the decedent fell into the water. Because he was working alone, there was no one to assist him and no safety ladder available, he was unable to pull himself up out of the water and eventually drowned. He was declared dead at the scene.

Recommendation #2: Place safety ladders and life rings throughout the marina.
