REPORT#: 15MI117

Construction Laborer Died in a Trench Wall Collapse

Michigan Fatality Assessment and Control Evaluation (FACE) Program

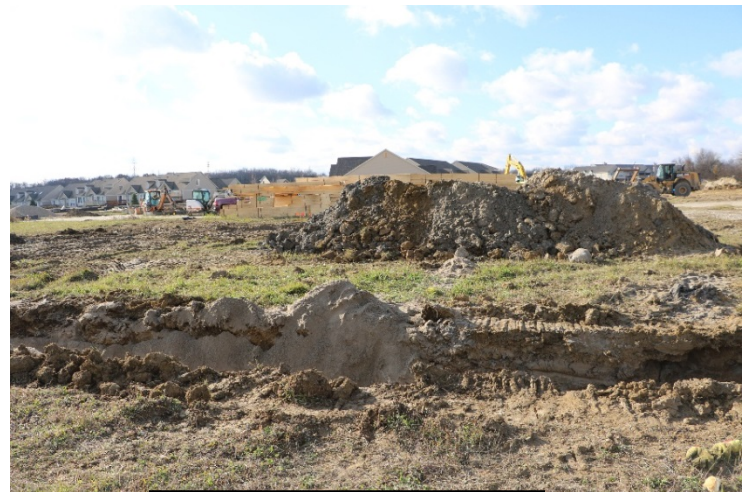
Figure 1. Placement of spoils

Coworker 2 was using a Kawasaki excavator with a 3-foot wide bucket. He placed the spoils on the side of the trench that collapsed. The spoils were placed more than 2 feet away from the trench wall as required by MIOSHA standard Part 9. (See Figure 1).

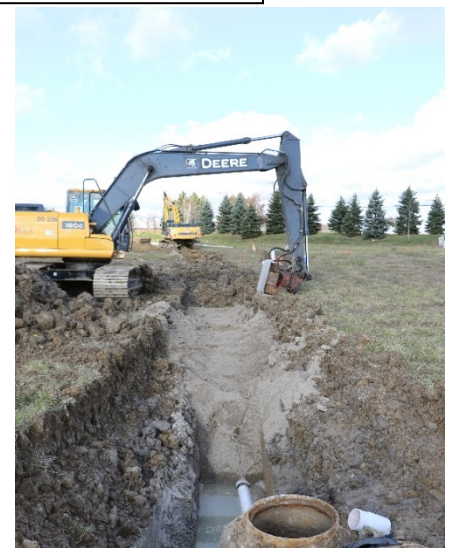
Figure 2. Water location in trench

Earlier that morning the excavator operator noticed more water at the west end of the trench and asked the decedent if he wanted the trench box that was onsite. The decedent stated no. (See Figure 2).

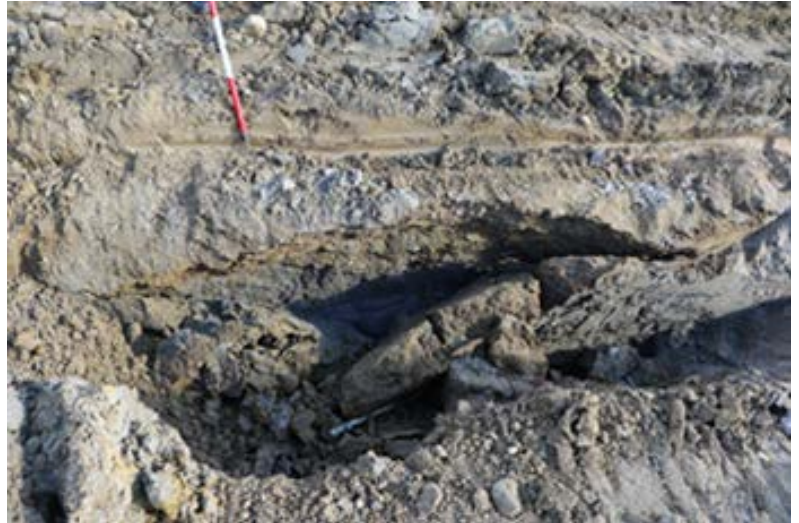
Figure 3. Trench wall collapse

When the foreman finished the placement of the survey stakes, he walked the site to check out progress. He came to the incident trench area where the decedent and Coworker 1 were working. The foreman looked over and noticed the south wall starting to give way and yelled for the decedent and Coworker 1 to get out of the trench. Both workers began to run east toward the ramp. Coworker 1 was able to safely exit the trench. The south clay/dirt wall collapsed, striking the decedent on his right side, burying him from the waist down side and pinning him against the north trench wall (See Figure 3). The decedent's shovel was pushed into the decedent's right side but never penetrated. The force of the south wall collapse caused the decedent to strike the north wall also causing part of the north wall to also collapse, although the bench was still intact.

Employees engaged in pipe installation activities in an excavation that had been benched on each side where the step back of the benches did not extend to the angle of repose as required by table 1, exposing the employees to a cave-in of the excavation, resulting in a fatality. The excavation, as observed by employees and others on site, was 6'-4" deep, 7' wide at the top, 4' wide at the bottom, and 25' long. The north and south sides of the excavation each had a 5' high bench that stepped back 18", achieving an angle of repose of 73 degrees. The soil was a wet sand at the bottom 18" of the excavation, with the remainder being a wet clay.

Employees engaged in pipe installation activities in a benched excavation where the height of the lower bench on each side was greater than the width of the trench measured at the bottom, exposing employees to a cave-in that resulted in a fatality.

Recommendation #1: Employers should ensure that employees working in excavations are protected from cave-in by an appropriate protective system, such as trench boxes, shields, benching and/or appropriate sloping of trench sides designed in accordance with MIOSHA Construction Safety Standard, Part 9, Excavation, Trenching, and Shoring. To ensure this is done correctly, a qualified person must inspect and approve the excavation, adjacent areas, and supporting systems on an ongoing basis.
