REPORT#: 17MI045

REPORT DATE: 10/22/19

Plasterer/Drywall Installer Dies From 30-Foot Fall Through Skylight

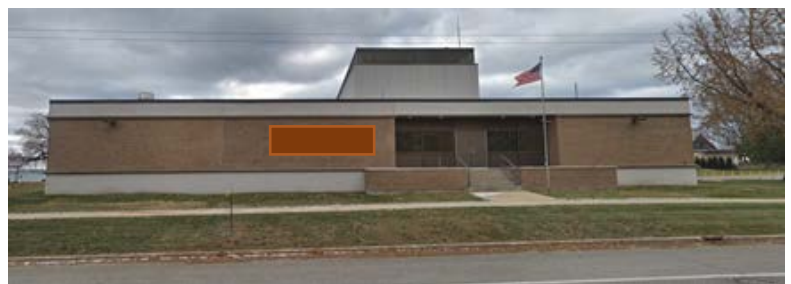
Photo 1. Front of water treatment plant undergoing renovation.

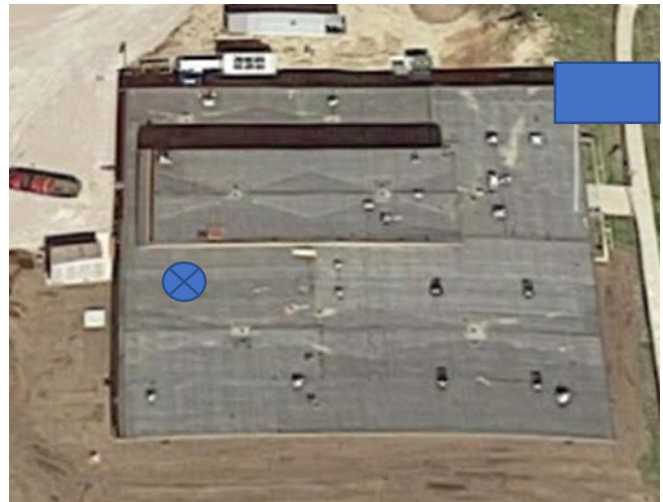
The penthouse was on the northern half of the one-story building, toward the western side (See Photos 1 and 2). At the time of the incident, there were no elevated warning lines or ropes along or near the edge of the roof. The distance from roof to the concrete floor below was 30 feet 8 inches.

Photo 2. Water treatment plant building roof. Blue circle with X was approximate location of incident skylight. Picture courtesy of Google maps.

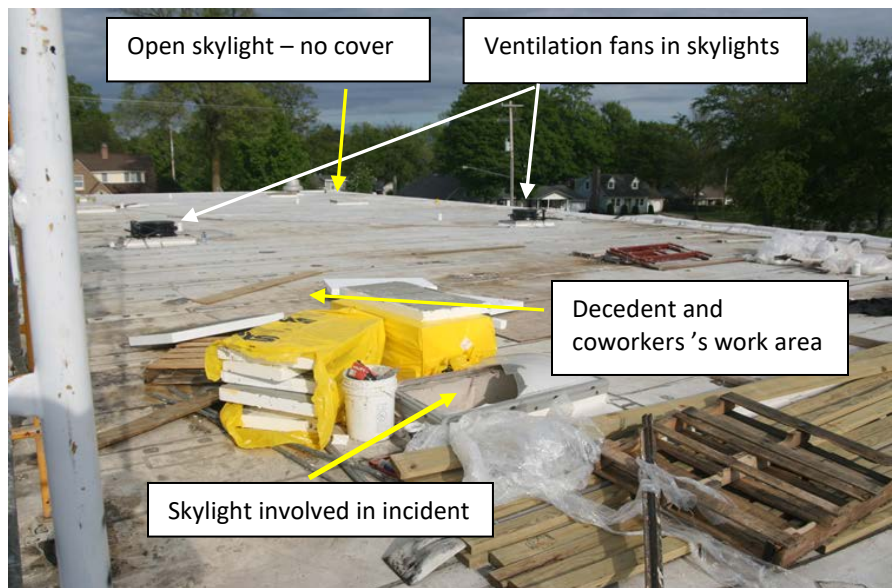
Several skylights had previously had their covers removed and no barricade or cover had been placed around/over them. Two of the opened skylights had ventilation fans placed in them, providing air movement to the first-floor work sites (Photo 3). The decedent's employer did not know which firm removed the skylight covers.

The skylight involved in the incident was within 11 feet from the southern penthouse wall. Next to the southern wall was a scaffold that was erected by either Firm 1 or Firm 2. The distance from the roof edge is unknown. The lumber seen in Photo 3 belonged to another contractor.

Photo 3. Incident area showing skylight involved in incident, open skylights with ventilation fans, and open skylight with no cover

After the incident, Firm 2 installed ¾-inch plywood over the 10 skylights and spray-painted "hole" on each piece of plywood. Firm 2 also placed warning lines at the roof edge.

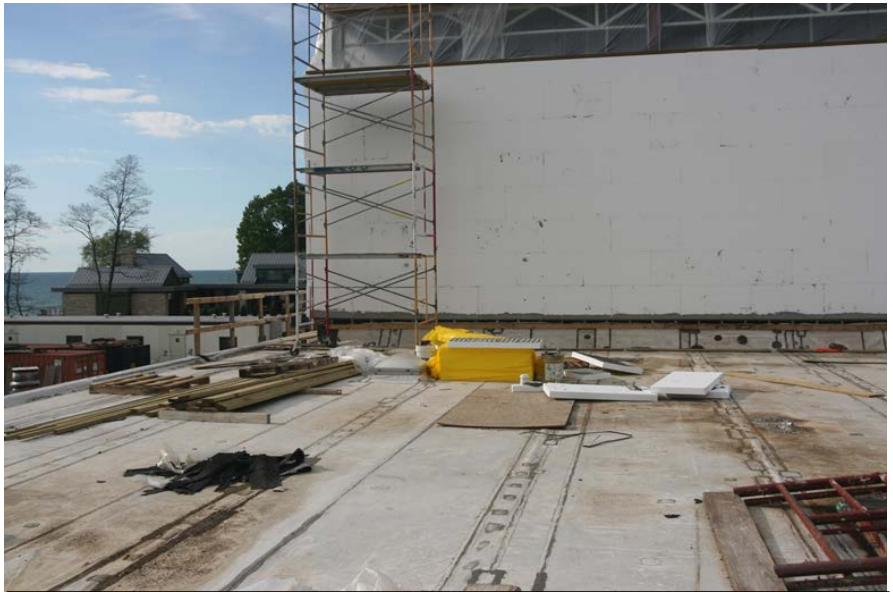
Photo 4. Incident area, looking north

to 10-feet from his mudding position to the boom truck. The decedent's path placed him between the skylight and the south side of the penthouse which had the scaffold positioned next to it (Photos 4 and 5).

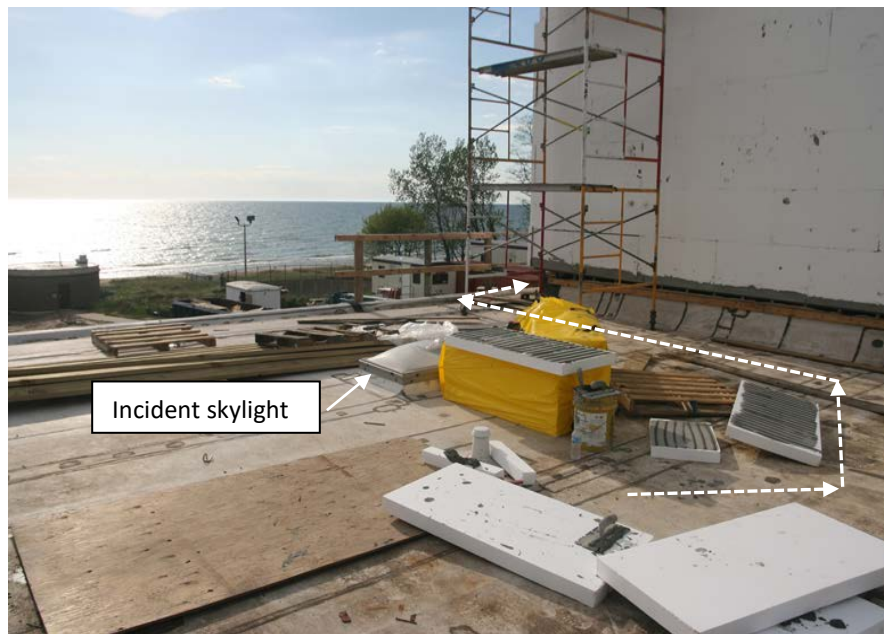
The decedent and his coworker, who was cutting foam, were working next to the skylight through which the decedent fell. The decedent was mudding the foam board near the west side of the roof at the east side of the skylight involved in the incident. The firm owner, elevated in a boom truck owned by Firm 2, was positioned on the southwest corner of the penthouse applying the prepared foam. After mudding the foam board, the decedent walked approximately 8-

Photo 5. Incident area. Dotted lines show most likely path of decedent when he carried the prepared foam board to the owner working in the boom lift

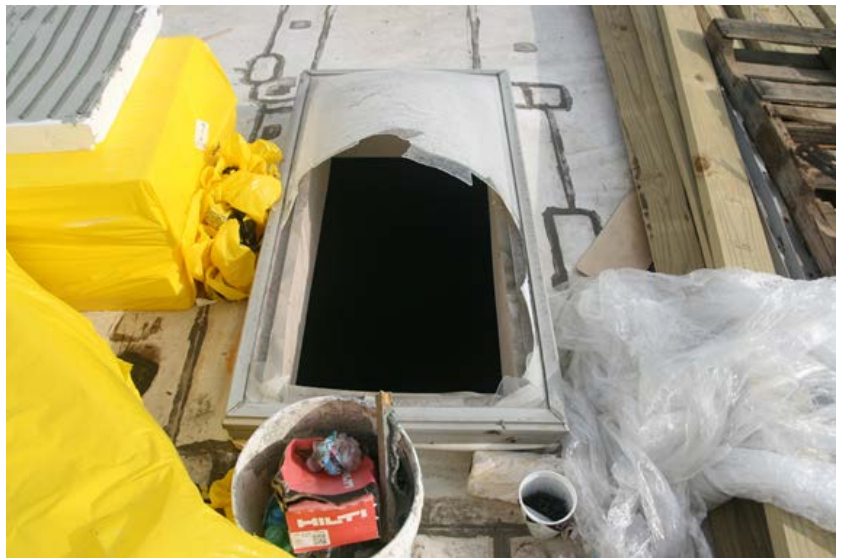
Photo 6. Skylight involved in incident

Plastic dome-type skylight cover was not capable of supporting twice the weight of employees who were working on the roof of the City water treatment plant. (*MIFACE removed the name of the city*)

Plastic dome-type skylight cover was not identified or marked for employees who were working on the roof of the City water treatment plant. (*MIFACE removed the name of the city*)
