**REPORT#: 17MI127**

**REPORT DATE: 06/07/19**

## Construction Laborer Died in Trench Wall Collapse

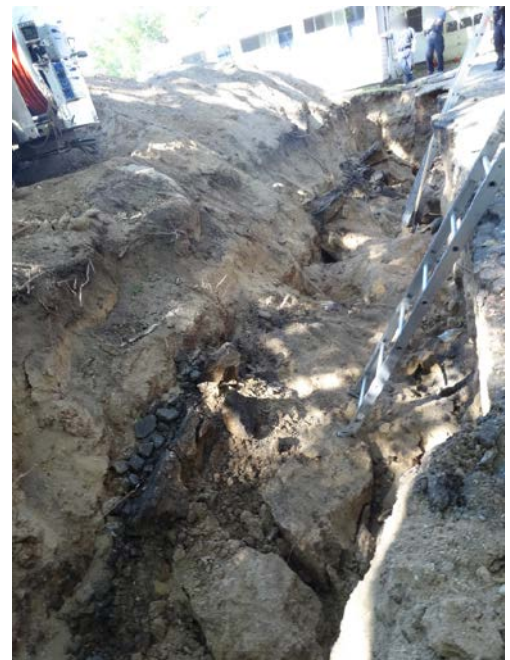
*Photo 1. Overview of incident scene near driveway trench wall collapse, looking north.*

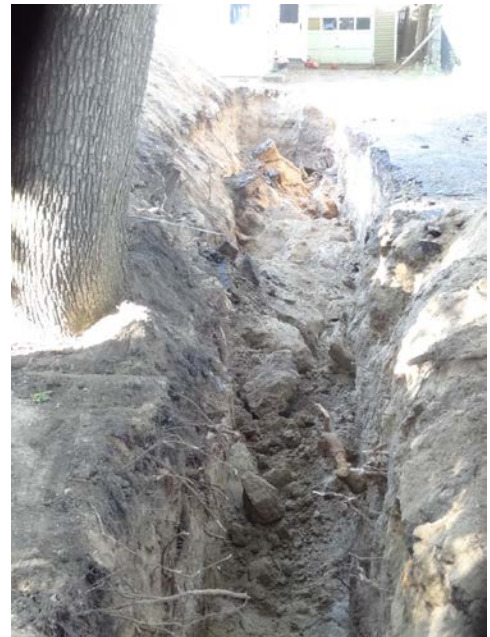
The south end of the trench was approximately the width of the excavator bucket. He sloped the south end of the trench to enable entrance to the base and did not place a ladder in the trench to assist with entering and leaving (See Photo 2).

*Photo 2. Overview of incident scene looking north.*

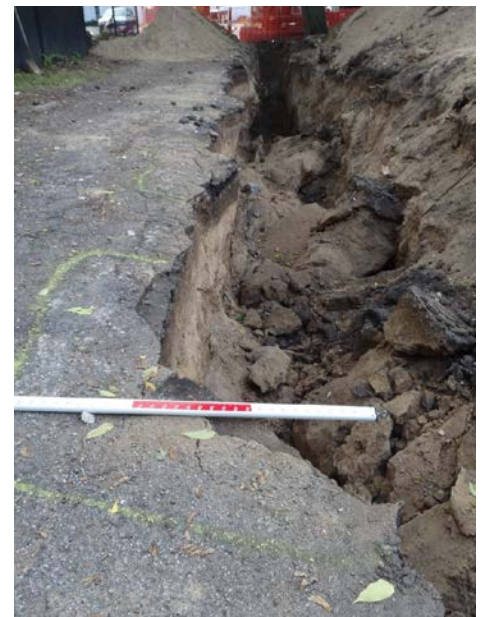
*Photo 3. Area of trench wall collapse, looking south.*

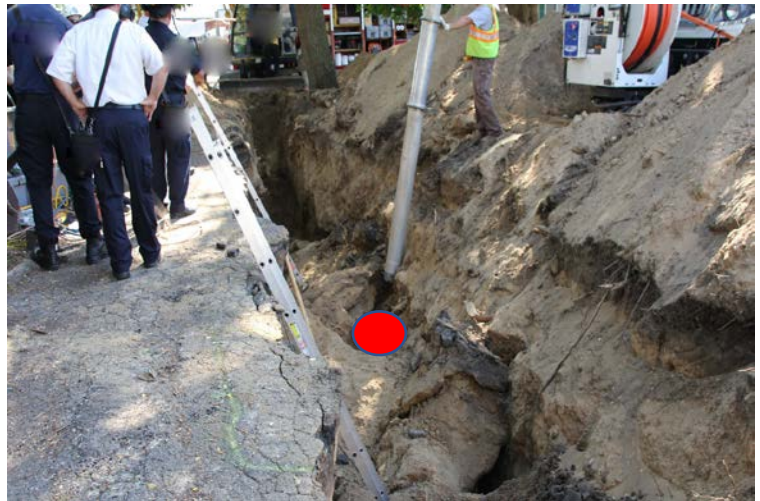
*Photo 4. Vacuum truck removing soil from around decedent. Red circle is location of decedent.*
