REPORT#: 17MI128

REPORT DATE: 8/5/19

Construction Foreman/Carpenter Dies from Complications From Fall From Roof

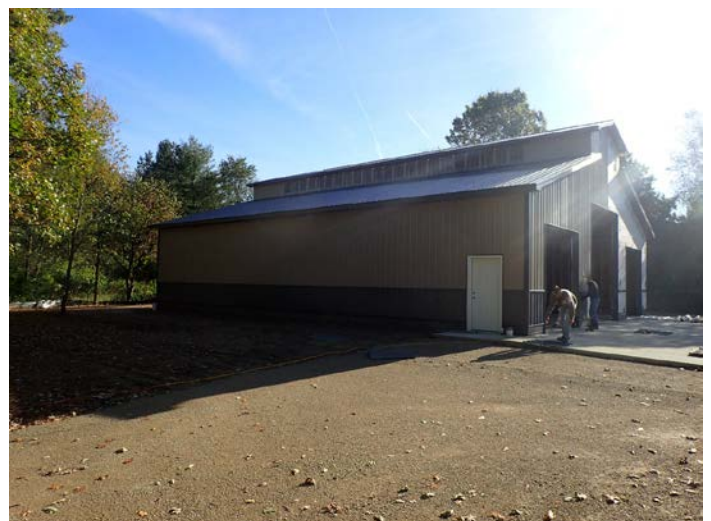
A friend of the employer wanted a pole barn to be built to be used as protected storage for various pieces of equipment and other items. The friend provided specifications for use for the building and asked if the decedent's employer would design it. After designing the building and given an "ok" for the truss design by the building owner, the decedent's employer began the building process. The decedent had been at the building site for the entire two months of construction (Figure 1).

Photo 1. Pole barn under construction

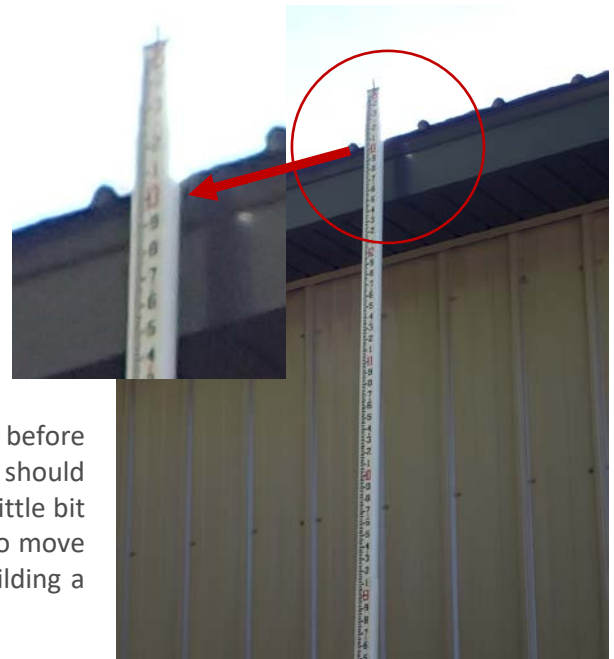
The crew was installing a metal roof. Per the employer, the building roof was 60 feet long with a 5/12 slope; the MIOSHA compliance officer indicated the roof slope was 4/12. The distance from the roof edge to the dormer was 22 feet. The roof was completely sheeted with plywood and hi-density felt. Approximately one-half of the west side roof and one-half of the north side roof had metal sheeting installed. Approximately half of the screws had been placed and screwed in. The work plan was to wait until the very end of the installation to completely screw all the screws in the holes that had been drilled.

Photo 2. Height of roof from which decedent fell

Employee exposed to falls of approximately 11 to 13 feet from a 4/12 roof pitch without the use of fall protection.

Recommendation #1: Employers should ensure that at least one of the following is used whenever employees are exposed to a fall of 6 feet or more above a lower level: Guardrail Systems; Safety Net Systems; Personal Fall Arrest Systems.
