REPORT#: 18MI072

Field Manager Struck by Vehicle in Active Roadway While Taking Depth Measurement

Michigan Fatality Assessment and Control Evaluation (FACE) Program

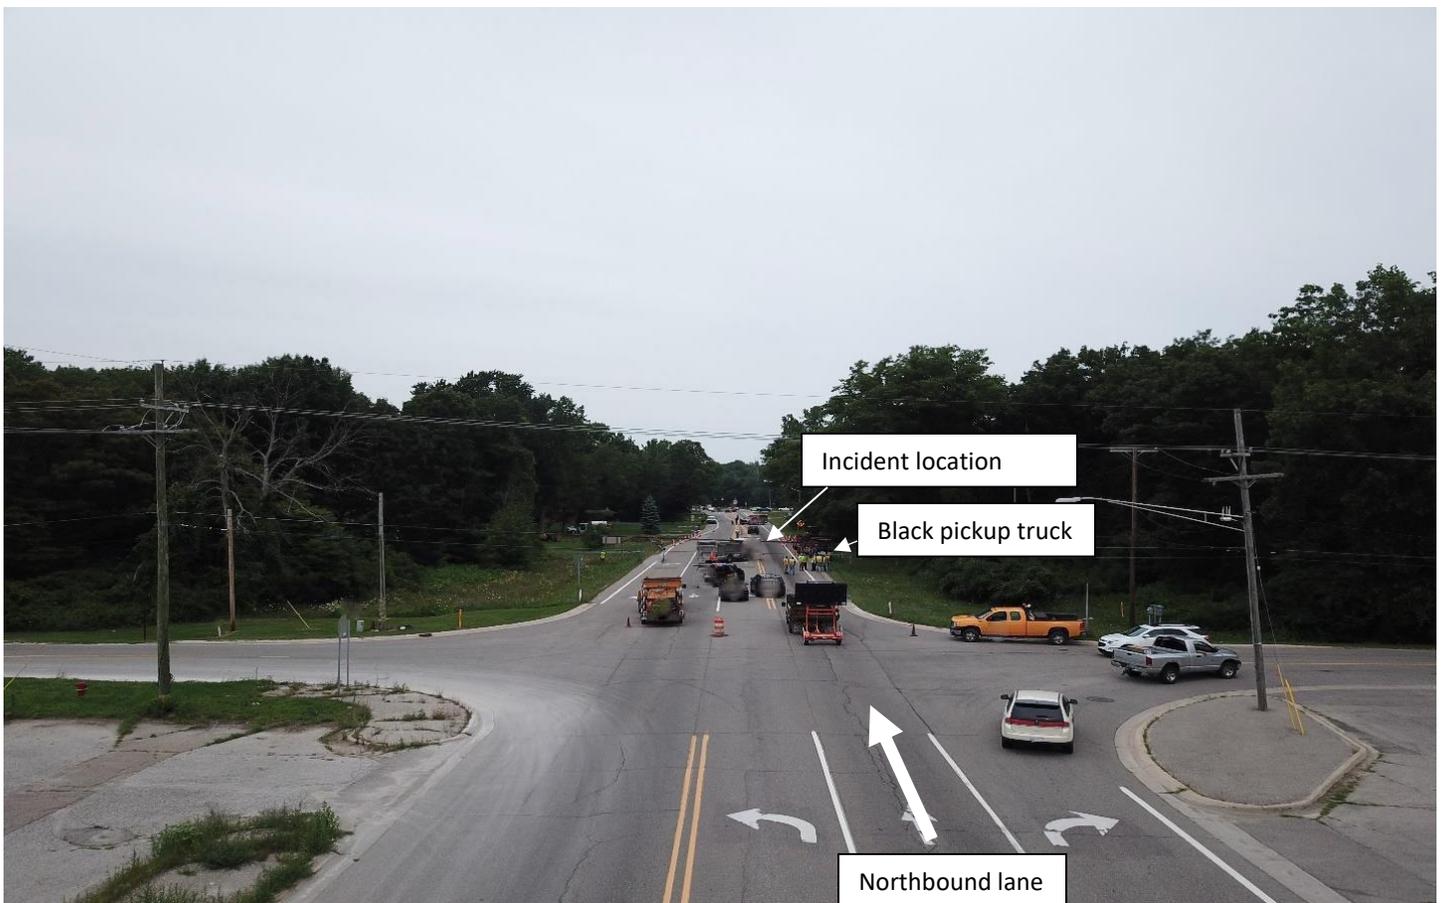
Photo 1. Drone view, south of intersection looking north

The north-south roadway had two through-travel traffic lanes, and as traffic approached the intersection, a middle (center) lane to make a left turn at the intersection and a right turn lane. (See Photos 1 and 2). The incident occurred approximately 1000 feet north of the intersection.

The road was dry and had a posted speed limit of 50 mph. There was no reduction of speed in the work zone.

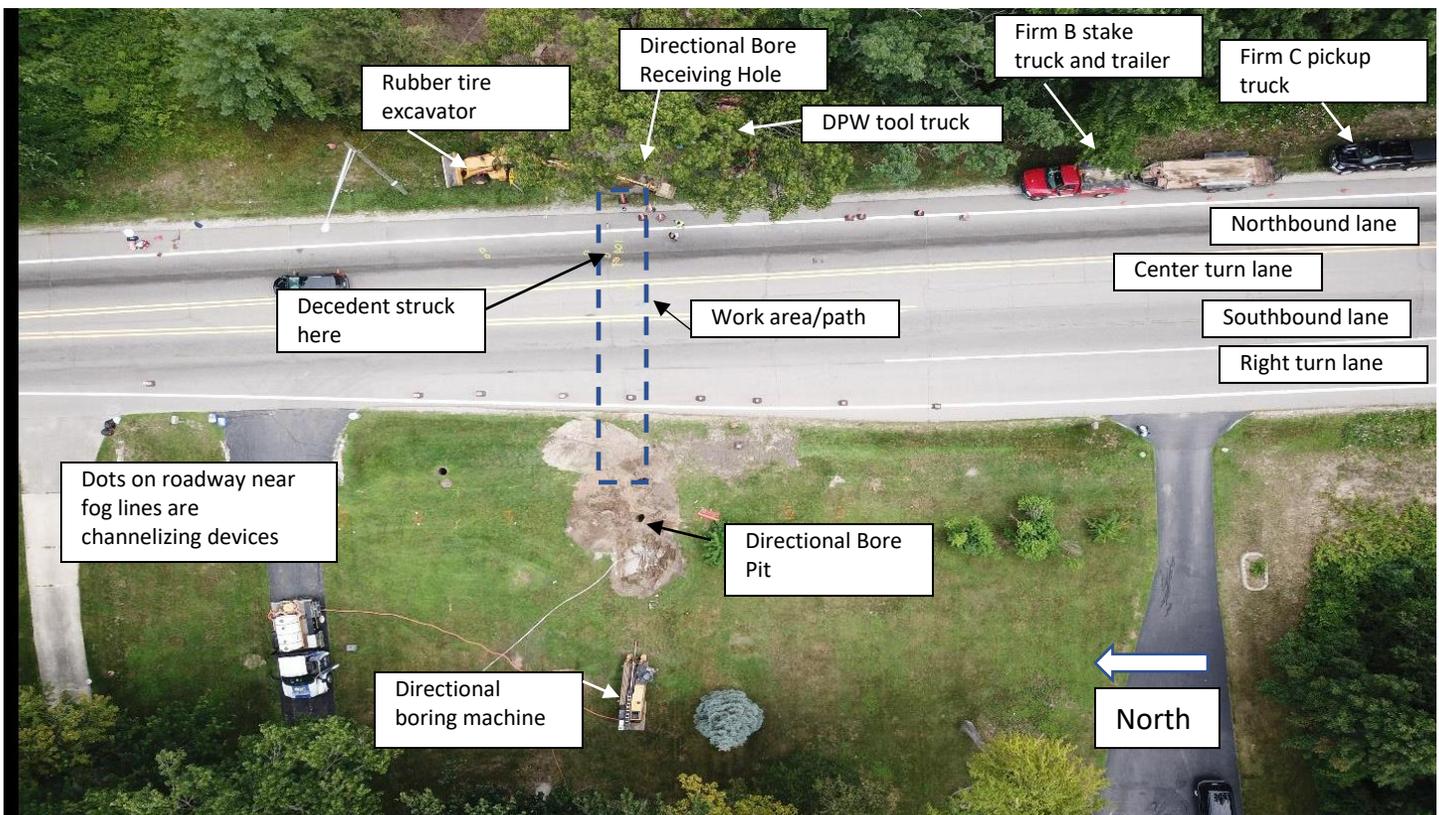
Photo 2 shows the excavation and directional boring equipment, vehicles, channelizing devices and the location of the bore and the decedent at the time he was struck by the oncoming vehicle.

- Near the receiving bore hole were the backhoe and Township DPW’s tool truck, a converted fire engine.
- Firm B’s stake truck with an attached flatbed semi-trailer, parked primarily on the paved shoulder. The amber lights on top of the stake truck were not activated. The truck’s four-way flashers were not activated.
- Firm C’s black pickup was parked primarily on the grass south of Firm B’s truck/trailer unit. The four-way flashers on the pickup were not activated.

A rubber-tired excavator was used to make two excavations, one on each side of the roadway, so the bore head of the head of the directional boring machine could enter and exit (exit hole is identified on Photo 2 as the receiving hole).

Photo 2. Responding police drone picture, overhead view of incident site.

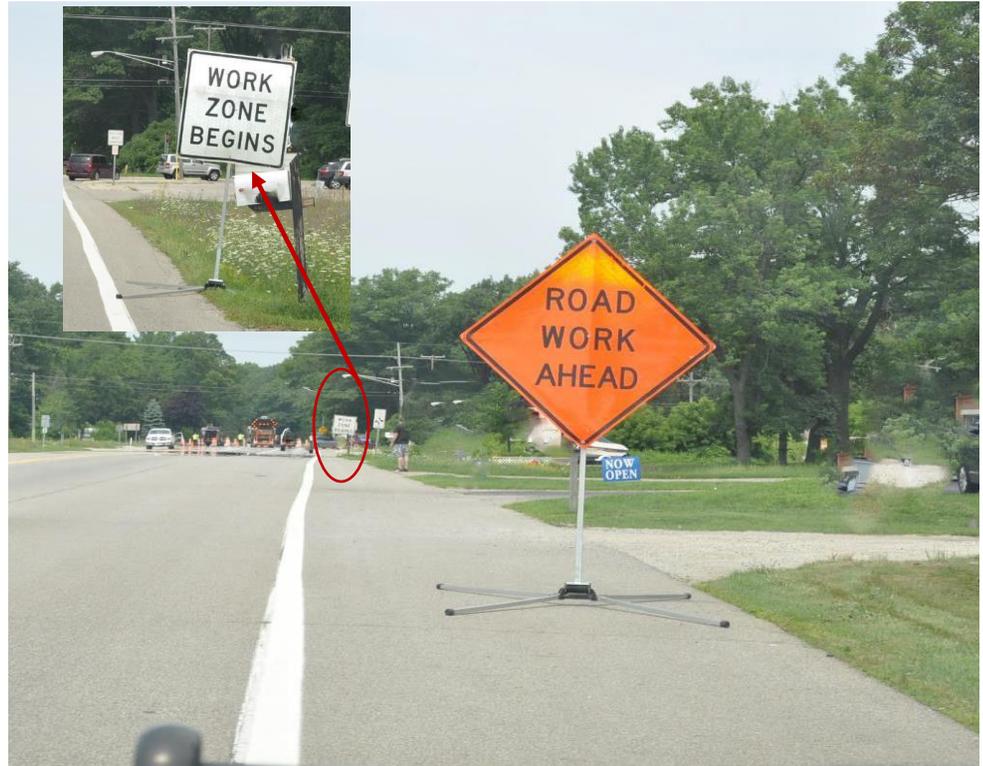
One "Road Work Ahead" sign and one "Work Zone Begins" sign was placed on the east side of the northbound roadway south of the intersection (Photo 4) and one set of signs was placed on the west side of the roadway, north of the incident site for southbound traffic. No "Work Zone Ends" signs were erected. There were no signs within the work area.

Photo 3. Road Work Ahead and Work Zone begins signs placed on northbound roadway, south of intersection

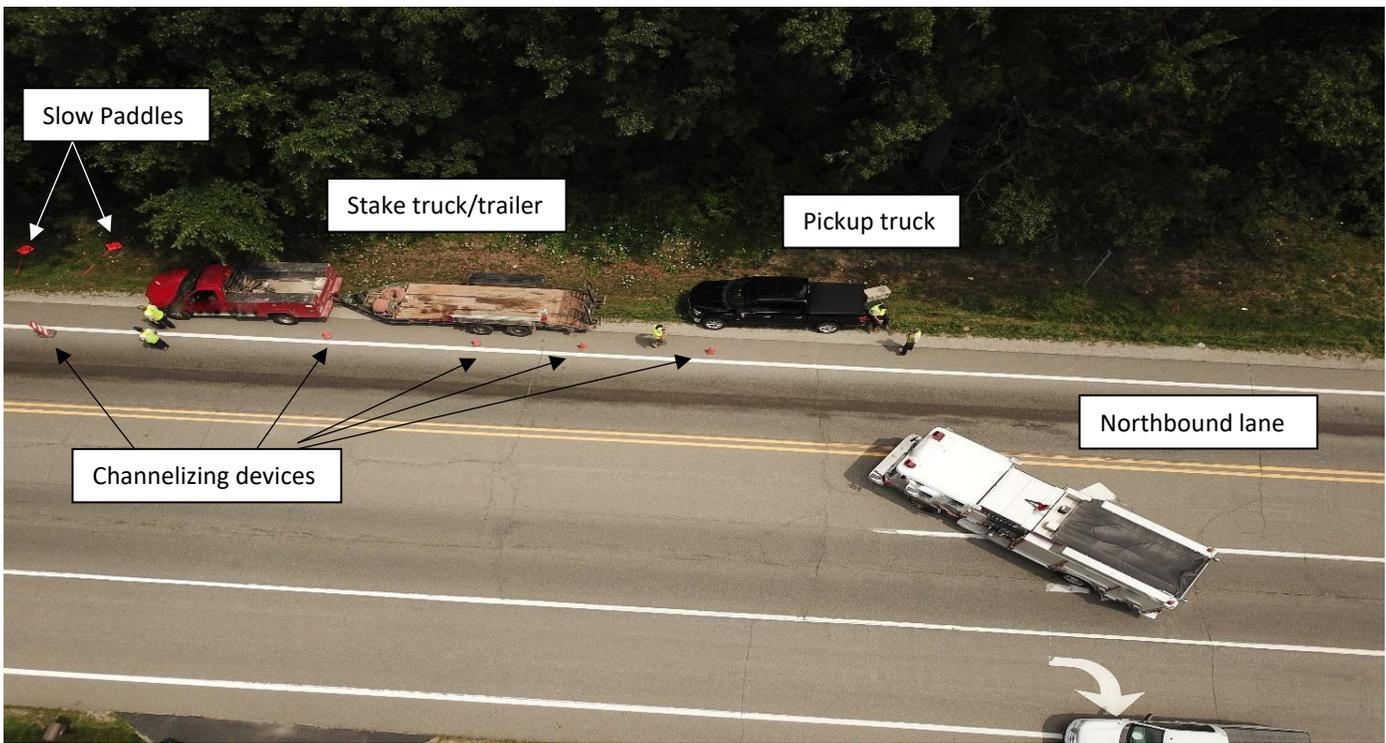
Firm A personnel had placed the temporary traffic control work zone signage and channelizing devices (traffic cones). The channelizing devices were of different sizes and placed on both the east and west sides of the roadway (Photos 1 and 3). On the east side of the roadway, traffic cones were placed near the rear of the semi-trailer and angled out from the edge of the pavement toward the fog line. Once the cones met the fog line, they were positioned three to four feet west of the fog line in a straight line northbound past the excavation area indicating the shoulder of the roadway was closed. On the west side of the roadway, traffic cones were similarly placed three-to four feet east of the fog line.

Photo 4. Location of construction equipment and channelizing devices

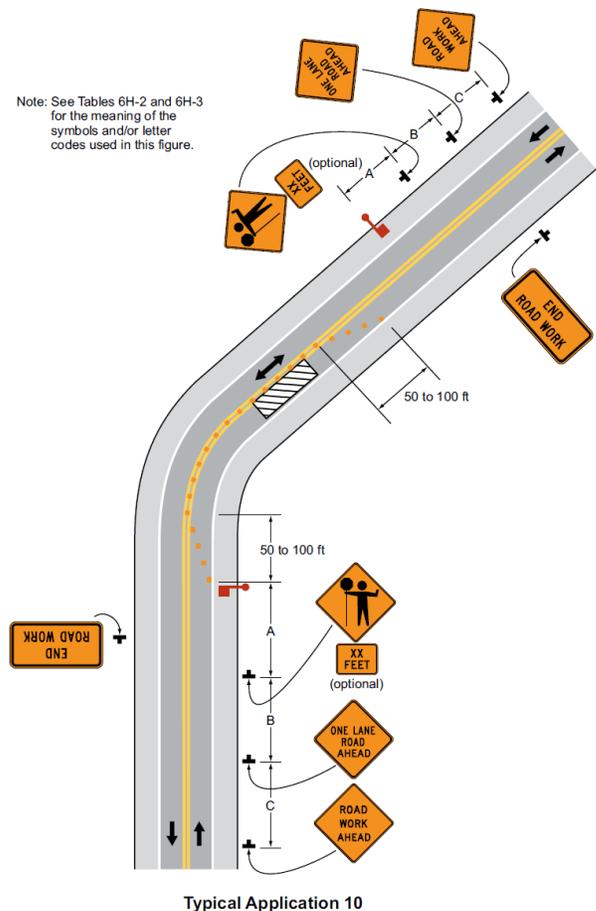
Figure A. *Michigan Manual of Uniform Traffic Devices, Figure 6H-10: Lane Closure on a Two-Lane Road Using Traffic Regulators.*

MIFACE recommends, due to the posted speed limit of 50 mph in the area and the assumed traffic volume (due to the many businesses located just south of the intersection) that the minimum MMUTCD traffic control device plan be TA-10: Lane Closure on Two Lane Road Using Traffic Regulators (see Figure A). Ensuring that traffic is stopped in both directions as the worker walks from one side of the road to the other side ensures the worker will not be struck by a vehicle. All traffic should be stopped when workers are crossing/working in the roadway. Traffic regulators are one method to ensure this.
