**REPORT#: 18MI105**

**REPORT DATE: 7/7/20**

## Construction Firm Owner Dies From Fall From 8-Foot Step Ladder Or Overhead Platform

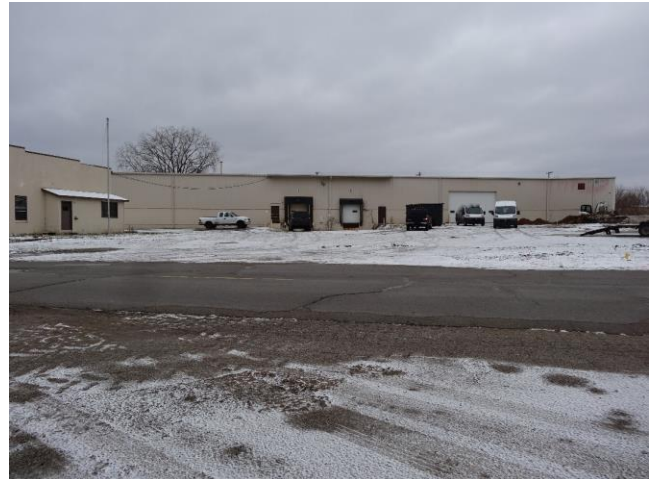
The incident scene was inside of a warehouse undergoing demolition/renovation (Photo 1). The decedent was working from either an 8-foot step ladder positioned on a level concrete floor or from an elevated platform. If working from the ladder, based on his height, he most likely was standing on the third rung from the top. The decedent was using a compressor-powered saw to cut away foam-covered plywood platform positioned between two trusses/floor joists.

Photo 1. Warehouse undergoing demolition/renovation

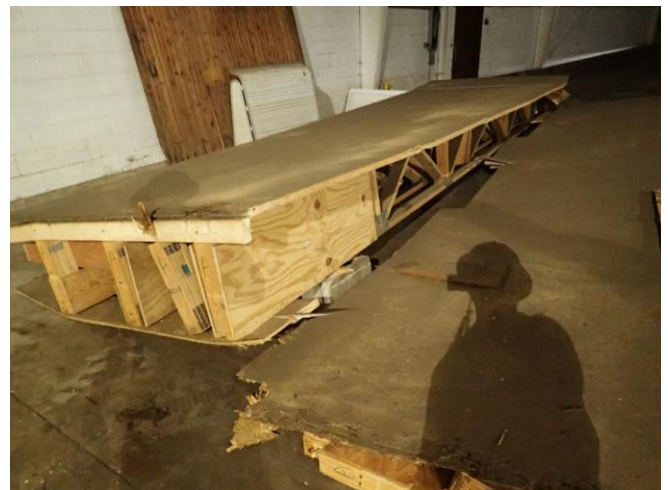
Photo 2. Example of truss/floor joists with foam-covered plywood that had previously been removed.

ultimately decided to use a Bobcat to lift them up and twist them away from their attachment points, and then use the Bobcat to move them outdoors (Photo 2).

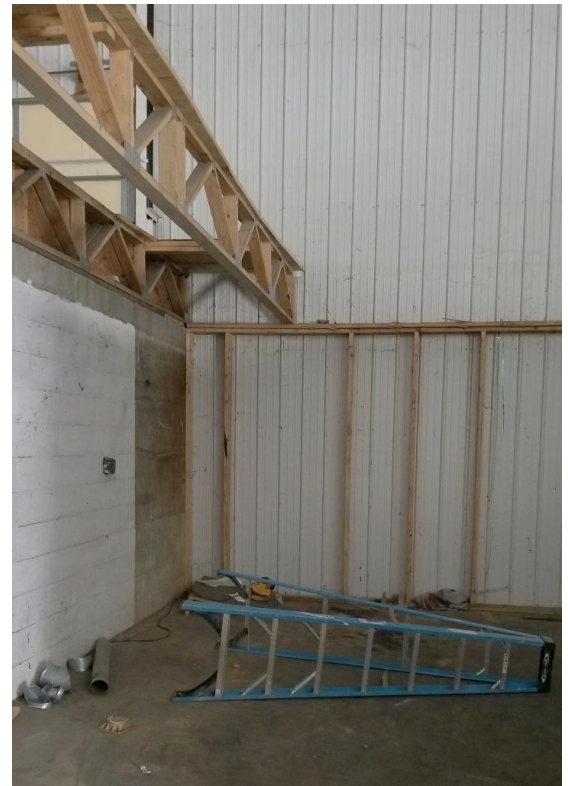
After the trusses were removed, the last truss (as described by the son as the most “dangerous” truss) required removal. The last two floor joists were associated with a 9-foot-high cement block wall (Photo 3). One of the two floor joists was positioned on the top of the cement block wall. They could not use the Bobcat to remove the truss because they did not want to damage the cement block wall.

The decedent’s fall occurred a few minutes after noon. His son was outside, working with the Bobcat as well as tearing the insulation-covered plywood floor from the previously-removed floor joists. He took a short break, and during this time, he heard the crash of the ladder and plywood hitting the floor, and then the compressor “go to idle” (the compressor idles when the saw is not in use). He ran to the source of the sound and found his father face down on the concrete floor. The ladder had tipped to the side. A piece of plywood was near his father, and the saw was laying on the plywood on the floor (Photo 3).

*Photo 3. Incident scene showing ladder tipped to side, saw used at the time of the incident, and portion of elevated platform which fell.*

The decedent selected a Type 1 (Heavy Duty) step ladder from which to work. The maximum weight the ladder was designed to carry was 250 pounds. The decedent weighed more than 250 pounds. Overloading a ladder can result in ladder instability. A safer ladder selection for the decedent would have been a Type 1A step ladder, which has a maximum carrying capacity of 300 pounds or a Type IAA (Extra Heavy Duty) ladder capable of supporting 375 pounds.

### ***Recommendation #1: Employers should try to minimize the use of ladders as a work platform.***

### ***Recommendation #2: Ensure proper ladder selection and safe ladder use.***
