**REPORT#: 17MI098**

**REPORT DATE: 10/22/19**

## Farm Owner Drowned in Ditch When Tractor Overturned to Side and Pinned Him

### Fatality Assessment & Control Evaluation

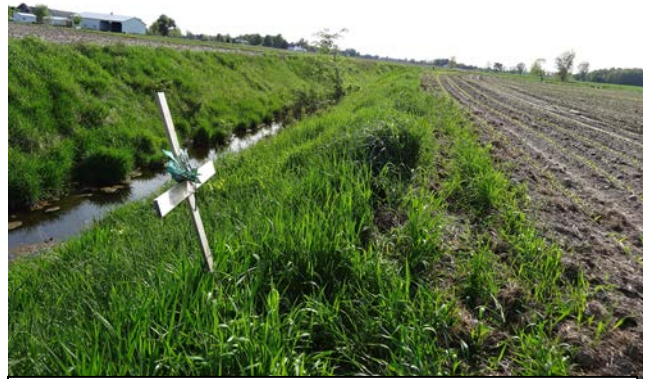
*Photo 1. View of field looking west. Cross placed at site of incident.*

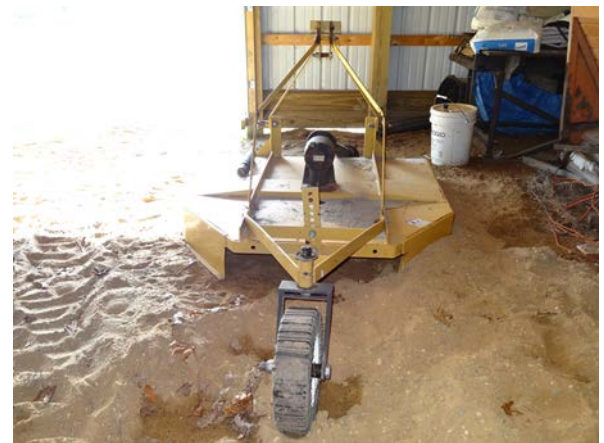
The John Deere 2320 tractor involved in the incident was purchased in 2009-2010. The tractor was purchased equipped with 42-inch long front forks and a roll over protection structure (ROPS). For reasons unknown, the decedent removed the ROPS. When mowing, the decedent attached a PTO-powered brush hog to the rear of the tractor (Photo 3).

*Photo 3. Brush hog used on day of incident*

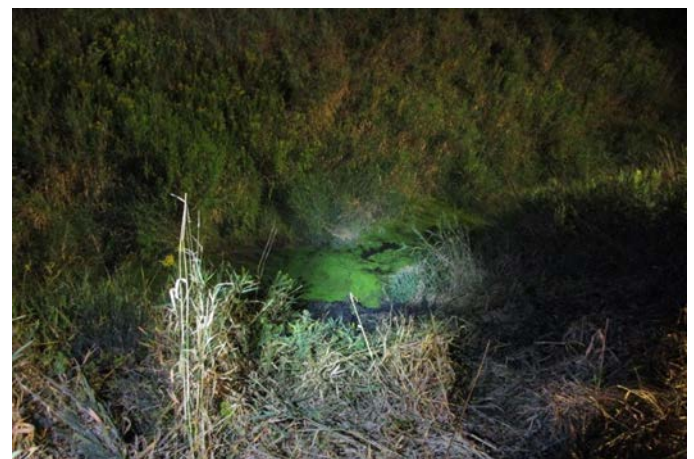
It appeared that the decedent had been driving eastbound adjacent to the bank mowing the weeds. Police noted that the incident site had an area that clearly showed where the vegetation had been knocked down at the bank of the drainage ditch at the incident scene (Photo 5).

*Photo 5. Incident scene showing ditch bank and water level.*

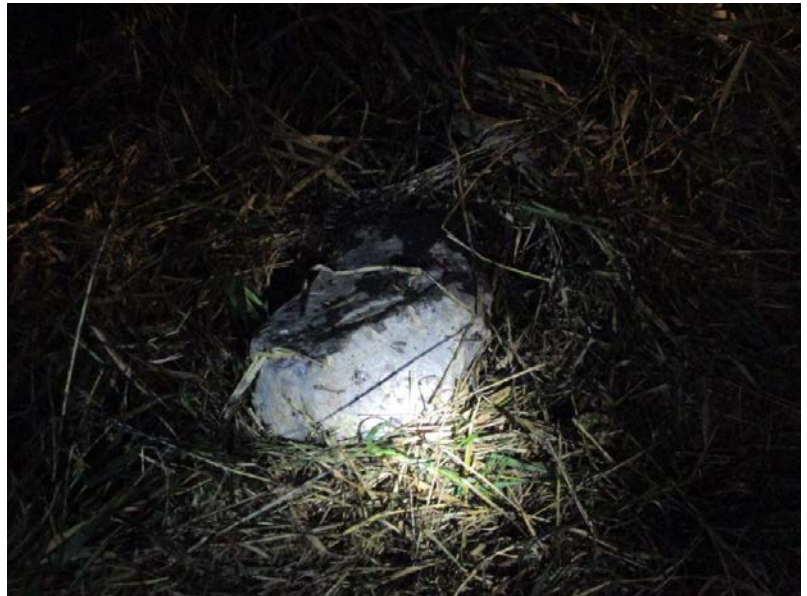
The incident was unwitnessed, and the exact sequence of events is unknown. Several hypotheses were developed based on potential scenarios: 1) The tractor struck concrete debris obscured by tall and/or lush grass (Photo 6). The impact either bounced the tractor or turned the steering toward the ditch leading to a slide down the slope enhanced by the tractor's "turf tires." Near the bottom the tires caught beginning an overturn that ejected the operator into the water. Due in part to the removed/disabled upper ROPS section the tractor completely flipped, landing on top of the operator and pinned the operator in a submerged condition; 2) the passenger side tractor wheel(s) were too close to the edge and the bank sheared, causing the tractor to slide down

*Photo 6. Concrete block at ditch edge that may have been a factor in this incident*

Where operations are to occur where there is a likelihood of obstructions hidden by plant growth operators should consider a worksite survey to determine if obstructions are present.

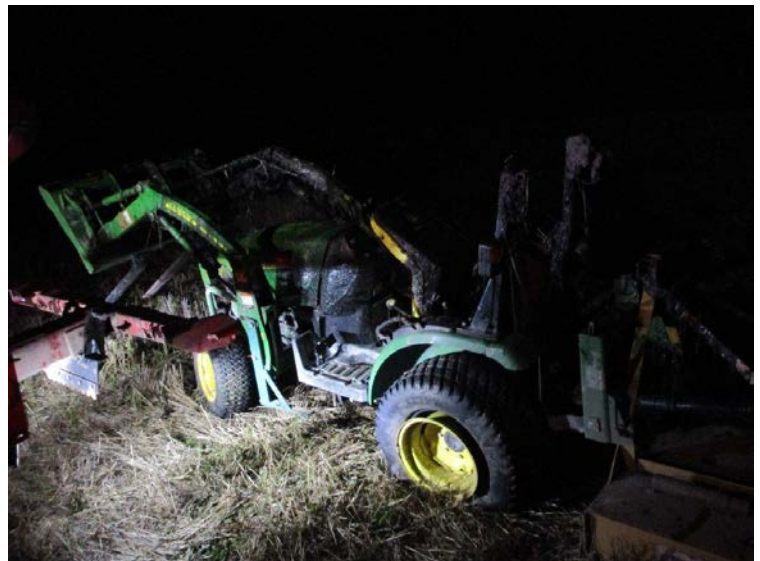
A towing company with the assistance of emergency responder removed the tractor and the decedent's body from the ditch. After the tractor was removed from the ditch, police found that the driver's side rear tire was flat.

When the tractor was removed from the ditch, the tractor bucket was elevated (Photo 7). It is unknown if the decedent had been operating the tractor with the bucket elevated or if this was caused when the tractor rolled into the ditch. Post mortem examination found evidence that he may have been, at one point during the rollover, under one of the rear tractor tires.

*Photo 7. Condition of tractor after being removed from ditch. Note elevated bucket and flat driver's side rear tire.*

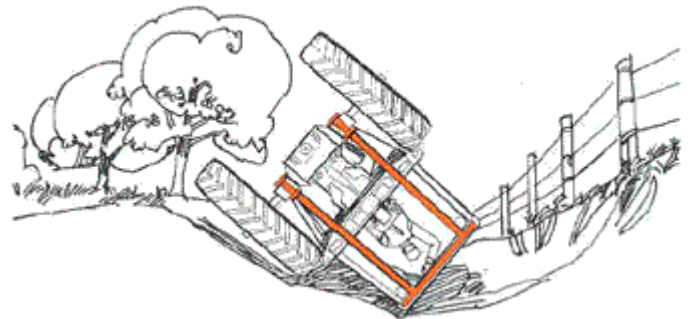
Discussion: Although the farm was on flat terrain, a rollover hazard existed at the confluence of the ditch edge and field. Rollover protective structures (ROPS), when used in combination with a seatbelt, are 98 percent effective in preventing death and serious injury in the event of a tractor overturn. The tractor had originally been equipped with a factory-installed rollover protection structure, but the ROPS was removed by the decedent. If the ROPS and seatbelt were used as intended, the decedent might have been able to exit the tractor seat after the tractor came to rest at the base of the ditch because the ROPS may have provided enough clearance between the tractor seat and the base of the ditch.

*Figure 1. ROPS protecting operator in tractor overturn to side*

**Recommendation #1: Tractor owners should ensure their tractors have a manufacturer-approved, certified, tractor specific rollover protection structure (ROPS) and seatbelts installed.**

To maintain the operator safety, tractor operators should ensure that all tractors are equipped with a tractor-specific ROPS and seatbelt certified/approved by the manufacturer. To maintain the zone of protection provided by the ROPS, the seatbelt must be used. Operators should assure any unit where the ROPS has been removed for authorized operations is only used for those operations. Older tractors manufactured prior to 1976 do not come equipped with a ROPS. To assist farmers in finding a ROPS for these older tractors, the University of Kentucky Extension program developed the Kentucky ROPS Guide, which can be used by any US or Canadian farmer to locate retrofit ROPS for older tractors or even “gray market” tractors (i.e., non-U.S. made tractors imported without manufacturer authorization). The guide is available online at <http://www.ca.uky.edu/rops>.

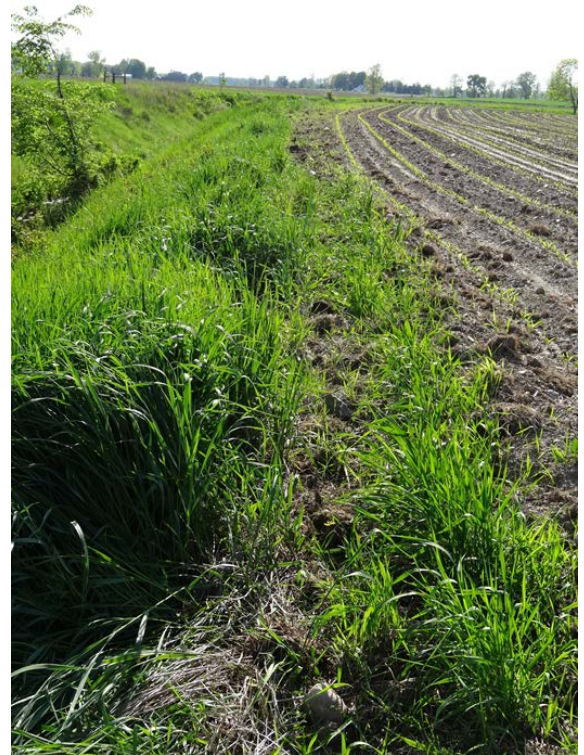
Discussion: The outside row of soybeans was planted approximately two- to three- feet from the edge of the ditch edge. This limited distance between the edge of the field and the ditch narrowed the traveling room the decedent had to avoid injury to the crop. A planting boundary should be established so that the outside planting row does not impinge on an access area to other fields/areas. The grass boundary from the edge of the ditch should be at least equal to the depth of the ditch. A good rule of thumb is to stay back from the edge of the ditch as far away from the bank as the ditch is deep. The weight of the tractor could cave the bank in if too close to the shear line.

*Photo 8. Looking west, field edge. Photo taken from location decedent’s tractor overturned.*

***Recommendation #2: Conduct a field survey to identify hazards, including hidden obstructions and establishing crop-planting limits/boundaries to maintain farm machine access.***
