MIFACE INVESTIGATION REPORT #17MI007

SUBJECT: Truck Driver Died After Being Thrown Back by Air Release from a Pressurized Tire Sidewall Failure

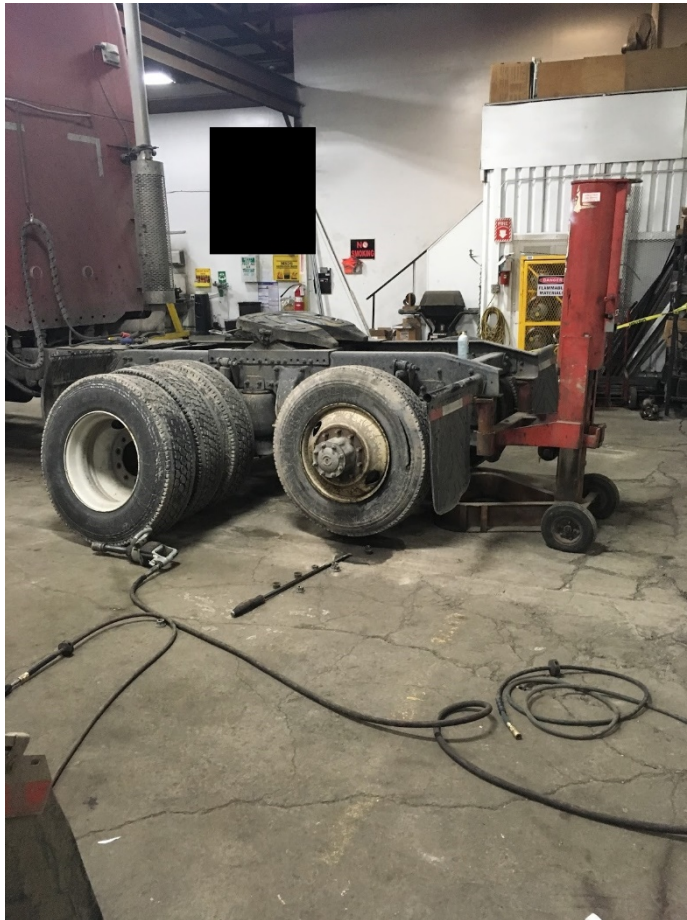
Figure 1: Incident scene

The decedent was starting his shift in the evening, having finished approximately 12 hours previously. The driver brought his Freightliner truck in to the maintenance department because of a flat tire on the inside wheel of the third axel on the driver's side. The decedent's truck was the only one present in the maintenance area that evening. The tire was a General Tire Model ST250, and had previously been retreaded. The driver accompanied the truck in the maintenance area (Figure 1), and was assisting two mechanics by setting and releasing the air brake as needed.

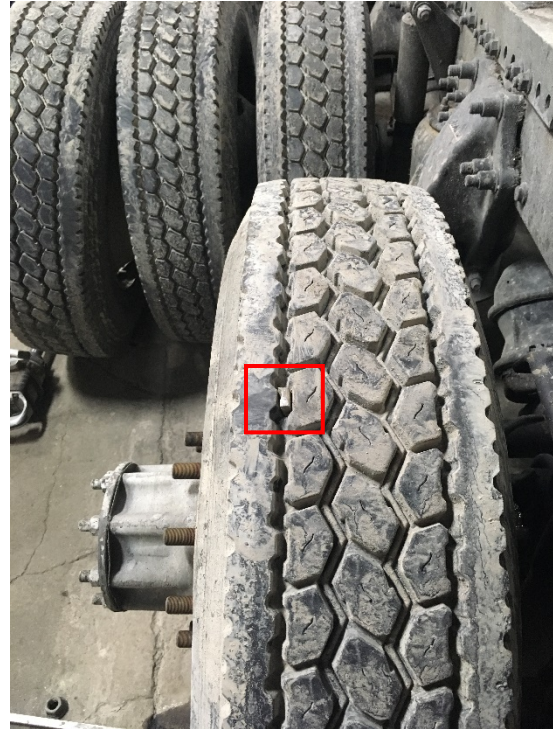
The mechanics initially tried inflating the tire with an air chuck and, when this failed, jacked up the truck to relieve pressure on the tire and attempted to inflate it again. After a further lack of success, the mechanics removed the outer tire, and used a TSI Cheetah bead seating tool to get the tire to take its bead. Following further attempts to inflate the now-seated tire using a clip-on air chuck, it was noticed that the tire had a leak. While one of the mechanics left to retrieve a tire plug kit, the decedent released the air brake and approached the tire to inspect it. He noticed a small piece of metal sticking out of the tread of the tire (Figure 2), and pointed this out to the remaining mechanic. According to the interview, the mechanic began letting air out of the tire in order to remove the piece of metal.

Figure 2: Metal debris stuck in tire

During their training for pre- and post-trip inspections, drivers should be instructed on how to look for signs of wear or damage on their tires, such as extensive or uneven tread wear or cracks or breaks in the rubber of the tire, including in the sidewall. Care should be taken to inspect inside dual tires, such as the one involved in this incident, as signs of damage might more easily be missed on inside tires due to their location. If a tire has been found to be underinflated (or, as in this instance, flat), the integrity of the sidewall should be carefully inspected, as this is a known contributor to the weakening of tire sidewalls.

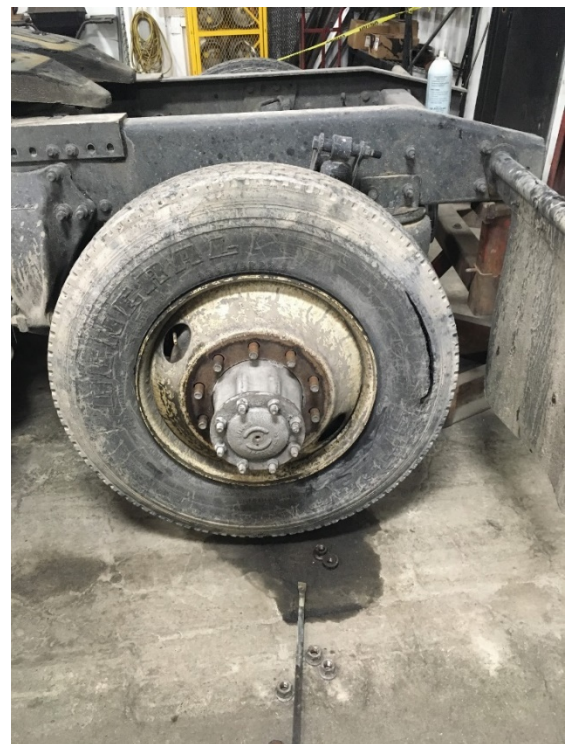
The mechanic warned the decedent about standing directly in front of the tire. At this time, the sidewall of the tire ruptured (Figure 3). The decedent was standing directly in front of the tire sidewall, approximately three feet away according to the MIOSHA investigation. The tire model

had an inflation pressure of 105 pounds per square inch; however, as the tire was flat and in the process of being repaired, it is unknown what the pressure of the tire was at the time of rupture. The driver was knocked back by the force of the pressurized air release, striking his head on the concrete floor, according to the mechanic present at the time. The decedent landed on his back with his head approximately 12 feet away from the tire.

Figure 3: Ruptured tire sidewall

- Use best safety practices, such as a tire cage, when performing tire maintenance, and provide training on the procedures.

Maintenance personnel, alongside any other employees or drivers authorized to be present during truck maintenance, should be trained in in best safety practices regarding tire maintenance and repair, including methods to prevent, or minimize the effects of, a tire explosion. The inflation of a tire should be performed while the tire is restrained within a device such as a tire safety cage. Cages absorb some of the impact of a tire explosion, and shield employees from components of the tire or rim that may be projected during the explosion. During this incident, the tire was being inflated and worked on while it was still mounted on the truck. The use of a cage or other restraint might have weakened the effect of the explosion and better communicated the hazards present to unaware employees, including the decedent.

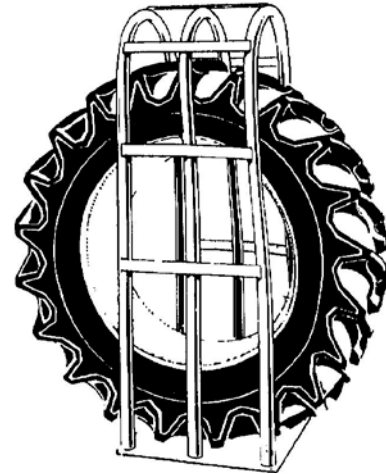
Figure 4: Illustration of a tire cage (source: <https://www.osha.gov/Publications/OSHA3086/osh3086.html>)
