# 2008 ANNUAL REPORT

## TRACKING WORK-RELATED DEATHS IN MICHIGAN

**F**atality  
**A**ssessment &  
**C**ontrol  
**E**valuation

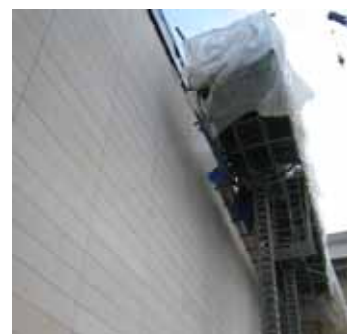
*A male journeyman mason died as a result of falling from an unguarded working surface of a Hydro Mobile 2 scaffold raised to 35 feet.*

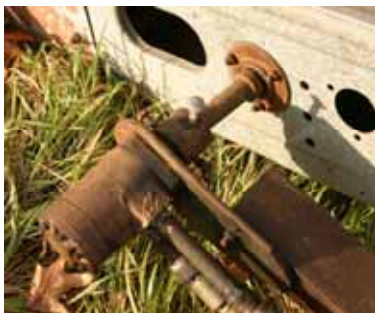
*A farmer died when his clothing became entangled in an unguarded rotating motor drive-shaft on a farm-modified ear-corn elevator. MIFACE Investigation Report 08MI135*

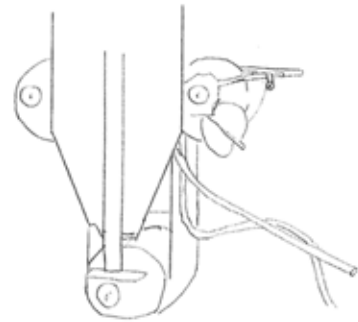
<p><i>Steel industry supervisor died when he was pulled from a catwalk, struck against a conveyor system support structure and fell to the floor below. MIFACE Investigation Report 08MI001.</i></p>

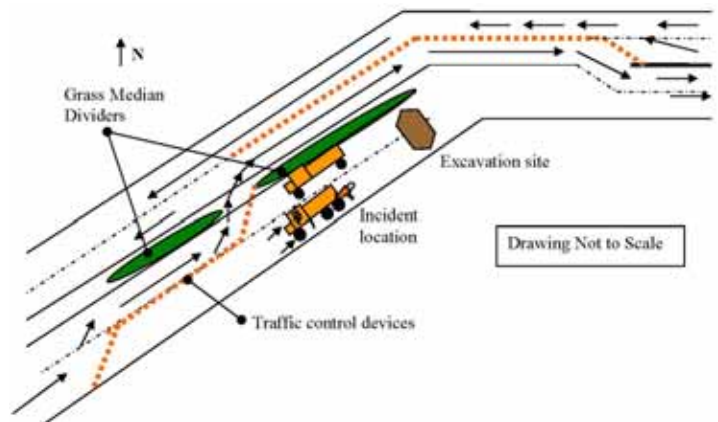
*A truck driver died when he was struck by a backing dump truck at a sewer repair project. MIFACE Investigation Report 08MI040*

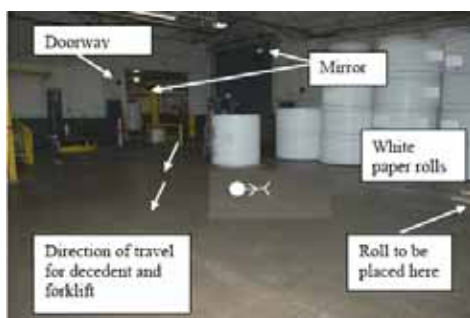
*A traffic supervisor was walking through a warehouse when he was struck by a clamp truck carrying a paper roll. MIFACE Investigation Report 08MI010.*

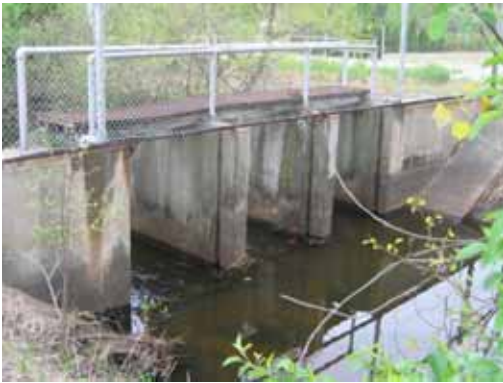
*A male farmer, who was a member of a volunteer cooperative drowned, as he was removing wood stop logs from the drain's water level control structure to relieve a high upstream water level. MIFACE Investigation 08MI135*

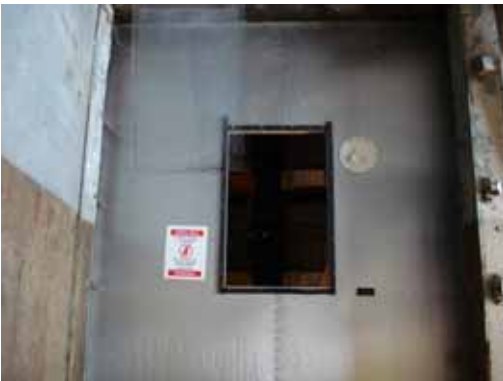
*A male laborer was asphyxiated when he entered a controlled atmosphere storage room.*

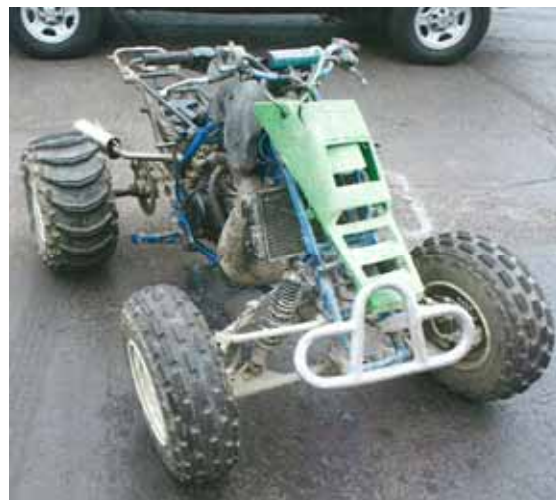
*A male laborer in an automobile repair shop died when both he and the Kawasaki Tecati Model XF 250 four-wheel all-terrain vehicle (ATV) he was test driving in the parking lot struck a concrete wall*

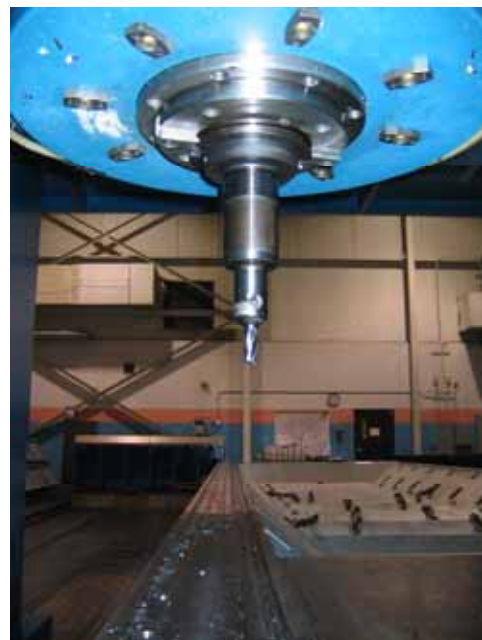
*A male machinist died when he contacted and then his clothing became entangled in the rotating vertical cutting head of a gantry mill.*
